LP BULLETIN

Bulletin 582 - 5/08 - Cargo Fire from Oxy-Acetylene Cutting - Worldwide

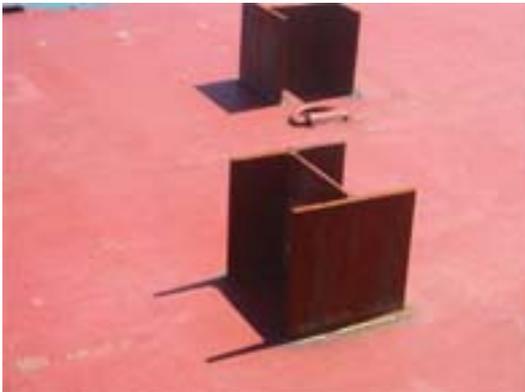
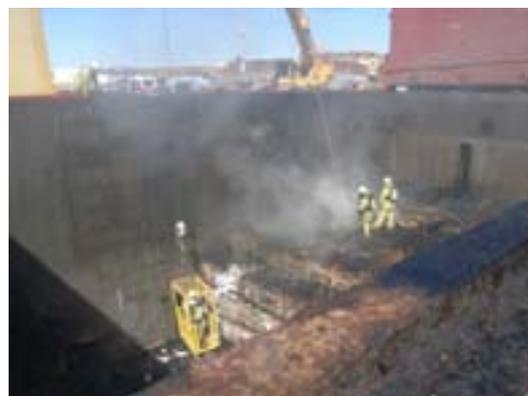
In this incident, in the process of removing the brackets, a hole was inadvertently cut in the aft cargo hold hatch cover. As a result, sparks and molten metal fell into the cargo hold and onto the pallets of cargo stowed below.

When smoke was sighted and the alarm raised, the ship's fixed fire extinguishing system was used to flood the cargo hold with carbon dioxide, and the ship was brought alongside a wharf where the local fire fighting authorities took control. Despite several methods to extinguish the fire, it was four days before the fire was confirmed extinguished and not before the hold was flooded with approximately 700 tonnes of water via the fire monitor on an offshore supply vessel.
