LP BULLETIN

Bulletin 584 - 6/08 - Case study: grounding - Worldwide

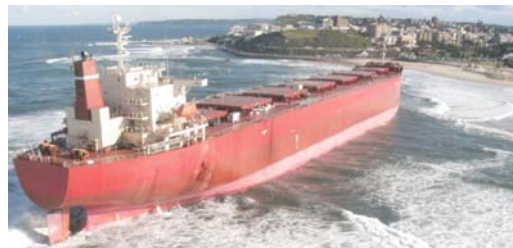
The master got the ship underway after winds were gusting to nearly 50 knots and her anchor was dragging. For more than an hour the ship moved, in ballast, in a direction parallel to the coast about one mile away with an onshore wind. The grounding occurred when the master decided to alter course to put the wind on the other bow. The course change in the extreme weather was poorly controlled and put the ship on a heading whereby she was approaching the beach. Inevitably the vessel grounded with both anchors in their hawse pipes.
