LP BULLETIN

Bulletin 592 - 7/08 - Case study: improper use of fumigant in bulk cargoes - Worldwide

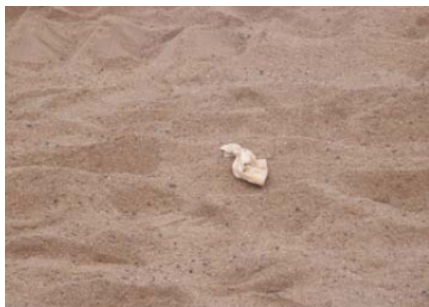
The socks containing the fumigant were buried in the cargo. The

surrounding cargo would have slowed the dissipation of heat from the reacting fumigant tablets. As a result, it is likely that the local temperature rose to a level above the auto-ignition temperature of the diphosphine gas and that the gas subsequently ignited.

1. Fumigant buried in the cargo with only the top part of the sock exposed
2. The fire affected areas of the cargo
3. The cargo on the wharf being hosed.

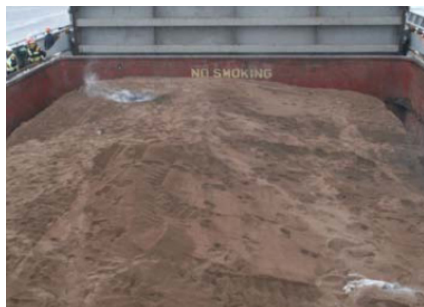
When the hold was opened, it was apparent that only two small areas of the cargo had been affected. Both of the affected areas had burnt in a circular pattern that was centred on the location of a fumigation sock. However, the fires had not grown in size over the ensuing days because as they developed they had consumed the available oxygen in the cargo hold.
