# LP BULLETIN

## Bulletin 608 - 11/08 - Unsafe Berth - Salvador, Brazil

**An incident investigation has found berth fendering at Salvador to be in a poor state of maintenance. Vessels sailing to the port should be vigilant to the condition and suitability of fendering before committing to coming alongside the berth.**

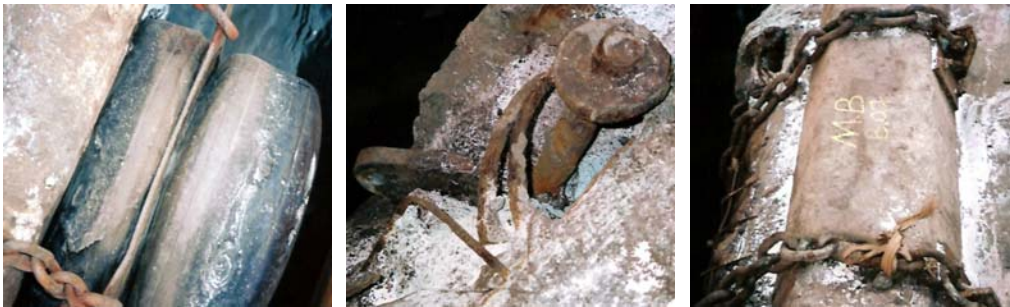
The survey has found that most tyres on the berths are partly damaged/cut, heavily pressed and with exposed hanging chains - in no condition to withstand the heavy pressure that can be exerted on them during normal vessel berthing operations.

In the case reported in this bulletin, the concrete base from which the fender was secured was found with signs of damage from several previous incidents. Additionally, the hanging chains were heavily pitted and corroded. One of the chains was also sighted to be partly damaged and bolts were missing from the securing arrangement.

A Vessel may be held liable for damage to fenders and it is important therefore to determine if there is any pre-existing damage before, and as, the vessel comes alongside. In cases where there is risk to the vessel it may be necessary to protest the berth is unsafe and request another berth be allocated. In other cases, even when it is deemed safe for the vessel to come alongside the berth, any existing damage observed should be reported and documented. As a matter of routine, it is recommended that the following precautions are taken:

- If it is suspected that claims have been submitted for pre-existing damage, the master should draw the port authority's attention to such damages and record details in a written report and in the logbook. A video recording or dated photographs may prove useful in defeating any unjustified claim.

- A close watch should be kept of mooring arrangements whilst at berth in order to prevent ranging damage. This is particularly important at berths not adequately protected from sea swell and weather conditions.
