LP Bulletin

Bulletin 617 - 1/09 - Poor Design of Watertight Door - Worldwide

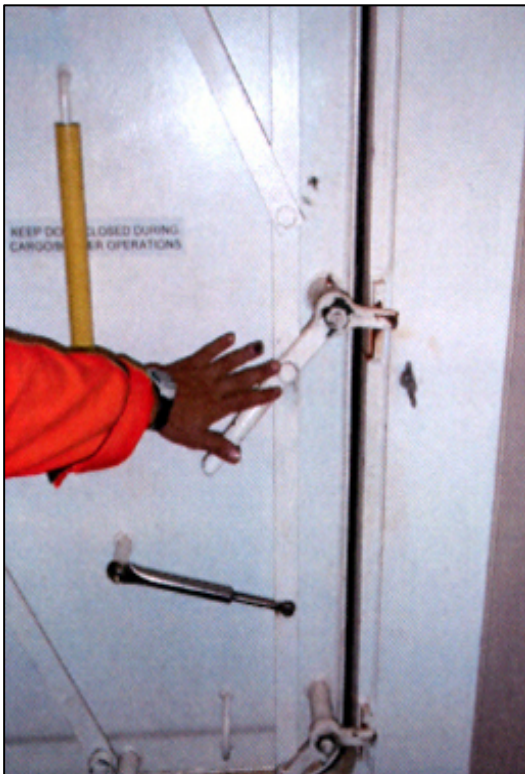
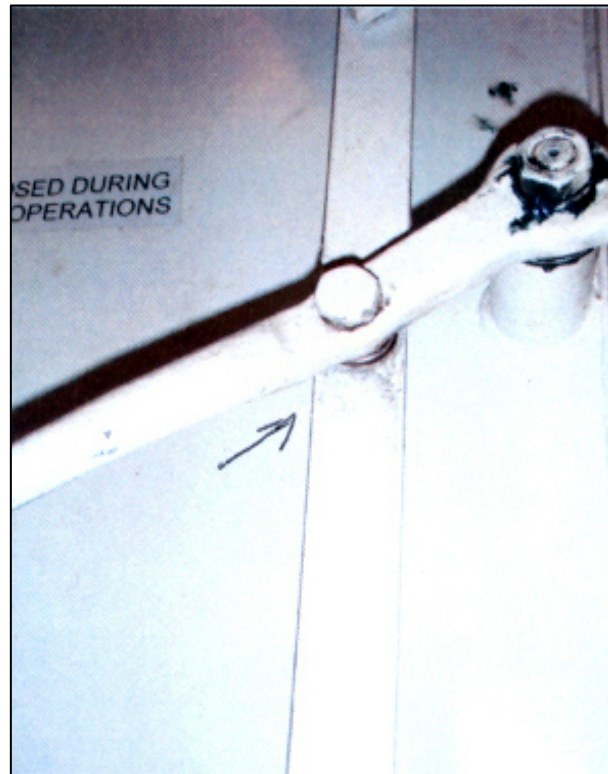
The Club is handling a case where a crewmember suffered injury to his hand while operating the watertight door on a newbuild vessel. As can be seen from the images below, the operating handle passes over a vertical bar which is another moving part of the mechanism. The two parts create a scissor action whereby they come closer together as the handle is pushed down to close the door.

As a result of the incident, the seafarer suffered injury to a finger that got caught between the two parts. Such injury can seriously affect a crewmember's ability to carry out his tasks on board and may result in repatriation and delays to the vessel.

The Association is concerned that other vessels may be fitted with the same arrangement on their watertight doors. Where this design exists, Members are encouraged to warn crew of the hazards associated with operating the door(s) and take measures to have the mechanism replaced, or prevent injury incidents through some other means.
