# LP Bulletin

## Bulletin 627 - 3/09 – Poor Lighting - Worldwide

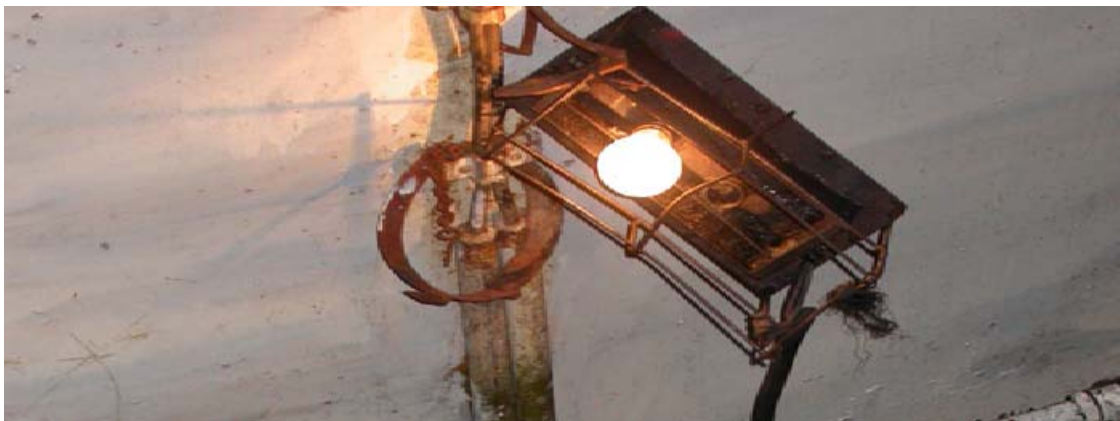
Whilst two vessels lay berthed alongside one another, a crew member from the most seaward of the two wished to lay a hose to the quayside to load fresh water. In doing so he had to bypass the vessel that lay between his own vessel and the dock, whilst crossing over he entered an area with very poor lighting and consequently fell into an open hatch.

Some of the major risks associated with poor lighting are slips, trips and falls but it should be remembered that the likelihood of any accident occurring will be greatly increased if adequate lighting is not provided. Whether it is working in an area that is not correctly lit or passing through an area with no lighting at all, the seriousness of the matter cannot be ignored.

Particular care should be taken to provide suitable lighting for all access ways, deck openings, gangways and emergency escapes. If temporary lighting is in use it should be thoroughly checked and rigged in a safe manner, all cables should be secured to prevent further risk.
