MARS 200845

Near miss while anchoring

Seaways July 2008

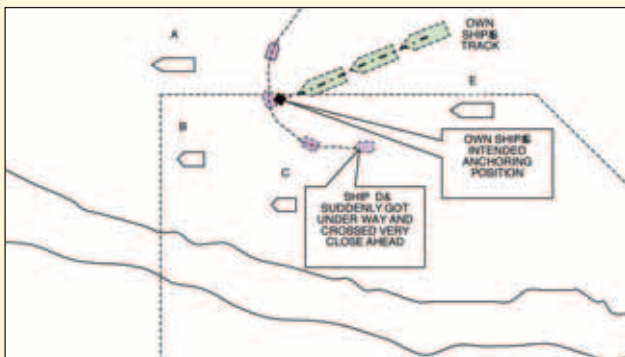
Own vessel, a large, deep-draught loaded tanker, was proceeding to anchorage at night under VTS instructions. It was decided to anchor at least seven cables away from all vessels. The duty officer was on watch and the master had the con, with the helmsman on the wheel. During the final approach, we observed five ships at anchor (A,B,C,D & E as indicated in the figure below), all lying on westerly headings.

When four cables from the planned anchor position, with a speed of 1.8 kts, the bridge team noticed movement and propeller wash of ship 'D', a small cargo ship. Her ARPA vector also confirmed that she was making way and was on a near-collision crossing course. However, she continued to display all deck lights and anchor lights. Having received no information on the ship's movements, the OOW called her and inquired about her intentions, as own vessel was on her final approach to the designated anchoring position. As contact was established with ship 'D' on VHF, she switched off her anchor lights and switched on her navigation lights, although the deck lights were kept on. She informed own vessel that she would be leaving the anchorage by passing ahead of us.

We informed ship 'D' of our deep loaded condition, our intended anchor position and approach speed and requested her to keep a safe distance. Vessel 'D' acknowledged and agreed to abide. To our surprise and shock, however, she then proceeded to alter course very close across our bow. The master immediately ordered full astern on the engine to avoid a collision. Ship 'D' finally crossed own vessel's bow only 200 metres off. A verbal report was made to VTS.

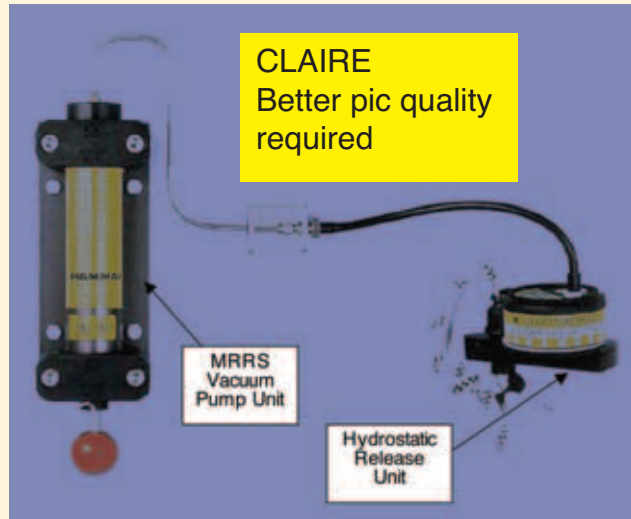
The liferafts were fitted with individual 'Hammar' manual remote release system (MRRS), with manually operated vacuum pump units. When operated, the pump evacuates a small bore pipe, actuating the corresponding hydrostatic release unit. In this case a large number of those pumps failed to activate the hydrostatic release units and, ultimately, the crew had to cut the liferaft canister lashings manually. The crew was able to launch all of the vessel's liferafts successfully in this manner.

MRRS pump units are clearly marked on the cylinder housing, 'Lubricate piston every second year'. The pumps that failed had not been lubricated as required. The malfunctioning MRRS pumps were replaced in kind with new units; USCG inspection showed that these operated properly.

The casualty investigation is not complete and additional recommendations are likely to follow. However in the interim, the United States Coast Guard strongly recommends that Hammar MRRS vacuum pump units, as well as all other survival equipment, be maintained in accordance with the manufacturer's recommended maintenance schedules.

Owners, operators, port engineers, inspectors and others involved in vessel safety should ensure that all appropriate steps are taken to properly maintain survival equipment

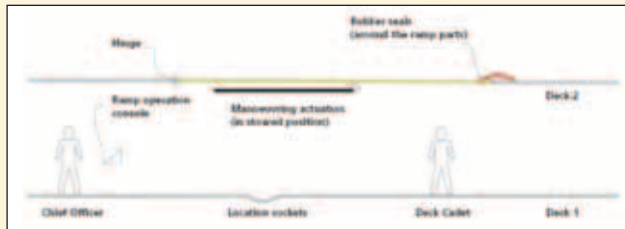
▲ Figure 1: Arrangement of hinged internal ramp

During the operation of a hinged internal ramp onboard a ro-ro ship in port, it accidentally swung down on to the deck below and fatally injured a deck cadet.

1. Rubber seal temporarily catching on fixed ramp section during lowering and then suddenly disengaging;
2. Dislocation of hydraulic actuators causing the free end of the ramp to fall down on to cadet standing underneath (see Figures 1–3).

1. Operating ramps on ro-ro ships form one of many operations of mechanical equipment and systems on board that pose hazards. These hazards should be systematically identified and control measures taken, including evaluation of the equipment, operating procedures and training for use of the equipment as required in the ISM Code.
2. Never stand underneath ramps when they are operated or unsecured.
3. To avoid similar accidents ensure:
 - Correct sequence of operation in order to reduce the possibility of rubber seals catching and to avoid any obstruction to the operators view.
 - The operator should check that all personnel are clear of the ramp before any operation.
 - All personnel, especially those new to the vessel, must be thoroughly trained in ramp operations.

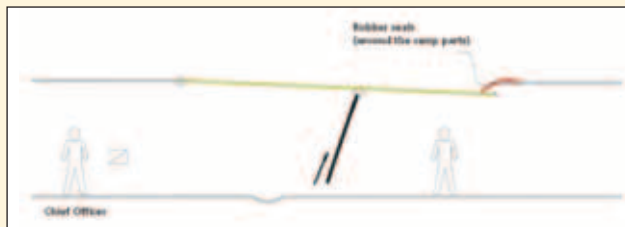
▲ Figure 2: The rubber seal temporarily caught on the fixed section while the actuators continued to retract, causing them to come out of their location sockets.

The CO started lowering the ramp. It was down about 10 cm when the rubber seal probably caught on the fixed ramp

section. The manoeuvring actuators continued to retract and came out of their location sockets, leaving the ramp hanging on the rubber seal only (Figure 2).

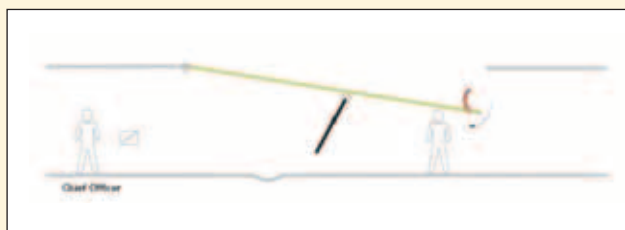
▲ Figure 3: The rubber seal suddenly disengaged from the fixed section and swung down, resulting in fatal injuries to the cadet standing underneath.

Then suddenly, the rubber seal disengaged from the fixed ramp section causing the hinged ramp to swing down on to the cadet (Figure 3).

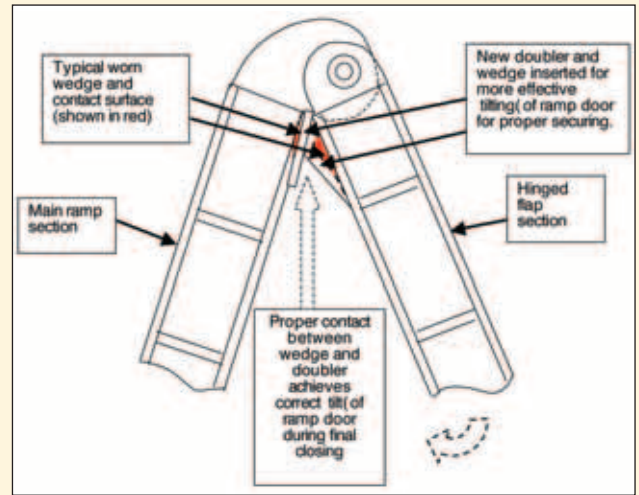
During a day-long experiment on a rare day at anchor, we worked the ramp door in and out several times and eliminated diverse causes such as possible wrong rigging, elongation of wire ropes, malfunction or wrongly adjusted limit switches etc. We finally identified the cause. In the original design, the hinged flap section had a series of triangular wedges welded along the inboard edge. These were meant to engage against

▲ Making the ramp door operable

the outboard edge of the main ramp section during the final folding movement of the hinged section, slowly tilting the ramp door so that the securing lugs would come closer to the drop cleats. These 'contact areas' were considerably worn down and the plate edge even torn in some places, but being on the lower side of the ramp when landed on the shore, the defect was not readily noticeable.

A new set of wedges and small doublers was quickly fabricated in the engine room workshop and immobilisation and hot work permits were obtained at the next berth the following day. Soon after cargo operations were completed, with the ramp suspended sufficiently clear over the wharf, the ship's staff went under it and quickly cropped away the small damaged sections and welded on the new inserts. For the first time in many years, the ramp door was operable normally and the unsightly chain blocks were returned to the store.
