# The Nautical Institute Marine Accident Reporting Scheme

MARS Report No 191 September 2008

## MARS 200862

### Lamellar tear in ballast hold

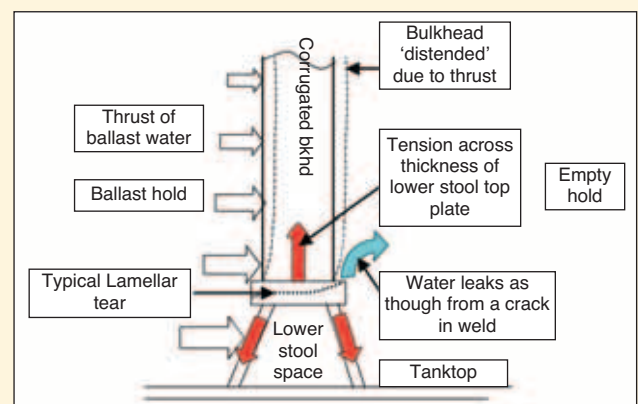
A 10-month-old capesize bulk carrier had done only four ballast voyages since delivery. During these voyages, there was evidence of seepage of ballast water from ballast hold no. 3 into cargo hold no. 4. The location of the 'leak' appeared to be at the connection between the corrugated bulkhead between holds 3 and 4 and the lower stool, centred about four metres to port of the centre-line. Dye penetrant tests did not reveal a crack in the weld, nevertheless, the management instructed the ship's staff to gouge the weld for about two – three metres and reweld the connection.

▲ 1. Side elevation of typical ballast hold showing how lamellar tear is caused

4. The problem may be exacerbated by poor material, design, construction, increased plate thickness.
5. In a large bulk carrier's ballast hold, the head of water exerts a very large force on only one side of the bulkhead, and causes a tensile force across the thickness of the lower stool top plate. This can only be countered by adequate scantlings of the bulkhead and proper design of its joints.

6. The administration and classification society must be informed immediately whenever a structural defect is discovered and repairs must be only carried out with and under class supervision.

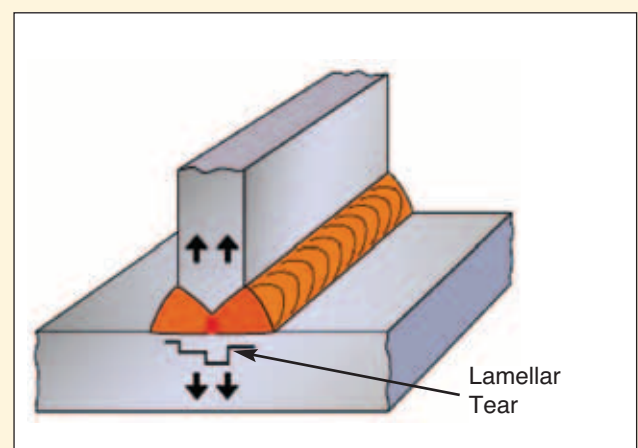
▲ 2. Close up of typical fillet welded joint at connection of hold transverse bulkhead and lower stool top plate

2. The tear normally exists within the thickness of the plate and so will not normally be visible on the surface.
3. Locations where a plate is subject to high tensile forces across the thickness (not along the longitudinal axis) are particularly prone to lamellar tears. Hence, fillet joints are susceptible, whereas butt joints never have this problem.

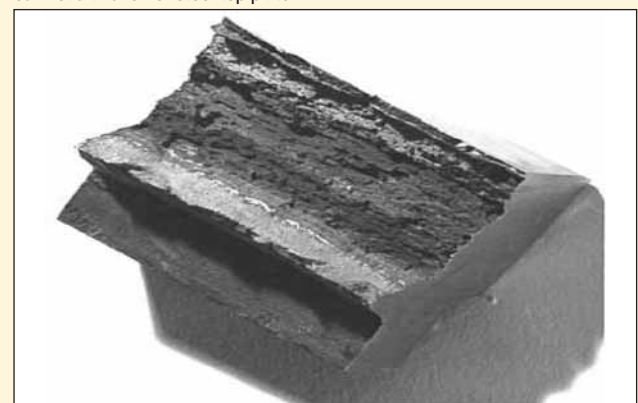
▲ 3. Cross-section of a typical lamellar tear showing 'porous' strata

1. A lamellar tear must be suspected whenever there is leak through a plate and traditional methods do not detect a crack. Ultrasound is more reliable than x-rays in their detection.
