MARS 200881

Severe food poisoning

MARS 200882

The importance of eye protection

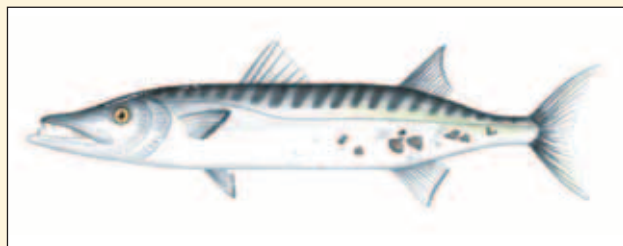
Investigations revealed that they were all affected by ciguatera poisoning. This is a common, non bacterial fish-borne form of poisoning, mainly found in tropical regions. It comes from eating reef fish whose flesh is contaminated with ciguatoxin. In some cases, the effects were very serious and long-lasting, especially for the master, who was still unfit for sea service a month after the incident.

▲ Great barracuda (*sphyræra barracuda*); Typical mass 40 kg

1. Information about the hazards of such fish poisoning will be included in the company's QA manuals.
2. The incident was widely circulated within the fleet and discussed during onboard safety committee meetings, and a copy of the bulletin made available for the crew in public areas.
3. Instructions issued to all ships not to eat fish caught in tropical shallow waters.

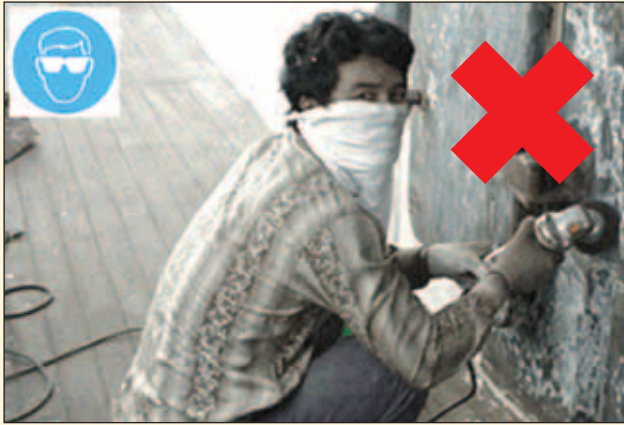
▲ Not this...

The image above shows a crew member operating a handheld grinder without wearing eye protection. Masters should ensure that their crews are properly briefed in all safety precautions when operating grinders and other power tools. Disregard for onboard safety rules should not be tolerated.

Operators of grinding and cutting tools should assume that the disc may shatter without warning and should ensure that the guard will deflect broken pieces away from themselves. The correct component parts which support and secure discs must always be used.

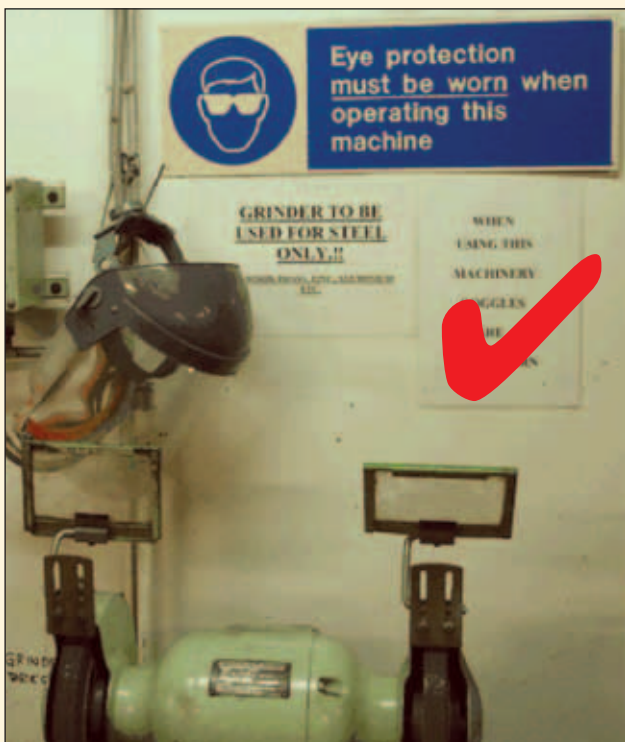
The image below illustrates good working practices on board ship:

- The grinder appears clean and well maintained;
- Safety guards fitted;
- Full-face protection available;

▲ ... but follow this example
