# The Nautical Institute Mariners' Alerting and Reporting Scheme

MARS Report No 201 August 2009

Providing learning through confidential reports – an international cooperative scheme for improving safety

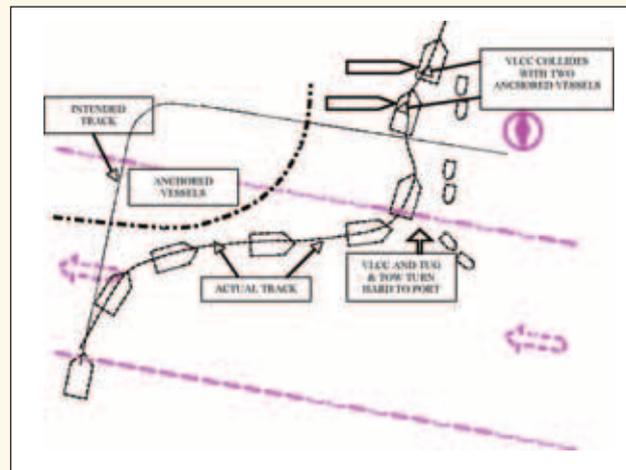
Arriving at a very busy tanker port, and with only three miles to go to the charted pilot station, a laden deep-draught VLCC,

displaying the appropriate signals for a vessel constrained by her draught (CBD), was crossing a west-bound TSS lane from south to north, making about three knots over the ground.

The passage plan envisaged a 90° alteration to starboard after the crossing and a track parallel to the TSS lane's northern edge leading to the pilot station. However, due to numerous vessels anchored within the traffic lane and obstructing her path along the crossing heading, she altered to an almost easterly heading within the west-bound traffic lane for safety (contrary to the general direction of traffic flow). She duly advised VTS of her predicament.

While on this course, a collision situation developed with a tug and tow, crossing from her port bow, on a southerly heading. The tug was not displaying signals to show that it was restricted in ability to manoeuvre (RAM), and despite being the give-way vessel, failed to take early avoiding action. At the very last minute, the tug suddenly altered hard to port and stopped her engine, and the VLCC, by now within one mile from the pilot station, also altered to port as an avoiding action.

However, due to the nature of the vessel's limited slow-speed manoeuvring capabilities under the prevailing circumstances, and possibly an adverse effect of sub-surface current, she drifted on to the vessels anchored close west of the pilot station and collided with two of them, causing hull damage to all the vessels involved.

1. Colregs violation by the tug and tow in avoiding impeding the safe passage of a vessel CBD, exhibiting the signals in Rule 28;
2. Area of high traffic density;
3. Limitations of the VLCC's manoeuvring capabilities;
4. Vessels unlawfully anchored within west-bound TSS lane and close to the pilot boarding area, allowing insufficient sea room for approaching vessels to embark pilot;
5. Due to her deep draught, the VLCC may have been subject to underwater currents different from the anticipated surface currents;
6. Experience of the members of the bridge team could be a contributing factor in determining the risks involved and ship-handling capabilities;
7. Insufficient planning, bridge team management and situational awareness. The bridge was also short of an additional lookout, required under the company guidelines.

1. Representation to be made to VTIS, to ensure that the safe passage of CBD vessels is not impeded by other vessels as far as is practicable;
2. Vessels violating Colregs should be reported;
3. Increased simulator training to be given to masters with seetime of less than two years in command;
4. There should be warning to mariners reflecting changes in currents that are different from the published data and which we presume are severely affected by reclamation of sea areas especially in congested surroundings.
5. The movement of vessels in and out of highly congested port areas to be more attentively monitored by VTIS.
6. Anchoring of vessels in the close proximity to pilot areas and traffic lanes, should be avoided;
7. The use of sea pilots, or an additional officer for vessels routinely engaged in transits through areas of high traffic density, is recommended.

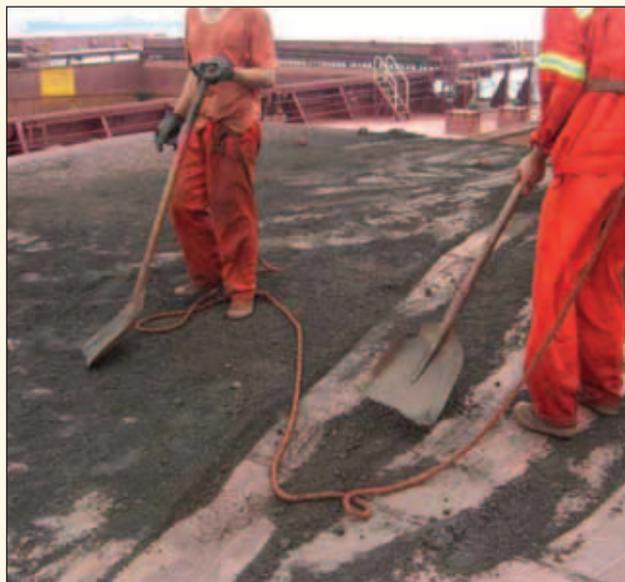
One of our inspectors has highlighted a dangerous practice aboard bulk carriers in some far-eastern ports. The

stevedores climb on top of the open hatch covers and shovel coal, which has spilt on to the top, back into the open hold. As you can see from the photograph, above, their only safety equipment is a rope joining them together. Should either one slip and fall into the hold or on to the main deck, it is doubtful such a system would arrest the fall. The stevedore on the hatch cover would find it hard to maintain his foothold on the coal debris, besides the dynamic jerk on the rope. A fall into a near empty hold would be fatal.
