MARS 200949

Sudden stoppage of steering motor

Unsafe modification to lifeboat davit

Fatal accident during mooring operations

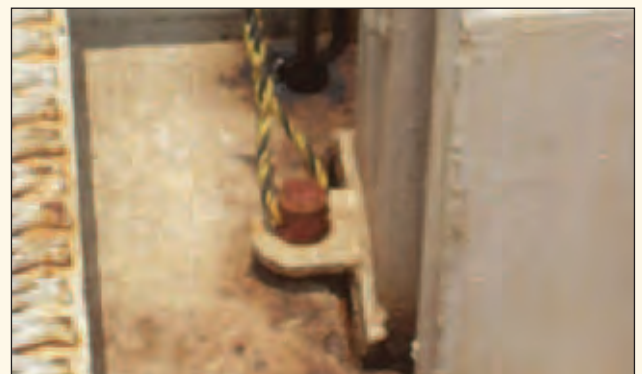
During rough weather it was noticed that there was some movement of the lifeboat davit. The ship staff, without consulting the management, welded an eyepad on to the lifeboat davit arm, aligning it with a hole on the fixed access platform. A pin was passed through these holes to secure the life boat davit.

The danger of such an arrangement is that any deformation of the pin will prevent the quick removal of the pin in an emergency.

1. This modification was not reported to the company. There was a failure in company's SMS reporting procedures.
2. Change management procedures in the company SMS were found to be inadequate.
3. No evidence of risk assessment for such modification recorded on board.
4. Despite the fall wires being fully tightened when the lifeboat was stowed, the weight of the boat was not adequately transferred to the suspension links on the davit arms, and the harbour pin could not be engaged.

■ **Item no. 4 above seems to suggest an incorrect length of fall wire(s), possible obstruction to the free movement of davit arm(s) or improper rigging of gripes: Editor**

▲ Figure 1: View of modified eyepad and securing pin to secure lifeboat davit

1. The unsafe securing arrangement was immediately removed.
2. This incident was conveyed to all vessels in the fleet.
3. The company's reporting procedures to be included in the SMS familiarisation and pre-joining briefing for masters and officers.

4. The management of change procedures in SMS to be amended to define levels of authority for carrying out maintenance on, repair of, modification to, or approving change in operational status of critical equipment, including safety systems and appliances.

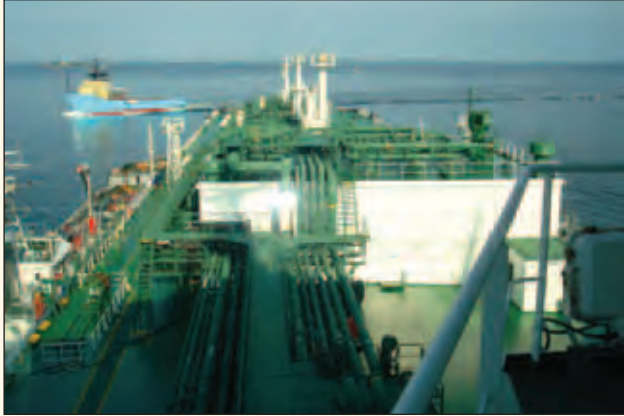
▲ Figure 2: LPG carrier and OSV

During a recent visit on board a large LPG carrier at anchor, I photographed an offshore supply vessel passing very close across the bows of the ship. In fact there was plenty of sea room to go further out.

The captain of the LPG vessel was very unhappy about this incident. He felt that there was little observance of the proper exercise of good seamanship in taking such risks in passing too close to an anchored dangerous cargo vessel, where even a minor misjudgement in conning the vessel or the occurrence of a breakdown of critical equipment would seriously endanger both vessels, lives on board, port facilities and the environment.

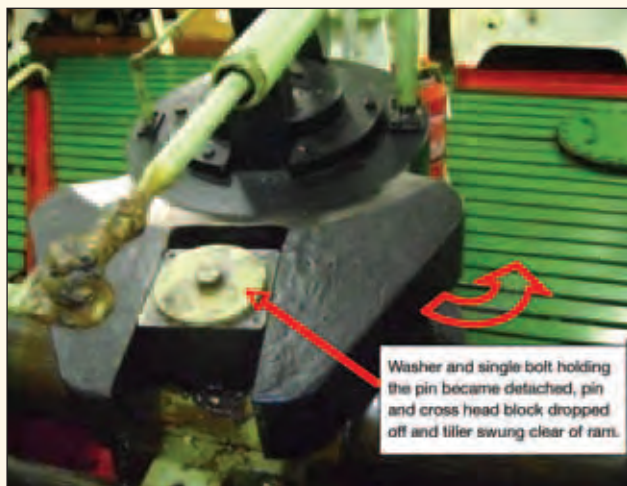
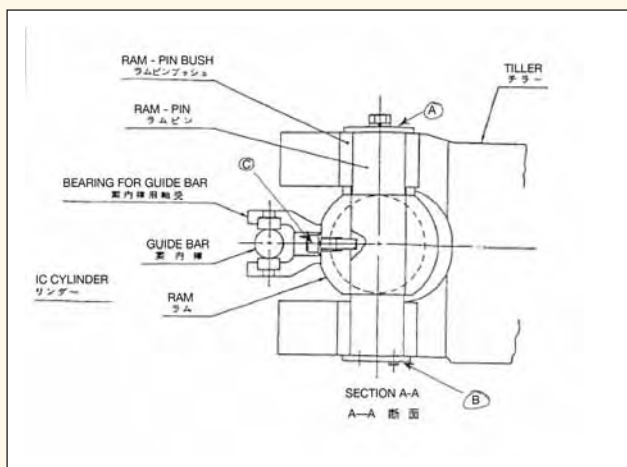
▲ Figure 5 and 6: How the tiller became disengaged.

While at sea, the steering gear ram-pin locking bolts worked loose and the cylindrical collarless pin fell off, causing the rudder tiller to disengage from the ram and swing 90 degrees, clear of the ram. Had the slew angle gone beyond this angle, the rudder could have potentially fouled the propeller rotating at full speed, with disastrous consequences.

The side elevation of ram/tiller connection seems to show that the ram pin is collarless and held in place only by plate washers and keeper bolts at positions A (above) and B (below).

■ **Editor's note:** This report does not explain why this crucial pin did not have a collar at the top, which would have prevented the tiller from disengaging. Ship staff should familiarise themselves thoroughly with the tiller/ram connection on board and ensure they are failproof.

Instructions have been circulated to the fleet to verify that the ram pin locking arrangements are intact during every steering check.

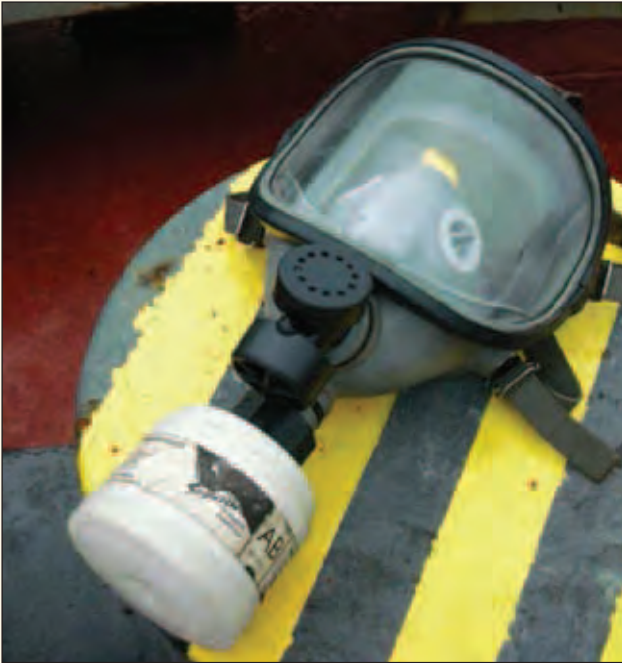
▲ Figure 7: 'Heavy duty' dust mask which the cadet could have mistaken for an EEBD. Such masks should be clearly marked 'Not for use in oxygen-deficient atmosphere' in a language understood by the crew.

7. Any dust/gas masks available on board must be clearly identified and labelled in languages understood by the crew detailing their limitations and with 'not to be used in oxygen deficient atmosphere' on them.

12. All personal safety devices must be suitably labelled to avoid misuse.
13. Material safety data sheets (MSDS) must be obtained from the shipper prior any cargo loading.
