Providing learning through confidential reports – an international cooperative scheme for improving safety

MARS 200955

Fatalities arising from cargo of steel turnings (swarf)

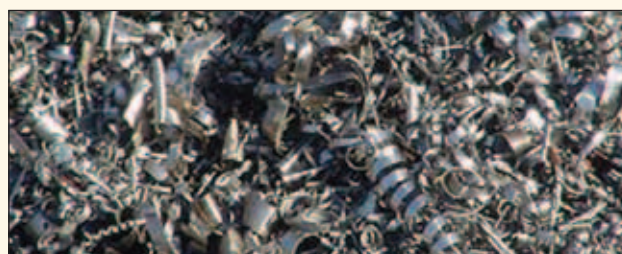
The terminal managers in the loading port did not consider the cargo to be hazardous, and the wet cargo was loaded in rain without trimming or measuring the cargo temperature. The correct bulk cargo shipping name (BCSN) for the International Maritime Dangerous Goods (IMDG) class 4.2 cargo was 'ferrous metal borings, shavings, turnings, or cuttings in a form liable to self heating (UN No. 2793)' and the BC Code lists the special precautions to be taken with this cargo, including the need to keep the cargo dry, monitor cargo temperature during and after loading. It was also noted that the ship's document of compliance – special requirements for ships carrying dangerous goods (DoC), did not permit this type of cargo to be carried.

▲ Steel turnings or swarf

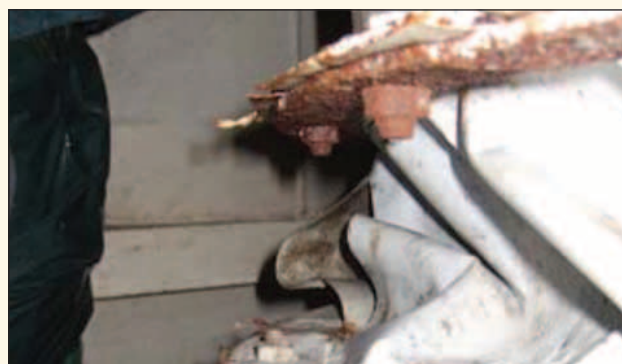
In order to provide a means for draining sea water and to remove cargo residues, the crew had made cuts in the bellows pieces on the cargo vent trunk on either side of the fan motor in the store. This allowed a path for the air from the self-heating cargo, to enter the store. When tested, the air in the cargo hold contained only six per cent oxygen.

▲ Fan bellows cut by crew, providing a path for oxygen deficient air from the hold to enter store room.

2. Owners, charterers and managers of vessels on which a prospective shipment of steel turnings or similar cargoes is being considered should ensure that the vessel's document of compliance (DoC) permits the carriage of the same.

3. Shippers, shipbrokers and cargo brokers and terminals that are involved in the shipment of steel turnings or similar cargoes should ensure that their personnel are aware of the dangers of this cargo; that it is stored and loaded in accordance with the BC code; and that masters receive the required documentation with the correct BCSN, IMDG class and UN number.

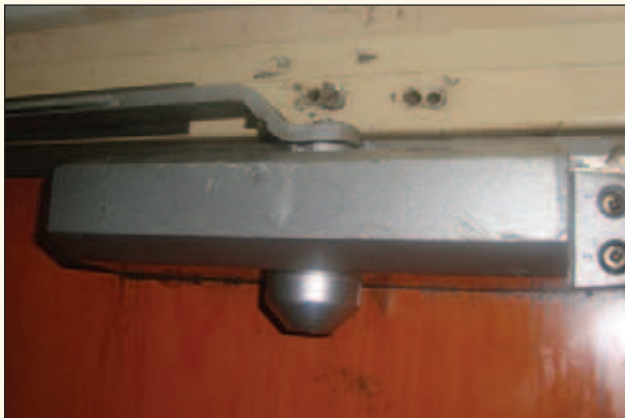
1. **Defects:** Oil has leaked out of the cylinder, causing no delaying action and the door slams instantly with great force, especially if assisted by circulating air. In many instances, repeated violent motion has torn away the actuating lever, putting the equipment beyond repair.
2. **Improperly mounted:** Most doorway frames are of pre-fabricated, powder-coated mild steel sheet, typically 2-3 mm

▲ Figure 1: Failed door closer: hydraulic oil has leaked and repeated, unsuccessful attempts have been made to anchor the actuating lever.

1. Shipowners, shipyards, classification societies and P&I clubs must jointly ensure that doors, drawers and associated fittings are robust and suited to the marine environment in which they are to be used.
2. Automatic door closers must be fitted on all doorways meant for public access and through which persons are likely to carry objects.
3. Doorway frames and shutters should be made of thicker gauge and door closers should be fixed using rivets or through bolts with backing plates and self-locking nuts.
4. The proper fitting and operation of door closers must be included in every safety audit.

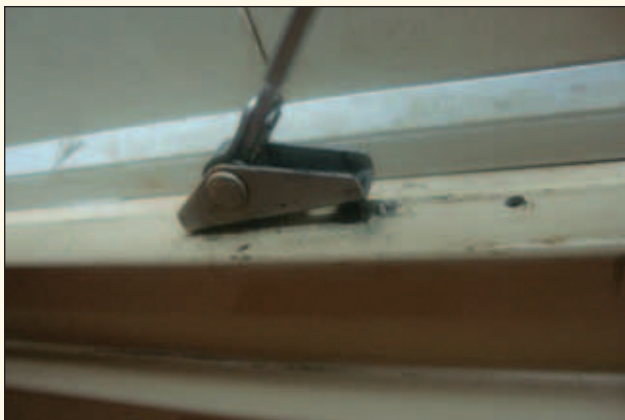
▲ Figure 2: The actuating lever anchor has worked loose from a new position and will soon fail.

thick. The door closer cylinder unit is mounted on the door shutter and made of similar material or, for, non-class A doors, may even be laminated 'particle board'. Fasteners are usually self-tapping or machine screws with very minimal grip. Not surprisingly, things start to come apart a few months after leaving the shipyard. To compound the problems of poor joinery, the countersunk machine screws holding the hinges have a tendency to slip or loosen and drop off. Finally all this 'work and play' puts a wobble in the highly-stressed anchoring point of the hydraulic closer's actuating lever, the screw hole expands and the screws get dislodged and the closer's components begin to droop and act as an obstruction, preventing the door from closing at all.

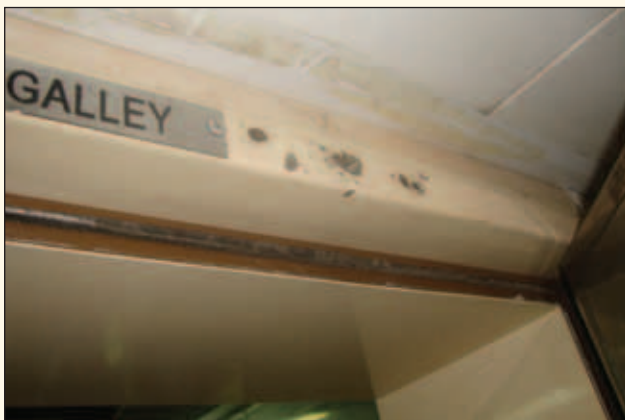
▲ Figure 3: Door closer missing on a very crucial doorway

4. Missing: Often due to frustration, the ship's crew removes the ill-fitting and malfunctioning door closer and even more hazardous arrangements are improvised like tie-back ropes, hooks, wooden wedges, and packaged items from the stores.

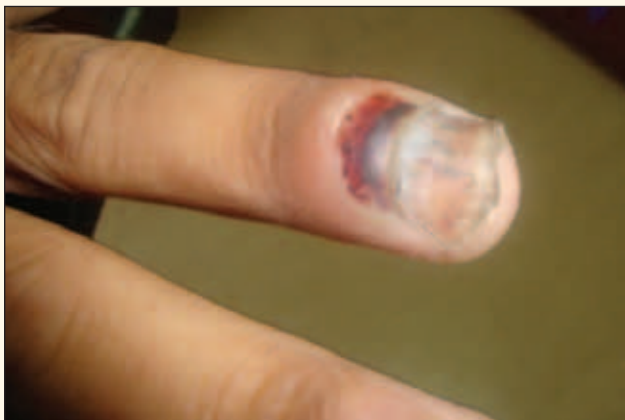
▲ Figure 4: A painful consequence of a door that closed too quickly

3. Poorly adjusted: Most sensible manufacturers provide some means to control the initial swing and the final closing rates. These must be adjusted optimally to give a smooth and controlled speed of closing, and fail-proof latch activation. A door that shuts with the speed of a falling guillotine poses an unacceptable safety hazard to persons.

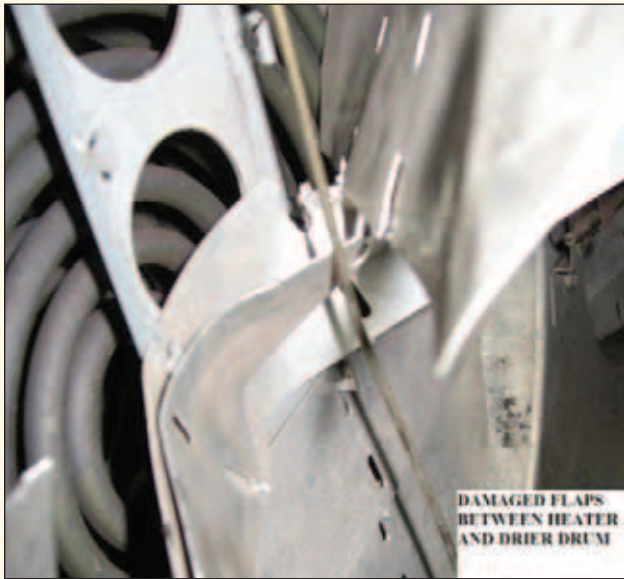
Investigation by the ship's staff determined that an increase in the operating temperature of the heater element, caused by lack of air circulation, led to ignition of the surrounding

▲ Figure 5: Damaged flaps between the heater and drier drum.

1. Close examination identified that a previously undetected failure of the 'jalousie' mechanical vents resulted in poor air flow and increase in operating temperature of the element.
2. On detecting the fire, the laundry was not evacuated and door was not closed. This allowed smoke from the fire to enter the passageway.
3. The manufacturer's instructions in respect of inspection and servicing the equipment was lacking in the detail that might have prevented this type of incident.

Lack of standards: Although in the company's planned maintenance procedure, washing machines, tumble and spin driers, irons and small electrical items are subject to a three-monthly general check/inspection, it was accepted that this was insufficiently detailed to identify the jalousie vent arrangement or its importance to the continued safe operation of the equipment.
