Providing learning through confidential reports – an international cooperative scheme for improving safety

MARS 200968

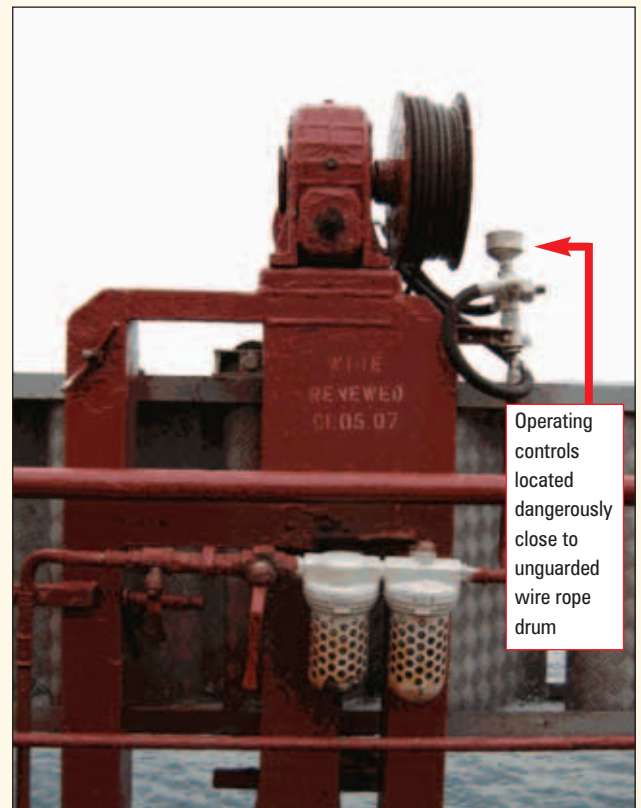
Loss of hand

A crew member, assisted by a cadet, was ordered to unlash and lower a pneumatically-powered accommodation ladder. Due to unfamiliarity with the procedures and equipment, instead of slowly 'breaking out' the ladder safely by means of the manual winch provided, the seaman attempted to combine both the swing-out and lowering movements by tentatively opening all the air valves and moving all the control levers to maximum.

As the winch paid out the wire rope with the ladder still in the stowed position, a number of loose turns came off the drum, coiling around the crew member's right hand, which was still gripping the main operating lever. Suddenly, when the ladder swung out and dropped, the loose turns instantly pulled tight, severing his right hand from the base of the thumb and shearing away the control handle. Reconstructive surgery was done, but it is likely that the crew member will have a permanent disability which will prevent him from continuing a seafaring career.

1. The crew member had not been properly familiarised in the preparation and operation of the accommodation ladder and failed to communicate this fact to the bosun when the task was assigned to him;
2. The accommodation ladder operation was not supervised by an experienced person and was conducted in an unsafe manner by the crew member, who did not follow the correct 'breaking out' and control valve operational procedures;
3. No operating instructions were displayed locally;
4. No risk assessment for the operation of the accommodation ladder appeared to have been conducted; and
5. Improper design – the control levers were located very close to the rotating wire rope drum, which had no protective guard fitted.

1. Accommodation ladder repaired and verified by class;
2. Ship-specific familiarisation about the proper operation of the accommodation ladder conducted and recorded for all crew.

2. Operating instructions to be posted at accommodation ladders fleet-wide.
3. Training on the safe operation of the accommodation ladder to be included in the crew familiarisation checklist.
4. Risk assessment for the use of the accommodation ladder is to be prepared and made available fleet-wide.
5. Controls of the accommodation ladder to be moved to a safer location.

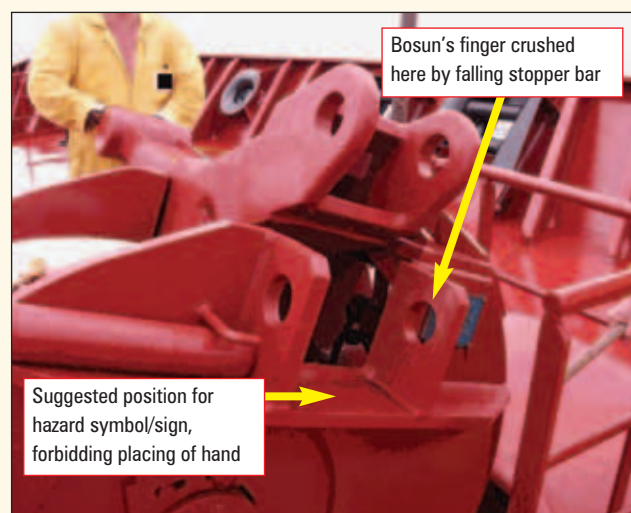
Loss of finger

Having embarked a pilot, a vessel had heaved up her anchor and was under way. On the forecastle, the bosun proceeded to show a newly-joined deck officer the features of the 'guillotine'-type anchor cable stopper bar arrangement. The bosun and the officer were positioned on the opposite sides of the device, with the stopper bar in its open position (standing upright), and so the officer's view of the bosun was obscured by the heavy bar.

In the course of their discussion, in order to demonstrate the correct method of securing the stopper bar, the bosun inserted his finger into the eye of the lug through which the securing pin is inserted. Unfortunately, at the very same moment the officer, unaware that the bosun's finger was in the 'guillotine', inadvertently released the hold-back hook of the stopper bar. As the bar fell down with great speed, the bosun's middle finger was crushed.

1. Human error: lack of situational awareness;
2. Inadequate risk assessment;
3. Failure to comply with safety precautions as per company's safety management system (SMS) and Code of Safe Working Practices (COSWP), Ch 25, 'Anchoring, mooring and towing operations';
4. The deck officer failed to put into place appropriate control measures to prevent inadvertent release of the locking bar from its open position;
5. The bosun failed to take into account the potential consequences of the unexpected release of the raised stopper bar.

1. Incident report circulated throughout the fleet for discussion at the next safety committee meeting.
2. During the next on-board training session, safety precautions during anchoring operations to be reviewed with all crew, in particular, the procedures stated in the SMS and COSWP.

1. The stopper bar's hold-back arrangement in the open position must be made fail-proof.

2. The stopper bar's counterweight should ideally be of such mass as to ensure a controlled rate of descent.

3. The stopper device's 'guillotine' and landing area must be permanently marked with hazard stripes and a symbol or sign forbidding the placing of hands or limbs on and within the lugs.

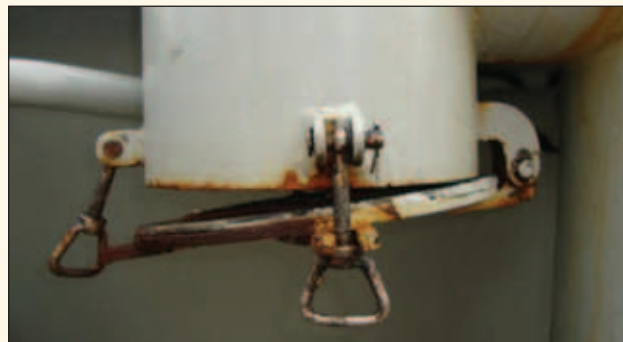
▲ Figure 3: Gooseneck vent with offset flap hinge

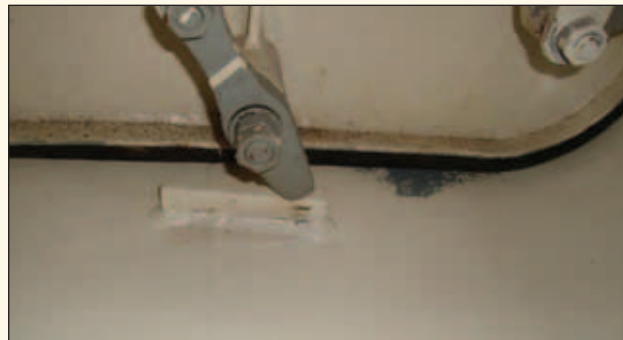
▲ Figure 4: Watertight escape hatch with wedge welded in wrong orientation

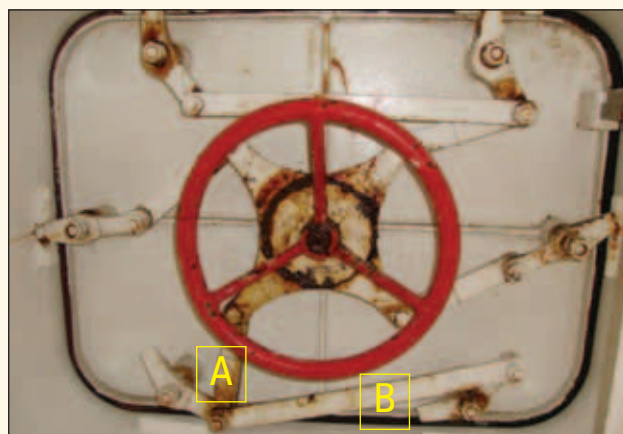
▲ Figure 5: Watertight escape hatch with mismatched linkage arms (A and B)

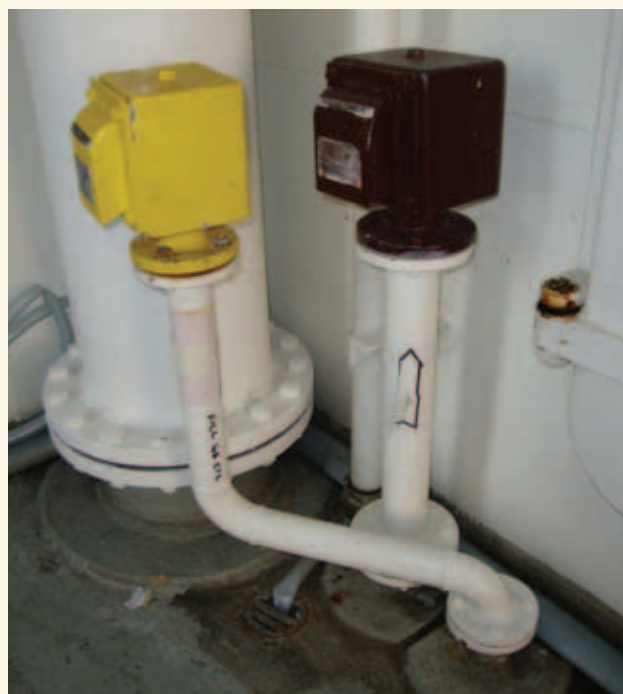
▲ Figure 6: Oil tank vents without a save-all and located directly over an open deck scupper. The marking seems to suggest that the crew is using the vent line for filling the tank, which increases the risk of spills.

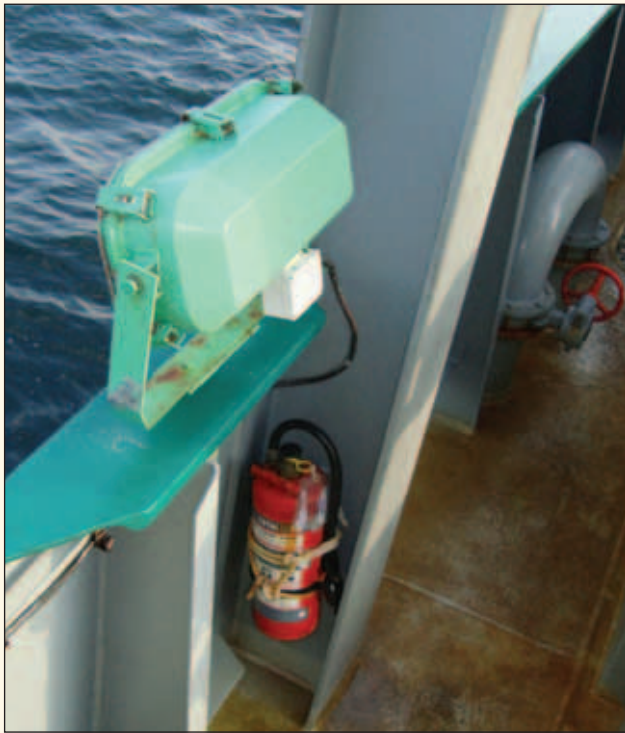
▲ Figure 7: Inappropriate location (main deck bulwark on a low-freeboard ship) for a portable fire extinguisher. This can result in: i) the extinguisher getting damaged or washed overboard by shipped seas, and ii) corrosion gradually weakening the body and increasing the risk of it rupturing under pressure when used in emergency or training.

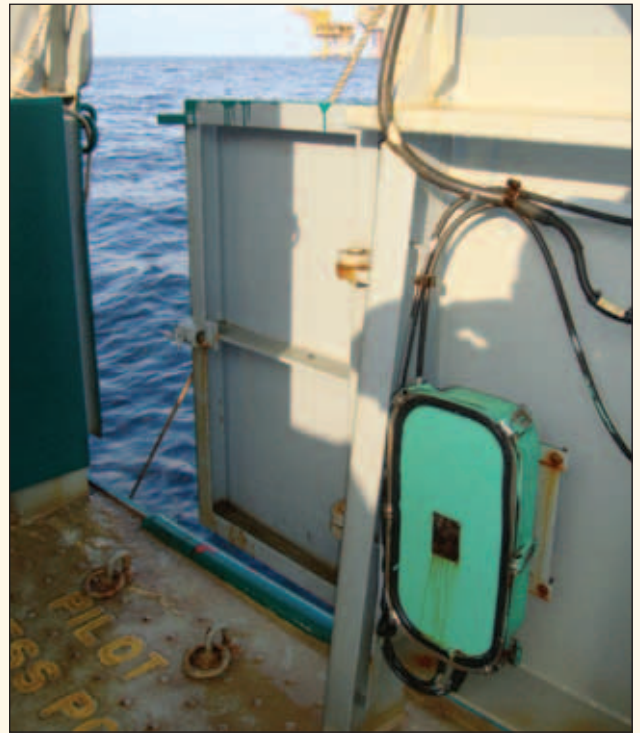
▲ Figure 8: Electrical junction box in a location frequently subject to sea water inundation. On this ship, all the circuits fed from this box were damaged.
