The Nautical Institute Mariners' Alerting and Reporting Scheme

MARS Report No 207 January 2010

Providing learning through confidential reports – an international cooperative scheme for improving safety

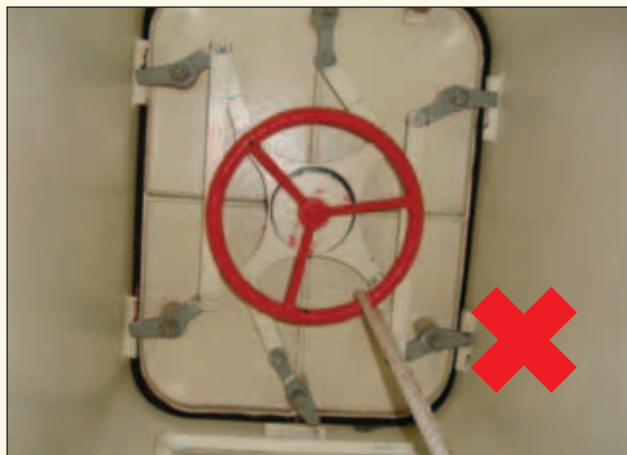
The first photograph (p 18) shows a commonly-used method of ensuring that an emergency escape hatch is secure against unauthorised entry from outside; in this case, the lid is tied down with a synthetic fibre rope that can be undone from inside during an emergency. On some vessels, wire rope and/or chains may be similarly used. However, such securing methods prevent entry from the outside through the same hatch, which may be necessary for fire-fighting. Subsequent photographs, show an alternative arrangement that satisfies both safety and security requirements.

▲ Figure 1: Hatch tied down with rope may be unopenable from outside for entry during fire-fighting operations

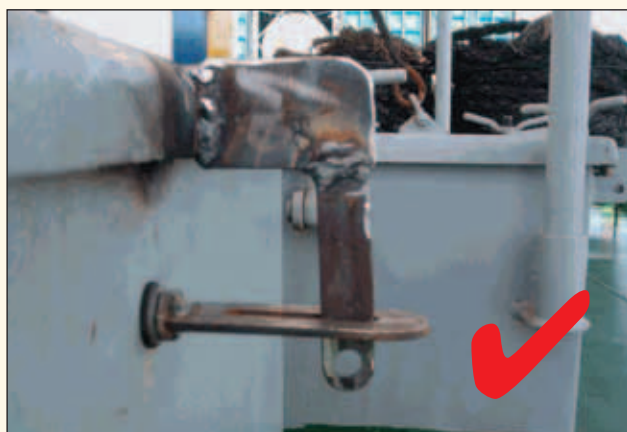
▲ Figure 2: Escape hatch with hasp and eye lug

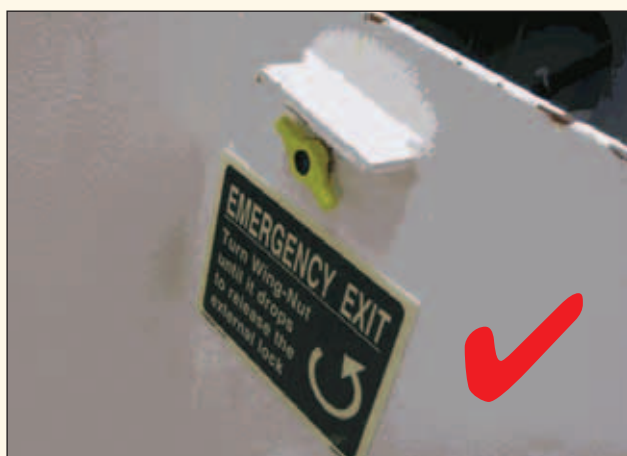
▲ Figure 3: Hasp is fitted with a wing nut that can be easily undone from inside. (Note photo-luminescent instruction sign and paint on wing nut)

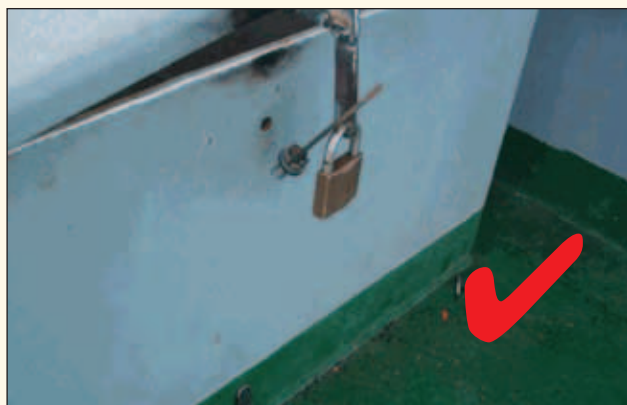
▲ Figure 4: Padlock, lug and hasp fall away when wing nut is fully opened from inside. For emergency entry from outside, padlock can be opened by its key in the normal manner.

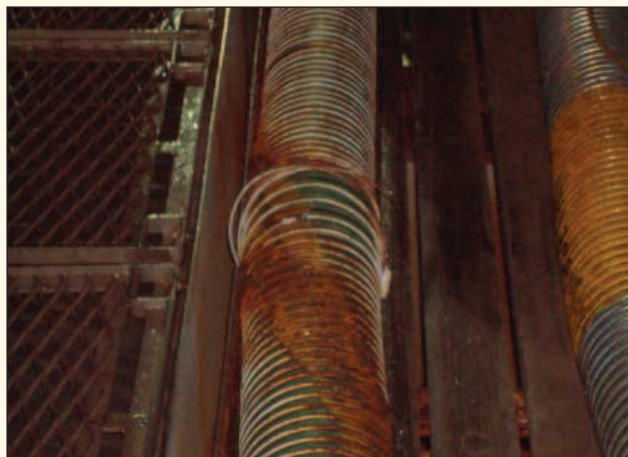
2. Inadequate SMS procedures for physical examination of hoses prior to use. The jumper hose's outer coiled wire sleeve was evidently rusty and it had been stowed for a prolonged period in an exposed location on the catwalk;

3. There was evidence that the use of rope slings to lift the jumper hose in the past had probably caused the coiled wire sleeve to be displaced, causing the hose to kink in places. In addition, the hose sling or bun was not used properly to distribute the load more evenly over the width of the sling;

4. Improper maintenance – the procedure of flushing of the hose with fresh water and drying was not followed properly after previous cargo operations;
5. Exposure to elements – the jumper hose was not covered to protect against sea water / sun which could have accelerated general deterioration;

▲ Figure 5: View of hoses stowed on catwalk showing corrosion and displacement of the external coiled wire sleeve

1. Following the failure of the hose, all the other hoses were hydraulically pressure-tested. During the test, one more cargo hose developed a pinhole leak; this was disposed of ashore. Additionally, some hoses were also landed for further testing and certification.
2. Recommendation to use only jumper hoses of optimum length.
3. All hoses supplied subsequently were equipped with permanent hose handling slings.
4. Suitable amendments have been made to the company SMS.
5. Information was being promulgated to the fleet by way of a safety bulletin to avoid a recurrence; it was also shared with the industry.

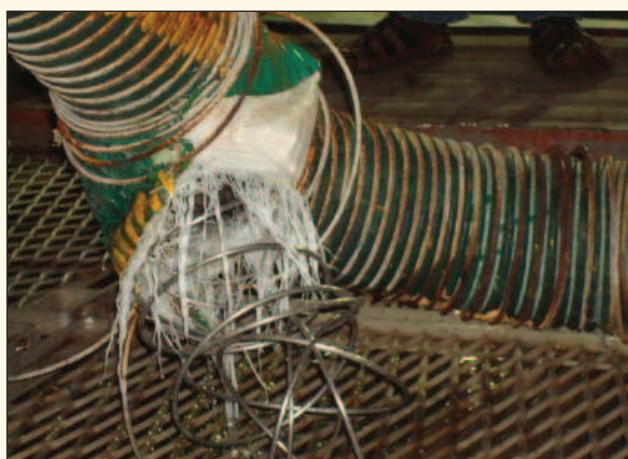
A chemical tanker was loading a cargo of paraxylene simultaneously into two tanks. To facilitate this, a jumper hose was inserted between the manifold connections of the two tanks on the offshore side manifold. Soon after the change of watch at midnight, the deck watch rating reported a minor (pinhole) leak on the jumper hose which rapidly developed into a major rupture. He immediately activated the shore emergency shut down (ESD) device. The terminal was advised of the situation, confirmed that the shut down had been effective, and the authorities and company were informed about the incident. No abnormal manifold pressures were noted at any time prior to or at the time of the hose failure.

As a result of the hose failure, some 100 litres of cargo spilled into the manifold drip tray and approximately 20 litres overflowed on to the main deck. The cargo quickly solidified as the ambient temperature was below the melt point of the cargo and no cargo was lost overboard.

6. Improper length – the jumper hose was probably longer than optimum length and the resulting sharp nip resulted in kinking of the hose.

▲ Figure 6: View of rupture on cargo jumper hose

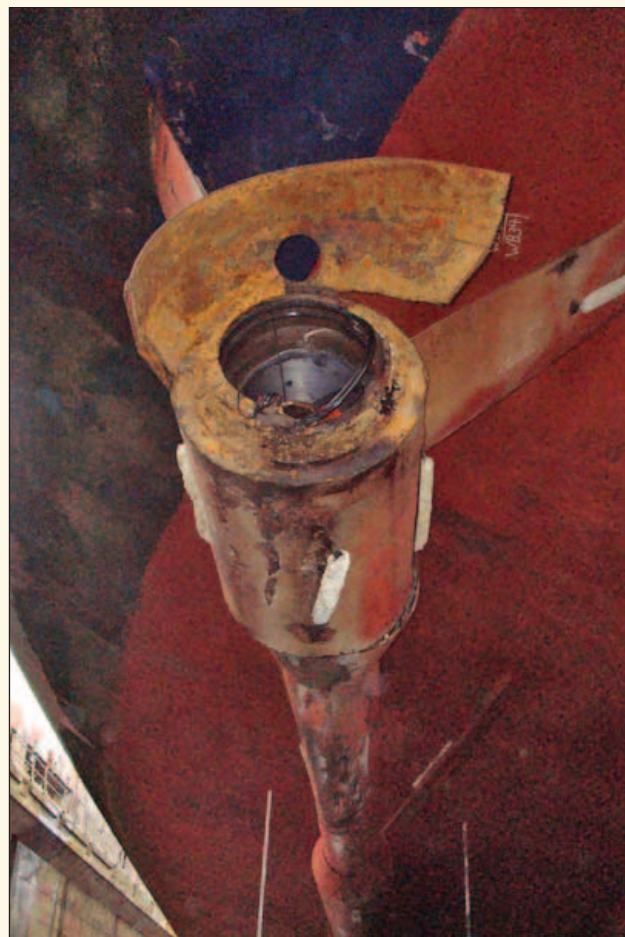
While sheltering off the port of Dover in heavy weather conditions, a passenger ferry grounded on a charted wreck. She sustained major damage, including the total loss of her port controllable pitch propeller hub and a section of tail shaft. The ferry was on a fixed service between Dover and Calais, and the occasional closure of either port was a feature of the run, especially during winter months. The ferry operator had produced comprehensive passage plans between ports served by the vessel. In addition, there was a selection of plans for other probable sea passages. However, there were no contingency plans produced that suggested where the vessel should wait in the event of a closure of one of the regular ports.

▲ Figure 7: Damage sustained by ferry's propeller

1. Charts covering likely contingency waiting areas should be prepared and ready for use before the start of the voyage. They should include clearly marked dangers and hazards.

2. The principles of effective bridge team management should be understood and practised at all times.

3. When additional aids to navigation, such as electronic navigational systems, are fitted to the vessel, the operators should be given effective training in the use and limitations of the equipment, even if the equipment is not intended to be the primary means of navigation.

4. Where navigation bridges are the focus for frequent requests for non navigational-related information, systems should be in place to ensure that watchkeeping staff is not distracted at critical times.
