Providing learning through confidential reports – an international cooperative scheme for improving safety

MARS 201036 Collision off port

Seaways July 2010

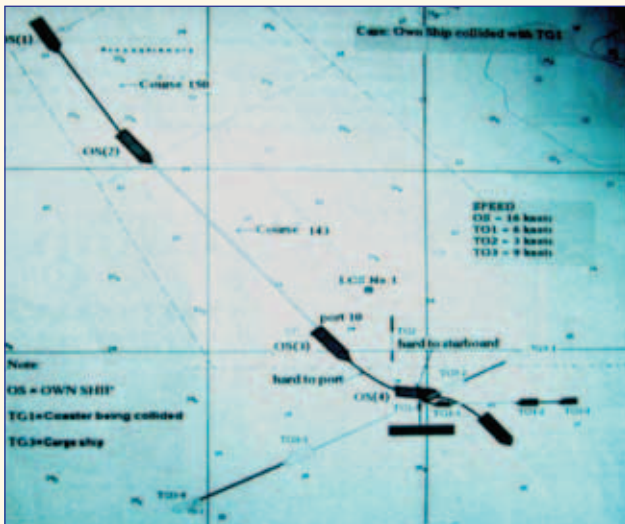
▲ Figure 1: Reconstruction of collision incident

1. OS(1), TG1-1, TG3-1, TG2 mark the positions at the same time when TG1 was acquired on our ARPA, bearing 132°(T) range about 3 nm.
2. Two minutes later, own ship was in position OS(2), and the other vessels were in positions TG1-2, TG2 and TG3-2 respectively.

3. Seven minutes later, when own ship was in position OS(3), port rudder was applied to alter course to port (presumably a navigational course alteration: Editor). About a minute later, the masthead lights and both red and green lights of TG1 were suddenly seen almost right ahead from our bridge and rudder was put hard-to-port. When TG1 disappeared under our bow (within ahead blind distance), our OOW, assuming that our rapidly swinging bow had swung sufficiently to port to clear TG1, and in order to swing our stern away from the coaster, put the rudder hard-to-starboard. TG1 was subsequently seen astern of own ship, and it was presumed by our bridge team that there

had been no contact between the two vessels as no sound was heard and no impact or vibration had been felt. Only when tank soundings the following day revealed loss of fuel oil from no.2 starboard fuel oil tank, collision with TG1 and hull damage was confirmed.

1. The passage plan must carefully appraise expected traffic conditions in port approaches and an appropriate bridge team management system and a safe speed for every leg must be specified beforehand by the master;
2. The effectiveness of slowing down in resolving developing close-quarters situations is shown clearly in the last simulated manoeuvre;
3. On very large vessels, the bridge team may not feel the impact of green seas or contact with small vessels or objects;
4. Even in the case of a presumed narrowly avoided collision, the emergency alarm must be activated immediately and own and other vessel's damage must be assessed, assistance offered and the incident reported promptly to appropriate authorities;

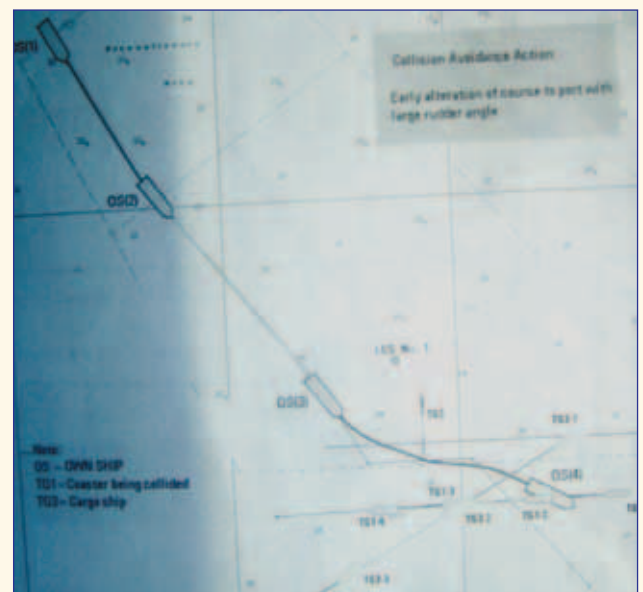
Figure 2 shows that if own ship had put the rudder hard-to-port instead of port 10° at position OS(3), TG1 would have passed clear close ahead of own ship.

▲ Figure 2: Hypothetical result on simulator if own ship had turned to port earlier with initial large rudder angle and maintained speed of 16 kts

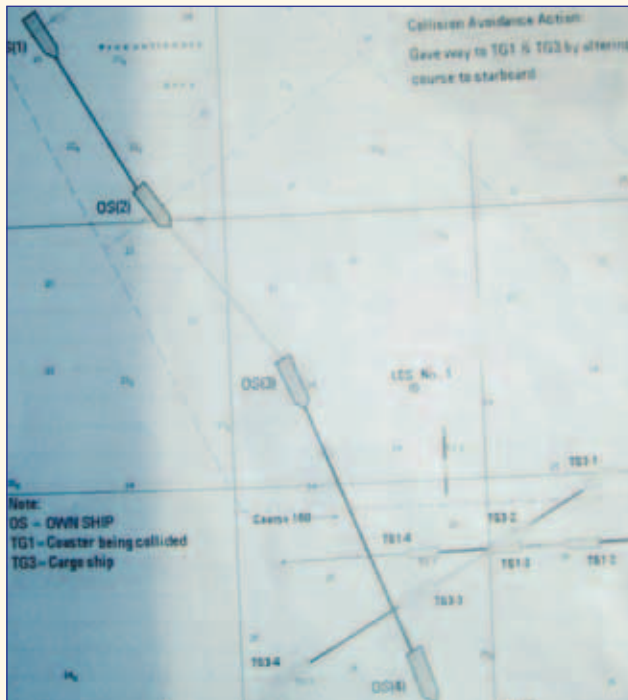
Figure 3 shows that if own ship had reverted to a heading to 150° at position OS(3), it would have been possible for own ship to cross close ahead of TG1.

▲ Figure 3: Hypothetical result on simulator if own ship had turned to starboard and maintained speed of 16 kts

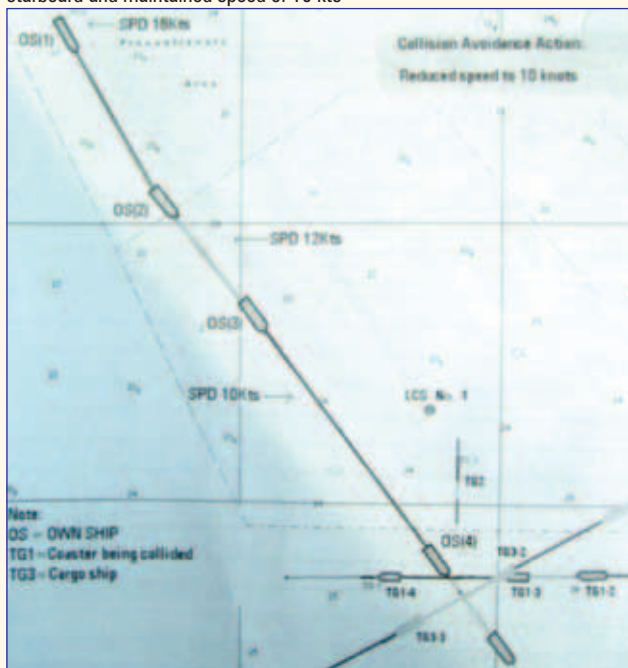
Figure 4 shows that if own ship had reduced speed rapidly from 16 knots to 10 kts, it would have avoided close quarters situation with all three of the other vessels.

▲ Figure 4: Hypothetical result on simulator if own ship had broadly maintained her heading of 143°(T) and reduced speed to 10 kts, safely clearing all three crossing vessels

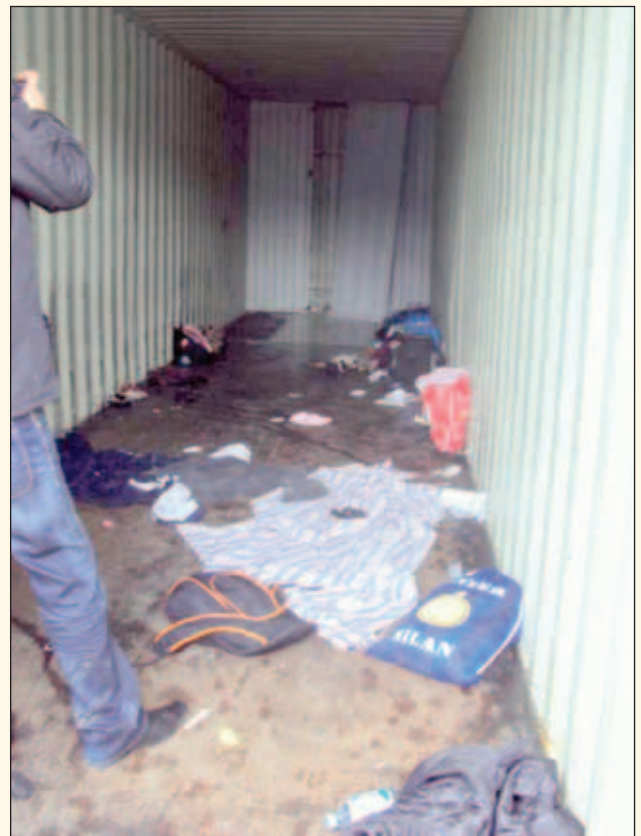
As the master of a container feeder vessel on the North African trade, my crew and I are ever vigilant against stowaways who make desperate attempts to enter the European Union illegally. Accordingly, at all African ports, our onboard procedures ensure that my highly reliable and competent crew open, inspect and seal every empty container on the quay before being loaded. Hence I was particularly shocked and embarrassed when, in an African port, some policemen suddenly boarded my vessel, claiming that 10 persons had stowed away on my vessel in an empty container which had been loaded the previous day. Soon, the suspect container was discharged ashore, the ship's seal cut, the doors opened, and 10 stowaways were discovered and taken into custody. It was then observed that a false rear panel (identical to the original one) was built inside the container, about one foot away from the actual rear panel, and the stowaways who concealed themselves within the gap remained undetected during the internal inspection by the ship's crew. Once the container had been stowed on board, the stowaways dismantled the panel and settled down inside the unit. However by the next day, with the vessel still alongside, the air inside got very stuffy and fearing suffocation, the stowaways called the local police on their mobile phones, giving them the container number and asked to be rescued.

▲ Figure 5: View of false end panel (stowaways were disembarked at the port before sailing)

1. The incident was reported to the company security officer (CSO).
2. As an additional security measure, it was decided to verify every empty container's interior dimensions during the pre-loading searching process. This can be achieved by two simple methods – through a laser distance measuring device or by confirming the internal dimensions with a tape or rope, with the lengths and widths of standard marine freight containers suitably marked.

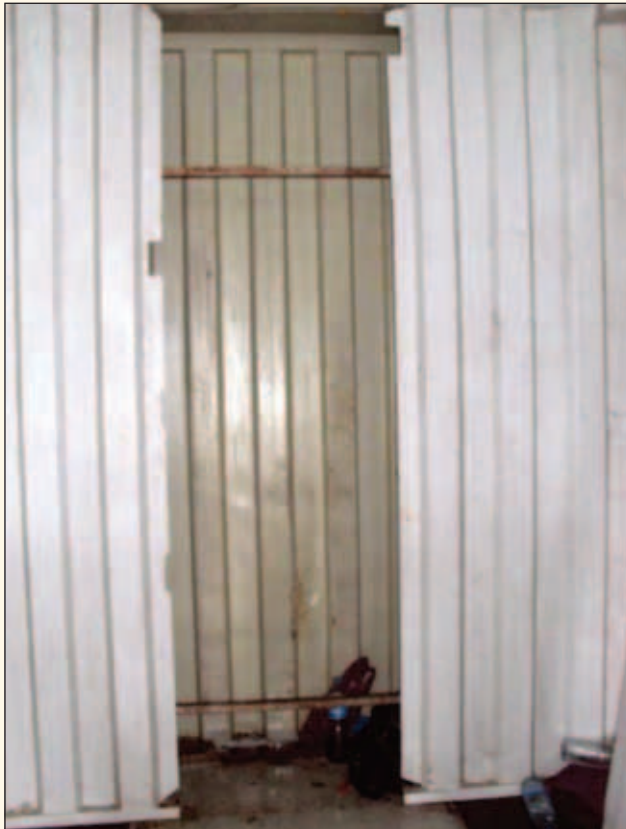
▲ Figure 6: Closer view of the false end panel, showing the space that hid 10 stowaways during inspection on shore by ship's crew

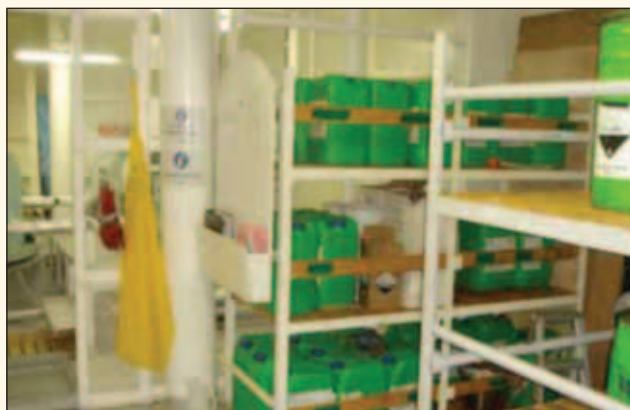
▲ Figure 7: Example of a well-laid out chemical storage area on board ship, showing PPE, placards and safety data sheets. Besides providing portable eye wash kits, it may be prudent to also provide an emergency shower and eye wash basin in the vicinity that can be operated by a temporarily blinded person: Editor

1. All personnel are to be made aware of the company PPE matrix; this is to be posted in strategic areas around the vessel as a constant reminder and reference tool;
2. Proper toolbox meetings to be held before beginning any work so that personnel are aware of the scope of the job and the correct procedures to be followed;
3. Correct PPE is to be kept in designated work areas and maintained in good condition. This includes safety goggles, chemical apron and face shield. Eye-wash solution to be readily available at location;
4. Personnel to be reminded of the dangers that are involved in handling/using chemicals;
5. The company generic risk assessment on handling and use of chemicals is to be discussed with all as a part of the toolbox meeting.
