MARS 201046

Empty thinner drum explosion

Pilot fell overboard due to ladder ropes parting

Hull damaged by own anchor and fire during repairs

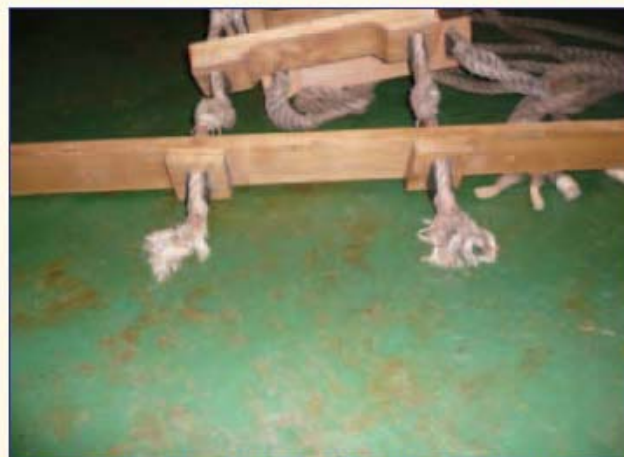
As soon as the pilot had climbed down the first few steps, the right side ropes parted without any warning and an instant later, the left side ropes parted as well. The pilot and the lower section of the ladder fell into the water between

▲ Figure 1: The 23.2 mm side twin ropes parted below the first upper spreader

The ladder's side ropes consisted of twin 23.2 mm diameter continuous ropes passing through holes drilled into the steps and whipped together above and below each step. The side ropes, the tails and the whipping ropes were of uncovered natural fibre. The steps looked new; only one face was scratched. The side ropes below the break showed strong traces of rubbing on almost all step intervals and the side ropes, as well as tails and whipping ropes, could be easily torn out by hand. The breaking test revealed that the strength of the side ropes had reduced to about 160 kilogram force (kgf) instead of the normal 3,500 kgf for a new manila rope of that size.

Microscopic examination showed that the ropes used were sisal, a fibre about 10 per cent weaker than manila, and infested with micro-organisms, which had steadily weakened the fibre after the ladder's manufacture and during storage, either on board or ashore.

■ **Editor's note:** To ensure safety, the deck crew must be trained to detect and report faults in pilot ladders. Additionally, the ship's officer attending pilot transfer on the deck should put on a suitable fall-arresting device and test the strength of the ladder by standing on the steps. In many ports, such as Singapore, the pilot will only board after witnessing this ladder test by a ship's crew member.

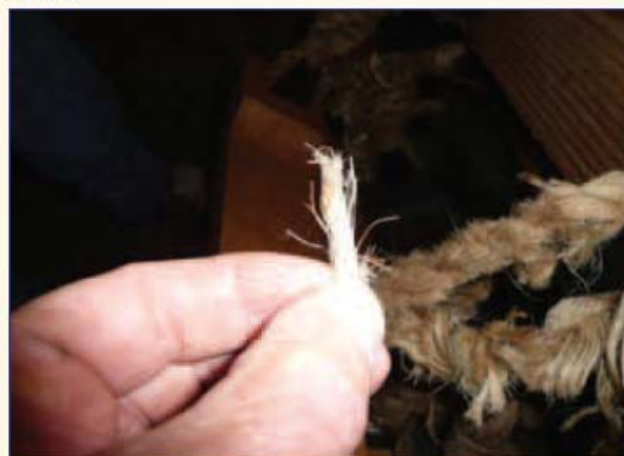
▲ Figure 2: Side ropes could be easily torn out by hand

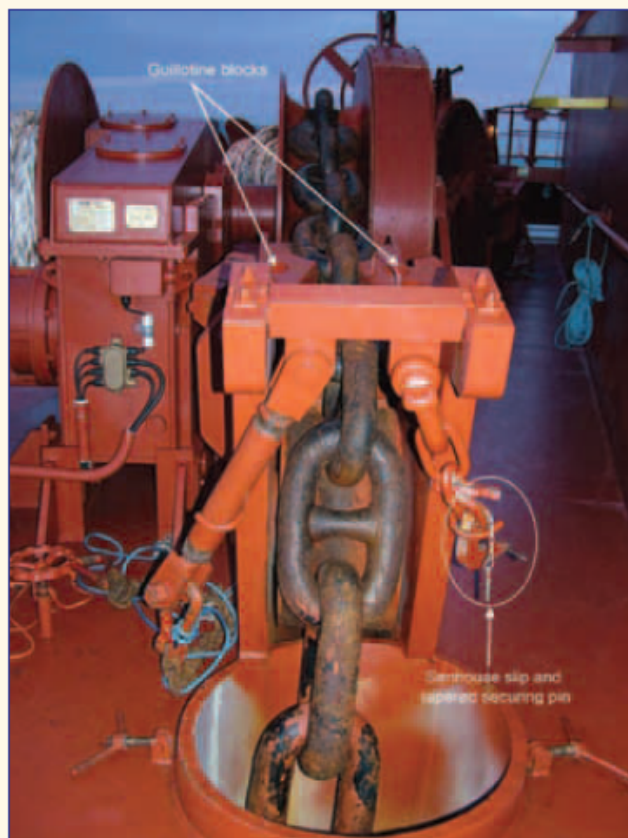
1. The chain lashing the Senhouse slip tapered securing pin was not fully secured;
2. The hawse pipes covers had not been fitted, allowing heavy seas to wash on to the forecastle deck. This caused the tapered pin to fall out and release both the Senhouse slip and the anchor cable chain lashing;
3. The anchor cable progressively dropped as the acceleration forces overcame the winch brake, which was not fully tightened.

▲ Figure 3: View of anchor cable securing arrangement

3. Make sure that the crew is familiar with the anchor chain securing arrangements. Bottle screws should be tightened after the Senhouse slip is connected to ensure the system is fully secured. All too often, the bottle screw is considered to be in the right position as long as the slip can be connected. The acceleration forces are high, and will find any slackness in the system;

4. The Senhouse slip holding the anchor chain lashing was fitted with a tapered pin. Mousing the pin or changing it for a 'drop nosed' pin would have made it more secure;

5. Winch brakes need to be applied tightly, and using a wheel spanner or extension bar to get added purchase may be necessary.

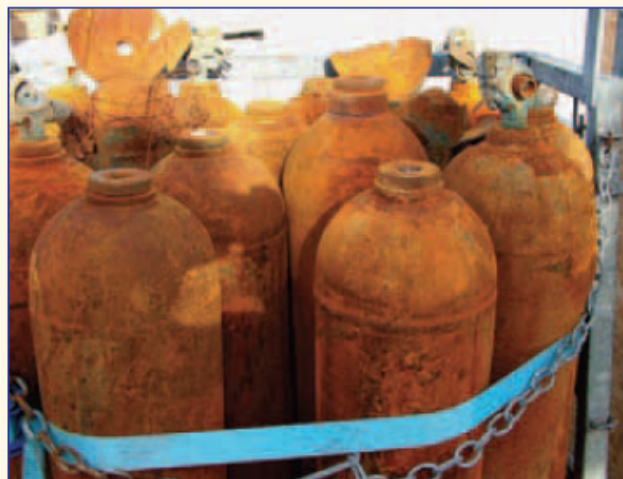
were no casualties. All the acetylene and oxygen bottles were badly damaged, the deck plating was distorted and the mooring winch and its power supplies were burnt.

1. The fire was likely to have been caused by a discarded cigarette, which had ignited clothing found in the vicinity of the mooring rope and acetylene hoses;
2. The acetylene ignited because the gas bottle valves were open. Because the 'in use' bottles were co-located with the storage bottles, the fire spread to the other bottles and so escalated;
3. Poor communications: none of the hot work permit to work (PTW) control measures were in place, and the contractors were not briefed on safety procedures because the crew were unaware of the intention to carry out hot work.

▲ Figure 4: Fire-damaged acetylene bottles

4. Where a port authority gives work approval in a foreign language, arrange for it to be translated so that the ship's responsibilities are fully understood;
5. Where the contractors provide the safety watchman, insist on him/her always being on station;
6. Conduct regular rounds of the work site, and do not hesitate to order work to stop if you believe safety is being compromised;
7. It is good practice to segregate the 'in use' gas bottles from the storage bottles to reduce the risk of a fire spreading.
