Bulletin 225 - 12/01 - Pitting Damage Claims - Stainless Steel Tanks

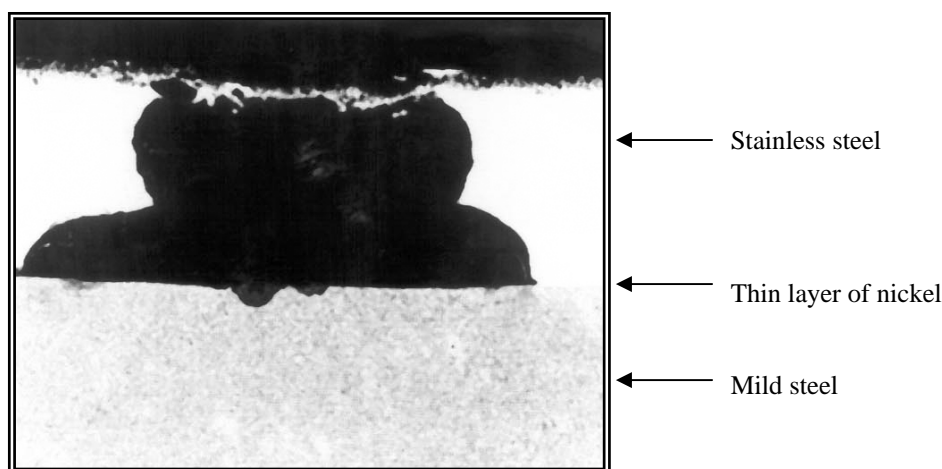
Another issue that has recently come to light is the pitting of tanks clad with 316 LN. The picture below is a copy of a cross-section through a typical pit at X20 magnification - the stainless steel cap at the surface of the pit is still intact, but the corrosion attack has progressed below the surface and attacked the thin layer of nickel (between the stainless steel cladding and the mild steel structure), after which it rapidly consumes the mild steel. A very recent case involved a cargo of acetic acid that fell through the tank top into the double bottom (through a single corrosion pit). Aided by a photograph of a typical corrosion pit in a stainless steel clad tank, the shipowners' defence was able to show that the chief officer / pumpman had exercised due diligence before loading as the pit through which the cargo fell would not have been detectable by the exercise of due diligence by virtue of the typical "cap".
