# LP BULLETIN

## Bulletin 550 - 11/07 - Navigation warning - Philippines

**A UK Club correspondent in the Philippines has warned of recent groundings on an uncharted reef at Dinagat Sound, Mindanao. Affected charts include British Admiralty chart 4475, United States chart 92110, and Philippine chart 4629.**

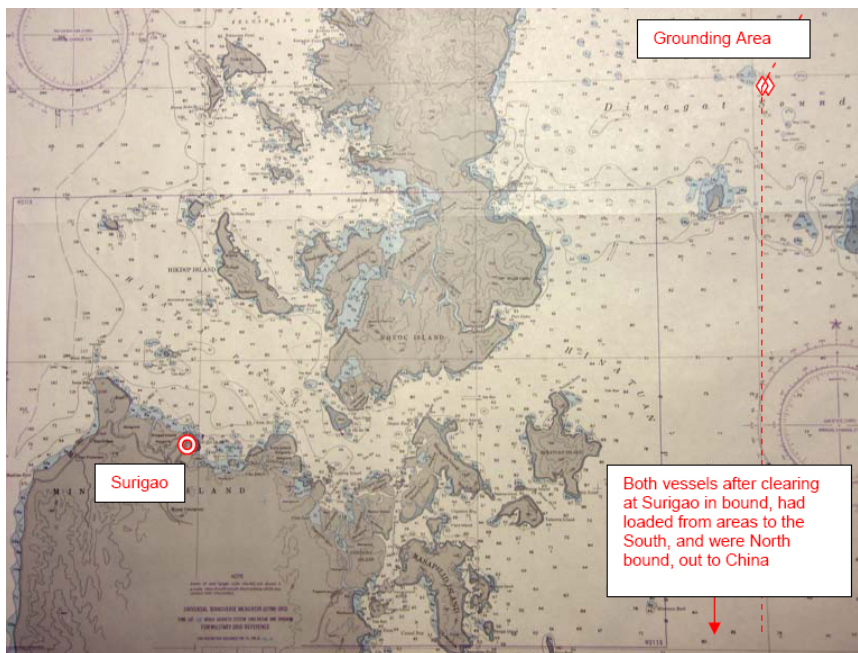
The nickel ore trade in the region has recently increased and shipments from Surigao in Mindanao (Southern Philippines) is loaded from barges at remote anchorages some distance from the port. Masters have chosen, upon departure, to transit Dinagat Sound, which is subject to strong currents and rip-tides, particularly during the monsoon period from September to February. Masters navigating these areas need to exercise extreme caution in order to prevent from grounding.

The image below illustrates the grounding area in relation to the Port of Surigao:

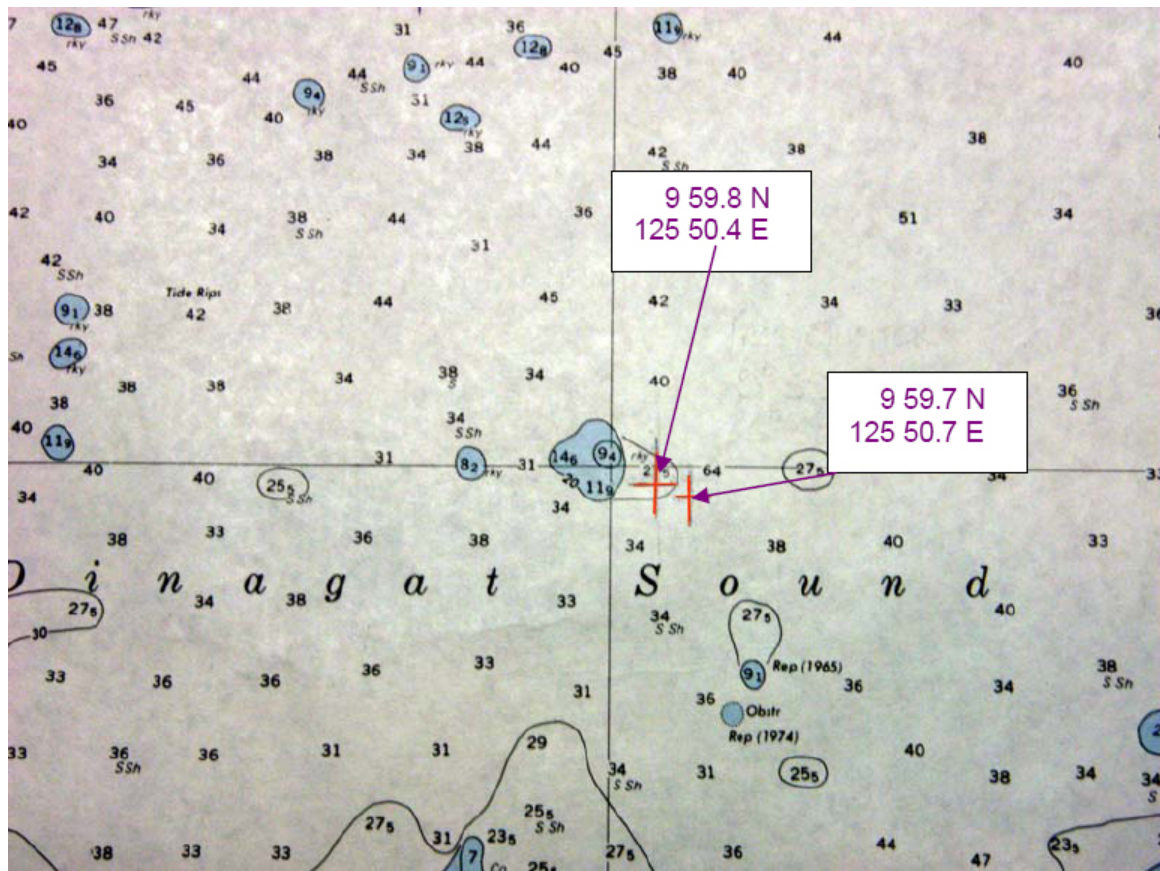
The charted depth of the coral reefs and shoals (based on partial surveys conducted before 1930) is 27.5m but the reef creates an actual depth of 10m. Two ships have recently grounded on the reef with sailing draughts of 11.8m and 12.5m.

Both ships to ground on the reef were handymax sized bulk carriers. The first ship grounded in position 09° 59'.8 N ; 125° 50'.4 E on 23 September 2007, and the second ship grounded in position 09° 59'.7 N ; 125° 50'.7 E on 21 October 2007.

A detailed view of the grounding area (American chart 92110 – all depths in metres):

The Club's correspondent has made the UK Hydrographic Office (HO) and local authorities aware of the navigational hazard. The HO has published details in Notice to Mariners 5035 of 2007.
