The Nautical Institute Mariners' Alerting and Reporting Scheme

MARS Report No 217 November 2010

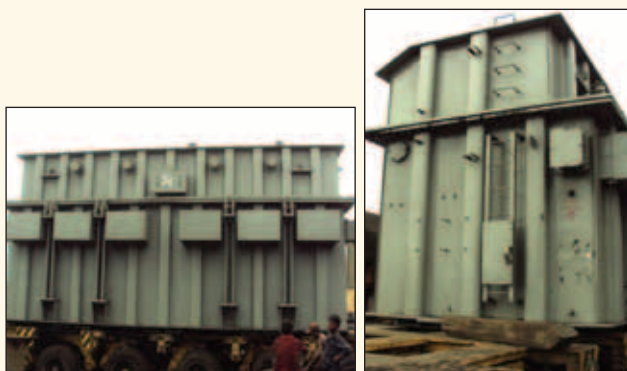
I am a port captain and among other jobs, I oversee the discharge of a large number of project cargo consignments. I have often noticed that the ship's staff has not planned the lifting and discharge process properly. Most worryingly, in some cases they were ignorant of the actual weights of the heavy lifts, and were intending to use the ship's gear without

realising that the weight(s) exceeded the SWL. At the load port, shippers and ship's staff must ensure that crucial information like gross weight, slinging points, centre of gravity etc are prominently marked on each unit (preferably on each side and the top) and discharging arrangements at the destination port are clearly understood between all the parties involved.

▲ Figure 1: A heavy lift without proper shipping marks

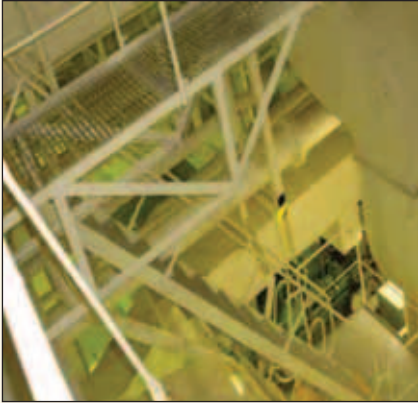
In rough sea conditions on a loaded passage on a VLCC, an engineer officer was going down the engine room from the second deck to the third deck. While doing so, he slipped and fell down the ladder, sustaining contusion injuries on both legs.

1. Lack of compliance: The company's personal protective equipment (PPE) matrix clearly states that leather gloves are to be used while in the engine room;
2. Damp cotton gloves had lesser grip than dry leather gloves;
3. Inadequate care exercised while moving around the vessel in rough sea conditions.

◀ Figure 2: Steep stairway in engine room where the accident occurred

1. Discuss the above incident at their next safety meeting.
2. Ensure that personnel are well rested and in full compliance with STCW rest hours.
3. Clean up any slippery surfaces immediately on being noticed.

4. Ensure proper PPE in good condition is used at all times including appropriate gloves, helmets, boiler suits, safety shoes, safety goggles, ear muffs etc.
5. Warn personnel to exercise due care while moving around the vessel especially in adverse sea conditions.

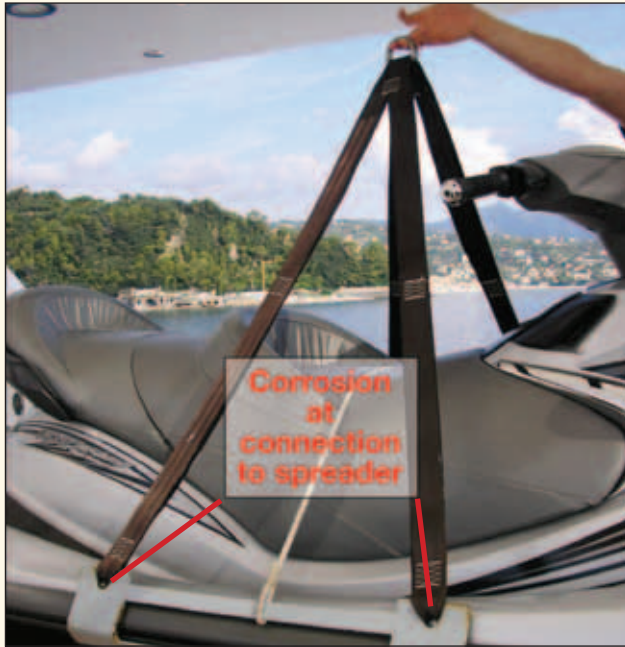
▲ Figure 3: Typical PWC slinging arrangement

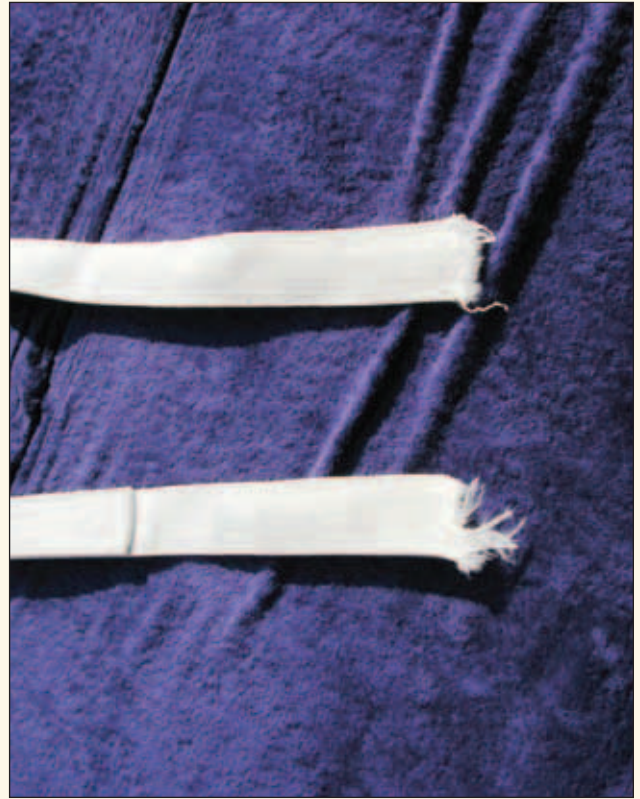
1. Deterioration of synthetic fibre web slings due to combined effects of exposure to solar UV radiation and tight crimped eye loop around corroded steel spreader beam;
2. Inadequate onboard maintenance and inspection regime;
3. Inadequate documentation – the history and origin of the lifting sling were not readily apparent. It was stated that it was supplied with the PWC, but the model and manufacturer of the sling could not be identified and no manufacturer's documentation of certification could be located.

▲ Figure 4: Evidence of deterioration caused by exposure to solar UV radiation

1. All webbing and rope strops should be stowed out of sunlight and, in any case, ought to be replaced at least every second season.
