The Nautical Institute Mariners' Alerting and Reporting Scheme

MARS Report No 219 January 2011

MARS 201101

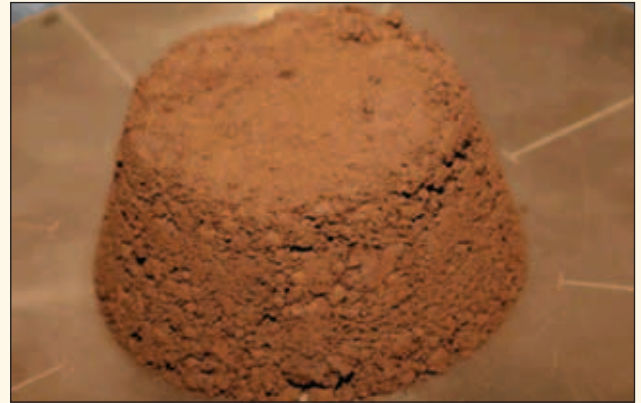
▲ Figure 1: Typical shape of sample cone prior to testing

Figure 1 illustrates the shape of a sample cone for a sample below FMP, while Figure 2 shows the shape of a sample cone after recent testing with a MC of about 31 per cent. Despite the cone being deformed, with a recorded cone expansion >6mm, it was regarded as being below FMP. The sample was not failed until the cone had expanded by a massive 20mm, as shown in Figure 3, with a declared FMP of 33.8 per cent. The mine was unable to justify their change of methodology, which ignored all the key indicators of a flow state (see page 300 of the IMSBC Code: [Editor](#)), and enabled them to ship wetter cargo at a greater risk to the vessel.

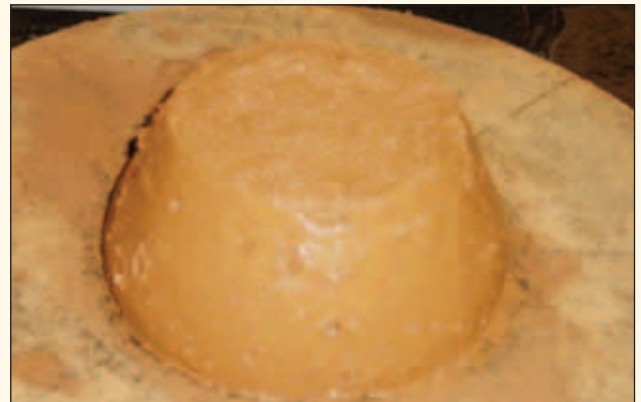
▲ Figure 2: Change in shape of sample cone after testing, corresponding to a 6.5mm cone expansion

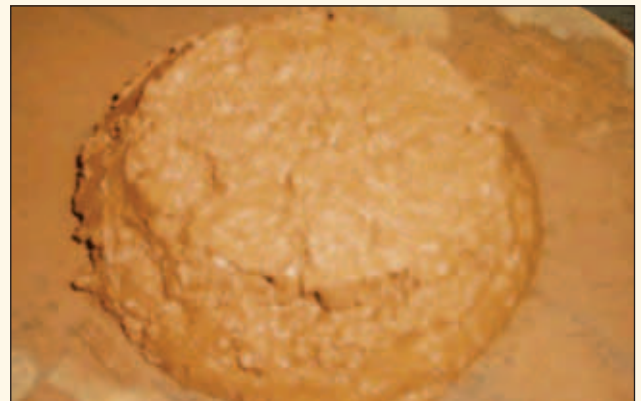
▲ Figure 3: Sample cone after testing with 20mm expansion at base

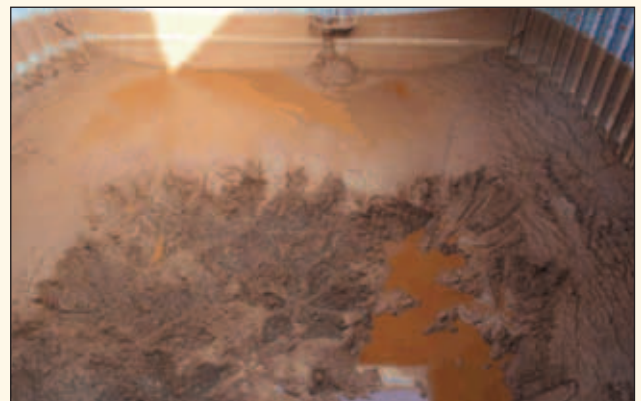
▲ Figure 4: Liquefied lateritic nickel ore

The interval between sampling/testing and loading must never be more than seven days. If the cargo has been exposed to significant rain or some form of moisture between the times of testing and loading, further tests shall be conducted to ensure that the MC is still less than the cargo's TML, which is generally determined as 90 per cent of FMP.

Mariners must remember the simple relationship $MC < TML < FMP$. Only if the MC is significantly less than the TML can the cargo be considered to be safe to load. It is also important not to confuse the commercial MC with FMP. Even though a receiver may be willing to accept cargo with a MC of 35 per cent by weight, it can only be accepted by the vessel if this is well below TML.
