The Nautical Institute Mariners' Alerting and Reporting Scheme

MARS Report No 227 September 2011

MARS 201152

Dangers of Aluminium Phosphide

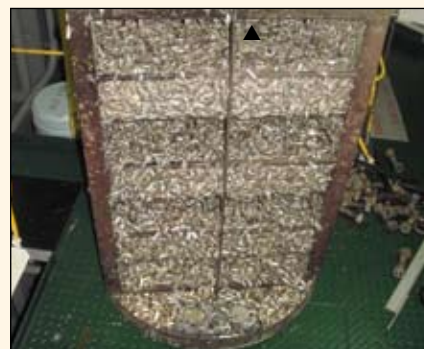
Our oil tanker was discharging at an Asian oil terminal. Simultaneously, the vessel was being inspected by a vetting inspector and the owner's superintendent was also attending. The inert gas (IG) plant was in operation. About four hours into the discharge, the C/E was informed that the seawater low pressure alarm had been activated. He came to the engine room and observed that all the sea water pumps were showing inadequate discharge pressure. At the time, the high sea suction was in use, and even though it was well under water, the C/E instructed the duty engineer

to change over to the low sea suction in order to improve the head. Immediately, the pump suction and discharge pressures became normal. After monitoring the system for some time, the C/E left for his cabin. After a few more hours, the problem recurred and the C/E again returned to find all seawater pumps had developed vacuum condition on the suction side and were showing very low discharge pressures. It was immediately suspected that the strainers inside the sea suction chests were clogged. However, with the cargo pumps and IG plant operating at full capacity, it was decided to use both the high and low sea suctions together to avoid stoppage of any of the seawater pumps. It was not possible to open up any of the sea chests to clean the strainer without halting the discharge, with attendant commercial implications. The Master and superintendent were informed of the serious situation, when, by chance, the terminal announced a temporary stop in cargo operation. Until this stoppage time, the engine room had spent a nervous few hours with the pumps struggling to develop adequate water flow.

◀ View of clogged strainer of sea chest

1. The fleet (especially a sister vessel) was advised to use high sea chest in ports as this is generally located close to several overboard discharges; e.g. ballast, condenser sea

water, fire and general service (GS), and IG scrubber pumps. The turbulence created in the vicinity of these overboard discharges may help prevent fish being drawn towards the high sea suction.

2. It was also suggested that regular injection of steam into sea chests might assist in keeping the strainers clear of unwanted fishes and other organisms.

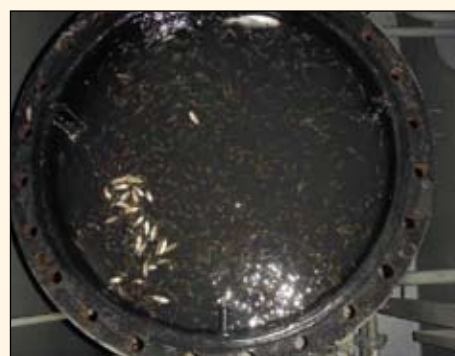
Sea chest with ▶ strainer removed

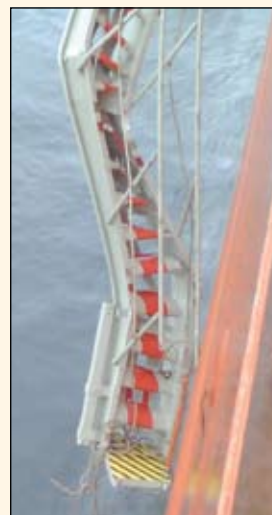
The A/B indicated the dangerous situation by hand signals to the deck officer, creating some critical seconds' delay in responses and in communicating the information to the bridge. Once aware of the situation, the Master requested the Pilot to instruct the tugs to push the vessel back towards the jetty, but by the time this was done, the entangled gangway had been subject to severe axial, twisting and crushing forces and was severely damaged.

1. The Master failed to effectively use the Pilot and tugs to retain the vessel alongside until all lines were retrieved, especially since there was a strong offshore wind;
2. The Master failed to exercise basic seamanship and wear rain protective clothing and station himself on the bridge wing during the unmooring operations;
3. The unusual layout of the backsprings, gangway and low clearance over the berth should have precluded leaving the gangway suspended over the side;
4. The deck officer at the aft mooring station wrongly assumed the role of winch operator, instead of directly supervising the operation and delegating tasks to his crew.

◀ View of damaged accommodation ladder

1. Masters to always position themselves on the bridge

wings during mooring and unmooring and closely oversee and control operations;

2. Members of the bridge team to always be suitably prepared for exposure to varied weather conditions;
3. Adequate weather-protective gear to be always be available in the wheelhouse;
4. Officer in charge of the mooring station to supervise the operation and effectively communicate with the shore and ship's staff and delegate tasks to his team.

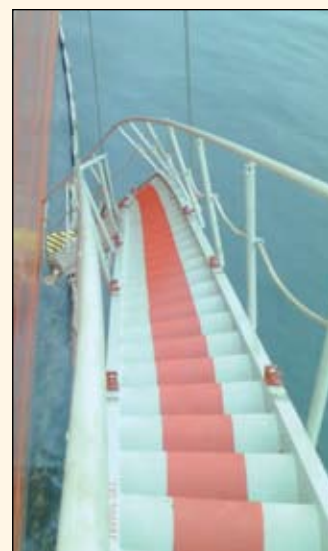
▶ Another view of damaged accommodation ladder
