The Nautical Institute Mariners' Alerting and Reporting Scheme

MARS Report No 222 April 2011

MARS 201122

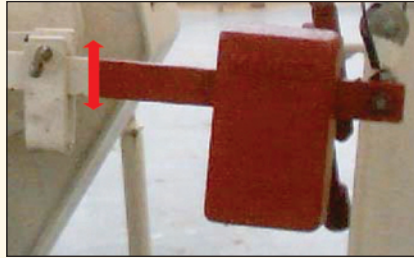
▲ Clearance between stopper pin and brake lever must be in accordance with maker's specification

1. Do not apply a downward force of more than 15 kgf to the counterweight of the brake lever, as this may damage the thrust bearings. If properly maintained and adjusted, the brake is designed to operate solely by the force applied by the counterweight.
2. Confirm the home position of the brake lever is in the horizontal position. The ideal position for the lever is in slight contact with the stopper pin. The allowable clearance between the stopper pin and brake lever is 10 mm.

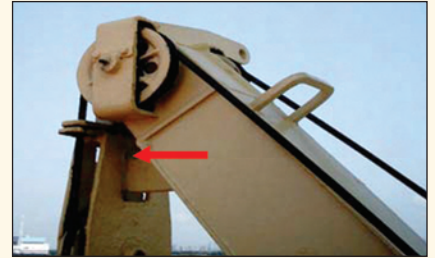
▲ After housing the boat, unwind the boat fall wire and allow the boat to lower slightly so that the suspension block (sling block) is resting on the horn of the davit.

After setting the davit arm stopper (cradle stopper), raise the brake lever of the winch slowly and unwind the boat fall wire to allow the boat to lower slightly. Mount the suspension block (sling block) onto the horn of the davit in order to release the load from the boat fall wire.

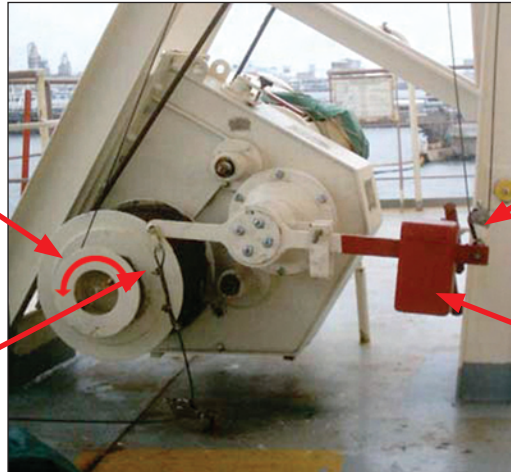
▼ Typical lifeboat winch showing properly reeved self-lowering wire and brake lever in correct position

Indicator arrow for correct winding of self-lowering control wire on auxiliary drum

Operating wire from embarkation deck release handle

Self-lowering control wire to lift brake counterweight

Avoid exerting downward force of more than 15 kg to avoid damage to shaft and bearings
