Providing learning through confidential reports – an international cooperative scheme for improving safety

MARS 201141

Crew fatality caused by parting of rescue boat wire fall

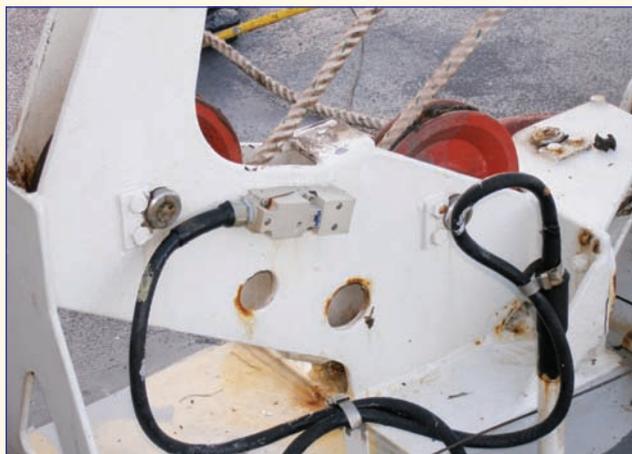
The crew of a large vehicle carrier was concluding a routine launching drill of the rescue boat in port. As the craft was coming up to its normal stowage position, a proximity sensor/limit or cut-off switch arrangement (Figure 1) that was designed to cut electrical power to the winch motor failed to operate correctly. With the davit having come up hard against its stops, the hoisting motor continued to wind in the fall wire, causing it to part. The rescue boat and its four crew fell nearly 29 metres into the water. One of the boat's crew died and two were hospitalised.

▲ Figure 1: View of proximity sensor/limit switch arrangement on davit (Note cable entry gland position raised above horizontal, potentially permitting ingress of water)

3. The proximity switch was incorrectly fitted with its cable entry gland higher than the switch body thereby increasing the possibility of water ingress.

1. Test all proximity switches on each occasion before hoisting operations commence;
2. Replace all proximity switches every two years;
3. Exercise caution when using pressure washers in the vicinity of these sensors/switches.

1. Ensure that all devices (inductive or mechanical) fitted to boat davit systems to prevent overload are tested on each occasion before a boat is hoisted and that sole reliance is not placed on such devices;
2. Follow manufacturers' recommendations regarding the maintenance and periodic testing, examination and replacement of safety devices, seeking clarification from manufacturers where ambiguity exists;
3. Verify the effectiveness of watertight seals on electrical equipment fitted to boat davit systems on weather decks.

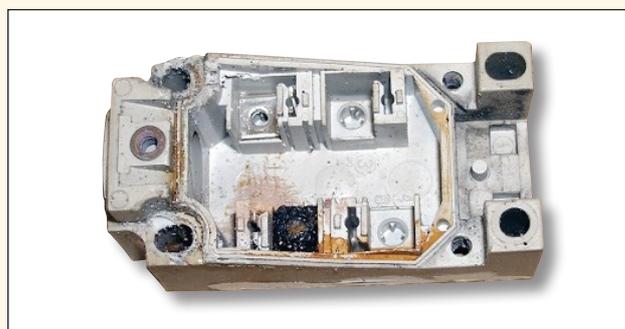
The proximity sensor/limit switch was tested in situ and was found to be defective. It had been installed in 2006, and during the ill-fated drill, was not tested before hoisting was commenced. Inspection revealed evidence of water ingress (Figure 2), although subsequent tests showed that the switch malfunctioned due to an unrelated electronic fault.

▲ Figure 2: Evidence of water ingress within proximity sensor/switch body

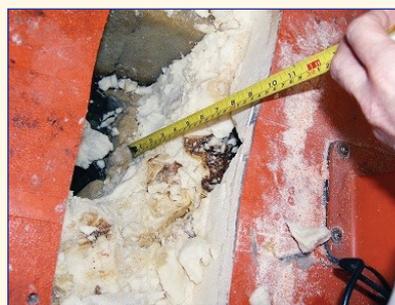
During the investigations, it was also unexpectedly discovered that water had entered the foam-filled buoyancy spaces between the inner and outer fiberglass skins of the rescue boat's hull (Figures 3 & 4). The craft was found to be approximately 450 kg overweight. Although the additional weight of water caused the davit's SWL to be exceeded, it was established that this would not have caused the wire to fail.

◀ Figure 3: Water seen in buoyancy space between inner and outer fiberglass skins of rescue boat

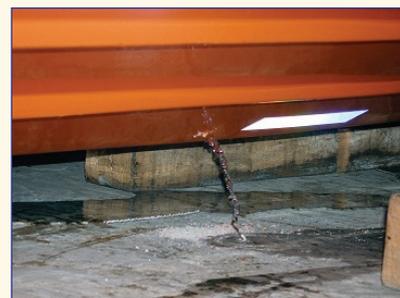
Figure 4: Accumulated water being drained through hole made in outer hull of rescue boat

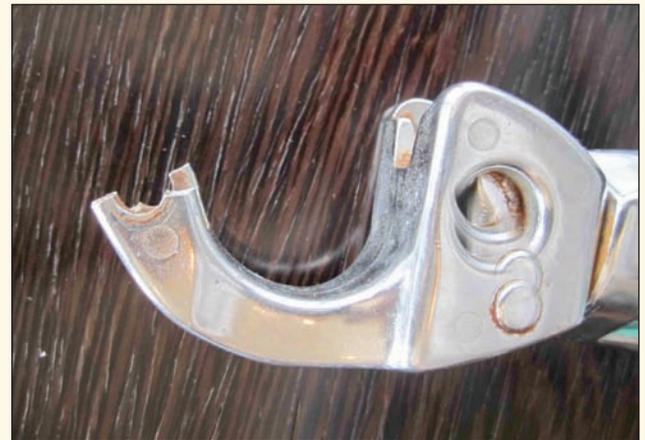
1. The hinged hook of the snap shackle had sheared off at the hinge pin;
2. The yacht and its fittings were about two years old;
3. The lifting gear and sling were duly certified for the load and had not been subjected to any severe loads since new;
4. Regular inspections of the sling were carried out as part of routine maintenance.

▲ Figure 6: View of broken snap shackle

1. All snap shackles replaced with conventional shackles of appropriate SWL;
2. Inspection routines have since been amended and risk assessments reviewed.
