The Nautical Institute Mariners' Alerting and Reporting Scheme

MARS Report No 223 May 2011

MARS 201127

Allision with wharf during unberthing

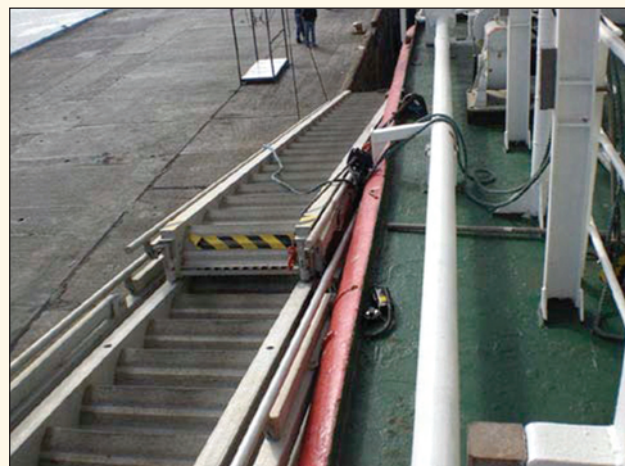
The bosun and an able seaman (AB) lowered and extended the vessel's double-sectioned gangway prior to berthing. All the locking pins were in place, in accordance with onboard procedures (see photos right). However, during the final approach to the berth, the bridge informed the crew that berthing plans for the vessel had changed, requiring the use of a different means of access. Crew were instructed to recover the now partly-deployed gangway. The retraction procedure for this double-sectioned gangway normally requires the end of the gangway to be landed, allowing tension to come off the fall wires, after which the locking pins of the extendable section can be easily released. The extendable section is designed to then slide back over the main section and the combined ladder is raised to the stowed position.

In this case, the bosun and AB overlooked the correct procedure and attempted to retract the extendable section by releasing the locking pins with the gangway still hanging and inclined overside and the fall wires under tension. With both the crewmembers standing above the extendable section, the AB first removed the inboard pin, which was not under stress. When he found the outboard pin jammed, he used a crowbar to lever off the extendable section of the gangway to loosen the pin. This action caused the pin to suddenly jump out, and the extendable section of the gangway slid rapidly upwards, trapping both the Bosun and the AB by the legs in the recess between the gangway steps.

▲ Gangway showing main and extendable sections

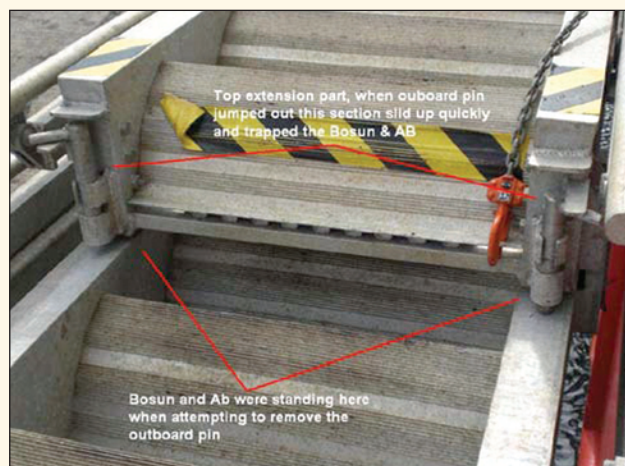
Realising the emergency, other crew members rushed to the site with a portable lever hoist (chain block) and managed to relieve the stress and free the trapped men. The AB suffered a serious fracture of the leg and was disembarked to a hospital ashore.

▲ Close-up view after incident, showing locking pins in open position and lever hoist (chain block) rigged as a temporary preventer

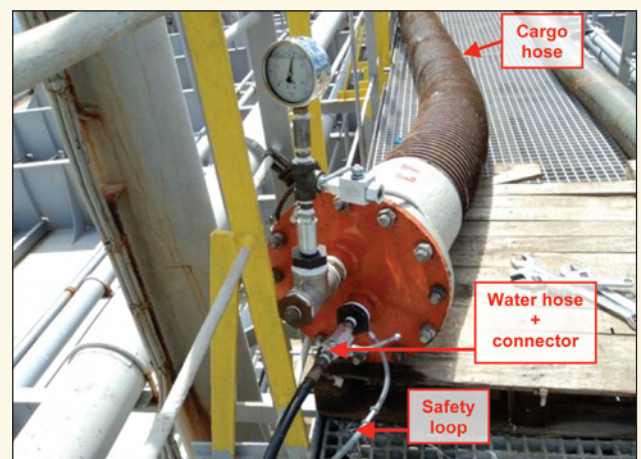
In our chemical tanker fleet, the annual pressure testing of cargo hoses is generally carried out by ship's crew, ideally when the cargo hoses are being used for tank cleaning. During such an operation, with the ship at a repair yard, the cargo hose pressure test was being conducted at a pressure of 12 kg/cm². A junior officer was part of the testing team, and was involved in documenting data and taking photographs. Suddenly, the connection between the water hose and cargo hose detached and the flailing hose coupling hit his left leg causing a serious fracture.

Worn and insufficient threads on the water hose coupling.

▲ Safe cargo hose pressure-testing arrangement showing safety loop across connector between water and cargo hoses

1. The shipyard was given a letter of protest about the accident.
2. Alert issued to the fleet instructing the crew to:
 - i. Inspect all tools and equipment which are used for the pressure test beforehand;
 - ii. Attach a safety loop or lashing rope across every temporary connection in the hose and piping system to prevent them from snapping back;
 - iii. Keep away from snap-back danger zones;
 - iv. Locate and monitor devices such as pressure gauges which are within a safety zone.
