Providing learning through confidential reports – an international cooperative scheme for improving safety

### MARS 201169

## Unplanned deviation led to grounding

*Seaways* December 2011

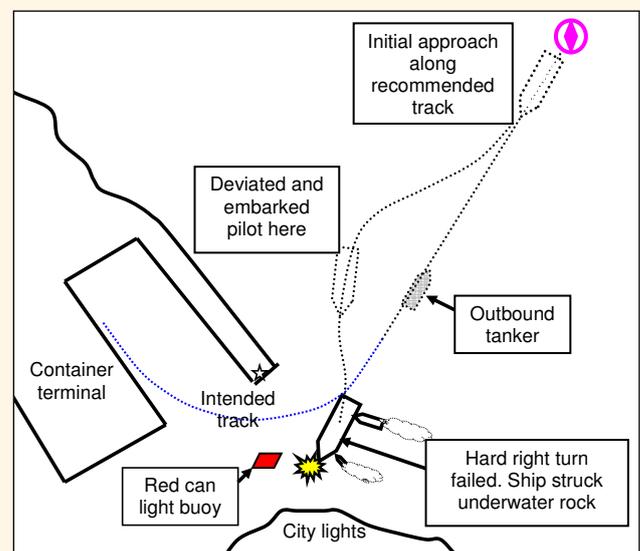
1. Bottom plating on port side of keel buckled extensively for a length of about 15 metres from stem and holed in fore peak tank and bow thruster space;
2. Bow thruster motor windings and wiring damaged by sea water;
3. Forepeak tank vent heads burst and detached from base due to the shock pressure wave generated by the water inside the fully-ballasted forepeak tank.

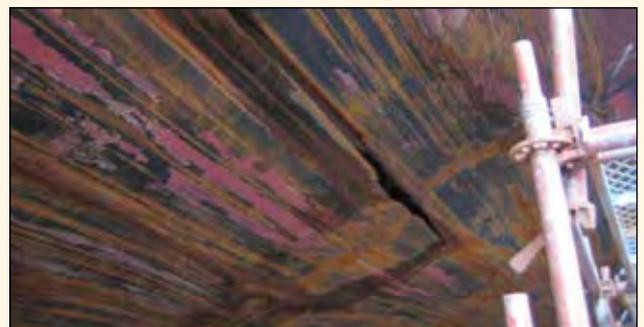
randomly-moving fishing vessels was encountered, causing the chief officer to make a number of course alterations over the next hour. By this time, the vessel was approaching the most navigationally constrained part of the passage, in the vicinity of the off-lying islands and reef. The ship was making 21 knots and she was well off her intended track. The vessel's position had been plotted only twice between 0600 and 0700, each plot based on a single radar range and distance. An electronic chart system was fitted, but was only monitored occasionally. Suddenly, a fishing vessel separated from the fleet and accelerated towards the container ship's starboard bow. Constrained by other fishing vessels on the starboard side, the chief officer altered course to port, directly towards the reef, which he had forgotten about. At about 0708, the ship ran aground at full speed on the reef, resulting in the breaching of five of her ballast tanks.

▲ View of bottom damage

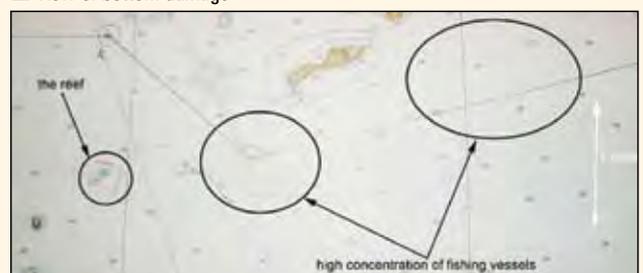
▲ Paper chart showing planned track and the reef
