Providing learning through confidential reports – an international cooperative scheme for improving safety

MARS 201218 Incinerator fire

MARS 201219 Improper stowage of oversize steel structurals

Fatality from parted mooring rope

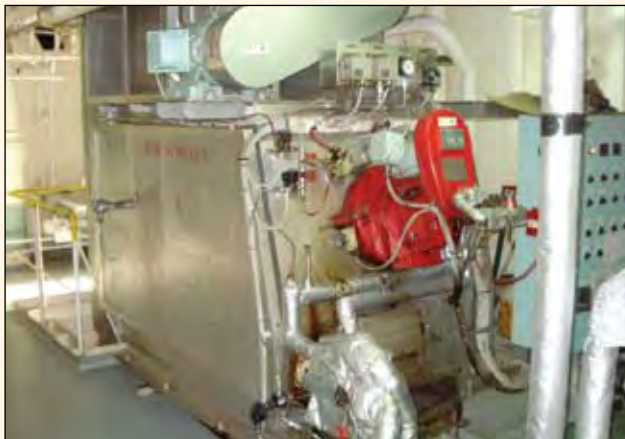
1. The atomiser unit's air nozzle holes were found to be choked with hard viscous sludge thereby restricting the flow of air into the incineration chamber. This condition seemed to have existed for some weeks prior to the incident;
2. Waste oil had failed to atomise properly and had collected and spread over the bottom of the combustion chamber and ignited, producing a large quantity of smoke;
3. The smoke activated the fire alarm, triggering the local fixed water mist fire extinguishing system.

▲ Exterior view of incinerator

1. Failure to maintain the incinerator's burner assembly as per maker's recommendations; in particular the atomiser nozzles had not been properly inspected and cleaned;
2. Failure to fully inspect the combustion chamber, which would have shown that waste oil had accumulated on the bottom from previous burning operations;
3. Failure to properly monitor the exhaust during past operations which would have indicated abnormal combustion.

Engineers' familiarisation form revised to include training and familiarisation in the use of the incinerator.

1. Discuss the incident at their next safety meeting;
2. Conduct onboard training on proper operation and maintenance of the incinerator, including emergency stop procedures, checks to be carried out prior to and during the use of the incinerator;
3. Ensure that the incinerator is cleaned and checked after every use;
4. Regularly test all safety devices on the incinerator as well as emergency stops.

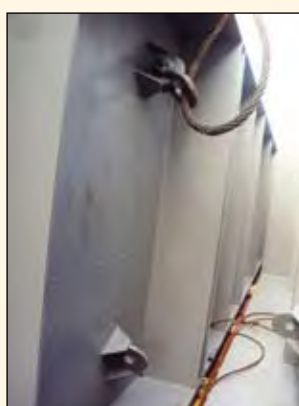
In line with my past experience, none of the lifts bore proper markings to show the gross weight, slinging method and centre of gravity. Further, the pieces were randomly loaded with some stowed standing on the flanged base (vertical orientation) and others on the side (horizontal orientation). Proper lifting padeyes were welded on both

sides of each lift, indicating that they were designed to be lifted and stowed in a vertical orientation only.

In my opinion, the shippers at the loading port had illogically stowed many lifts wrongly on the side and the ship's staff had not questioned the stowage nor considered the modalities at the discharge port. The manufacturers were also negligent in not marking the lifts to indicate correct lifting and stowage methods.

◀ Orientation of dedicated padeyes confirm that the lifts must be lifted and stowed only in the vertical orientation, i.e. on either the upper or lower flange

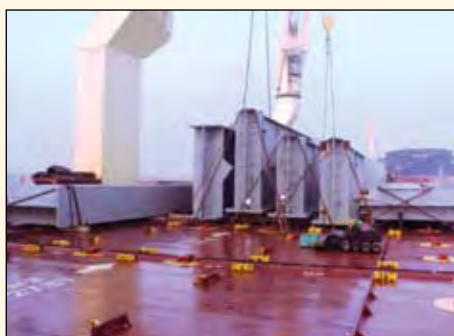
The consignment was destined for a project site deep in the hinterland, involving transportation on a single lane road by special trailer for a distance of nearly 900 kilometres from the discharge port. Fearing the trailer could overturn if the lifts were loaded in the vertical orientation, the road haulier insisted that all the lifts were loaded on their sides. Citing safety reasons, the vessel's master refused to turn over the vertically oriented pieces with ship's cranes.

After heated discussion between vessel, charterers, road transporter and the port, all the cargo was unloaded as stowed, with the road haulier arranging for the vertically oriented lifts to be turned over at the storage yard inside the port with three mobile cranes, at his own risk. The vessel duly completed the discharge and sailed. The flipping operation ashore involved serious risk to personnel, cargo and equipment and indeed resulted in some minor damage to the cargo and also the paving of the storage area.

First lift being discharged by twin deck cranes. All the vertically oriented lifts were later turned on their sides by the road haulier on the shore

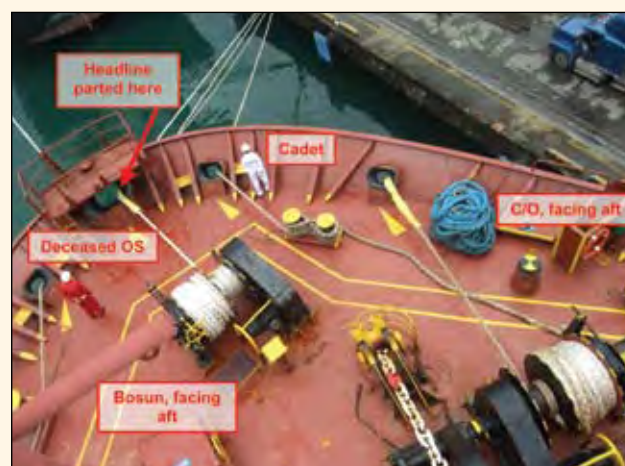
Without the Master's knowledge, the pilot then ordered the tugs to stop pushing. Instantly, the ship's bow began to swing away from the berth. At this time, the OS approached the centreline fairlead to visually estimate how much slack was required on the additional headlines that were being sent from the port bow for the eyes to reach the bollard ashore. Without warning, the first headline parted, snapped back and struck him on the head. The C/O immediately reported to the Master that the first headline had parted, but as his line of sight was obscured by the mooring winch, he could not see the injured OS. However, the Bosun informed him that OS had been struck by the parted rope and had collapsed on deck. The C/O promptly conveyed this to the Master.

1. Failure on the part of the OS and other crew to recognise the danger of coming within snap-back zones of taut mooring lines;
2. Both the C/O's and the Bosun's attention were focused towards the stern and neither was aware of the excessive tension on the single headline;

3. Both the C/O and the Bosun were unaware of the OS's location as the former's line of sight was obstructed by the centre mooring winch and the latter was operating the winch controls in an aft-facing position;

4. Failure on the part of the trainee and cadet to warn the OS in time;
5. Unusual location of the winch controllers which had recently been moved from a conventional deck pedestal location to the inner forward side of the fore peak store hatch trunk or coaming, causing the operator to adopt an aft-facing stance (this modification was carried out on the orders of ship's managers to avoid the recurrent heavy weather damage to the controllers in the original exposed location);

▲ Reconstruction of accident site showing location of persons

1. Conduct a thorough risk assessment of mooring operations and a review of the mooring procedures being followed onboard;
2. Properly inspect all mooring ropes to identify and replace damaged ropes in line with company procedures and ensure a detailed record of inspections and condition is maintained;
3. Conduct training for all crew on identifying and understanding the dangers associated with snap-back zones;
4. Ensure that no modifications are made to the layout of mooring arrangements and associated equipment without completing a risk assessment and obtaining the requisite approvals.

1. Ensure the effectiveness of control measures put in place following this accident and review them regularly;
2. Ensure that a sufficient number of experienced crew is available at each mooring station.

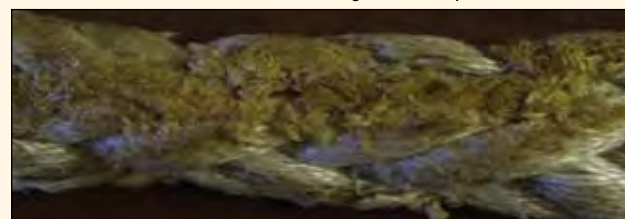
The parted mooring rope was an 8-strand polypropylene rope, 72 mm in diameter and the test certificate stated its minimum breaking strength of 101.6 tonnes when new. The rope had been in use for a year and its condition was assessed as 'satisfactory' when last inspected a month earlier. Following the accident, a representative sample of the rope outboard of the failure zone was analysed and it was concluded that:

1. The representative sample had suffered a large reduction in strength;
2. The main cause of this strength loss was external abrasion damage;
3. The abrasion damage had slowly become cumulative before the failure incident;
4. Internal abrasion damage also contributed to the failure, but to a lesser degree;
5. The pre-existing external abrasion damage on the failure zone was worse than the representative sample, causing the rope to fail at that point;
6. Thermal degradation had also possibly contributed to the rope's failure.

6. In the absence of roller fairleads, all mooring ropes had to be led through Panama fairleads or chocks. The high frequency of port calls caused significant external abrasion damage;

7. Improper assessment of the rope's true condition by ship's staff. Ropes should have been withdrawn from service if the company's retirement criteria had been followed correctly;

▲ Evidence of abrasion damage near the failure zone

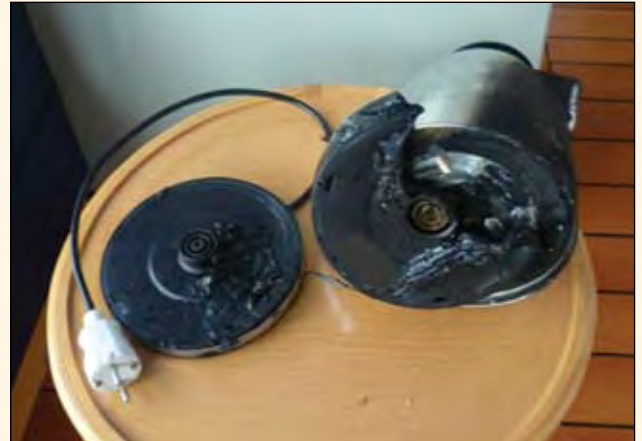
The electric kettles being used on board typically consisted of a cordless stainless steel jug fitted with a plastic base that contained the electric heating element. Power was supplied via a male-female central connector mounted on the base unit, also made of plastic. Following a mid-afternoon coffee break, the crew had left the messroom and had failed to notice that the water in the kettle was still boiling and the automatic thermostat switch had not operated and cut off the power supply to the heating coil. Some minutes later, all the water had evaporated and without any more heat load, the temperature rose high enough for the plastic base and kettle bottom to melt and ultimately catch fire. The strong smell of burning plastic drew the attention of a passing crewmember, who, after seeing the fire and smoke at the base of the electric kettle, quickly disconnected the power cord from the supply socket and transferred the burning kettle and base unit into the adjacent galley sink and turned on the water, successfully extinguishing the fire.

1. Automatic thermostatic switch malfunction;
2. Negligence on the part of the crew in not observing that

the kettle was still boiling when they left the messroom at the end of the coffee break.

▲ View of fire-damaged kettle and base unit

1. All existing kettles permanently removed from use and replaced with new ones;
2. Prominent notices displayed near all electrical appliances requiring the disconnection of power cord from electrical supply outlet when not in use;
3. An incident report was sent to the office to be shared with the rest of the fleet;
4. Incident discussed at the next onboard safety meeting.
