Providing learning through confidential reports – an international cooperative scheme for improving safety

### MARS 201222

## Multiple injuries from falling hatch lid

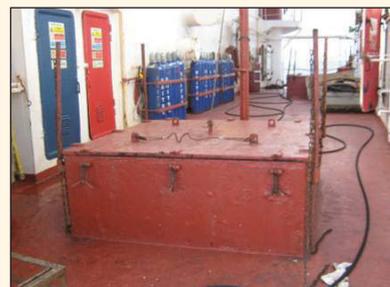
A disused washing machine was being lifted out of the engine room through the hatchway located on the main deck. The hatchway had a portable lid which was designed to be lifted and stowed clear by means of a portable davit fitted on one side of the coaming. However, the crew assigned to this task decided to partially tilt the lid open and temporarily hold it at that angle by using a wire rope sling and chain block attached to the davit. The Junior Engineer (J/E) was on the main deck observing the operation. As the lift was being prepared, the engine room alarm sounded. The J/E leaned over the open hatchway trunk to look into the engine room with his right hand resting on the coaming edge and his left hand taking the support of the partially open lid. Suddenly, the hauling chain of the block parted and the lid fell down, striking a glancing blow to his head and trapping his right hand. He sustained a deep cut on his scalp (not wearing helmet) and multiple compound fractures to his right hand. He was given first aid onboard and repatriated urgently for extensive restorative surgery ashore. It is likely that he may have permanent deformity and disability in his right hand.

1. Improper and very unsafe method of opening and holding hatch lid;
2. No risk assessment or tool box talk was conducted before commencing the task;
3. The lifting arrangement and points of attachment were not assessed for condition, stresses and adequate capacity;
4. None of the crew present recognised the obvious dangers arising from the wrong working practices employed.

◀ View of hatchway showing portable lid and base of lifting davit

1. Casualty administered first aid onboard and later repatriated for emergency medical treatment;
2. Defective chain block permanently removed from use;
3. Hatch lid modified to incorporate safer lifting and permanent fail-proof securing arrangements;
4. Incident discussed onboard at safety meetings held on all company vessels, with instructions to ensure that:
  - Prior carrying out any task, a proper risk assessment is conducted and recorded;

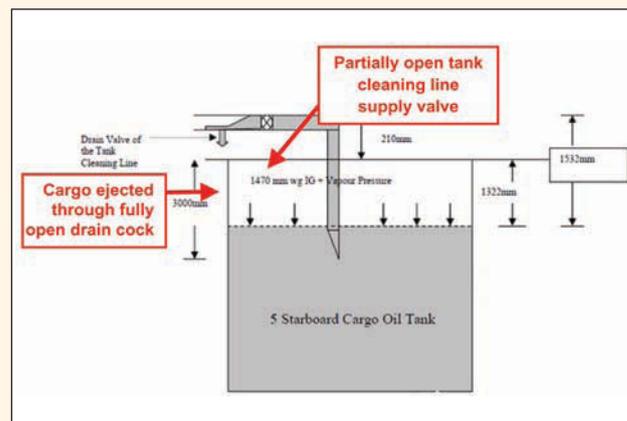
4. With the near-full loaded condition, the tank cleaning machines were submerged in the cargo. The increase in vapour pressure inside the tank due to cargo sloshing resulted in the cargo being pushed up into the tank cleaning line. The cargo then passed through the partially opened tank cleaning valve and fully opened drain valve on to the deck, resulting in the oil cargo spilling on deck;

▲ Diagram showing the circumstances that caused the backflow and escape of cargo from tank cleaning line

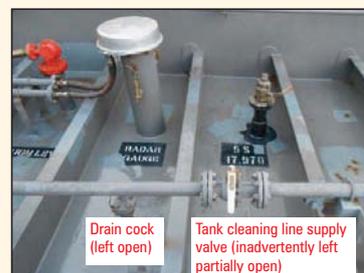
Chief Officer (C/O) on bridge watch noticed a small pool of oil cargo moving with the roll on the main deck starboard side, between the deck longitudinal and ship's side. The Master was immediately called and the oil spill emergency response plan was activated. Upon the Master's arrival on the bridge, the C/O proceeded to the main deck. Meanwhile, the crew had plugged all the scuppers on the main deck. The crew found that cargo was coming out through the open drain cock on the tank cleaning line branch to 5 Starboard Cargo Oil Tank (COT). This valve was immediately shut, and the deck team then discovered that the supply valve for 5S Tank Cleaning machine was also partially open. The supply valve was then also closed tight. Although no oil or sheen was visible in the ship's wake, it is possible that some oil could have escaped to the sea during the hours of darkness.

▲ Deck fittings at spill site

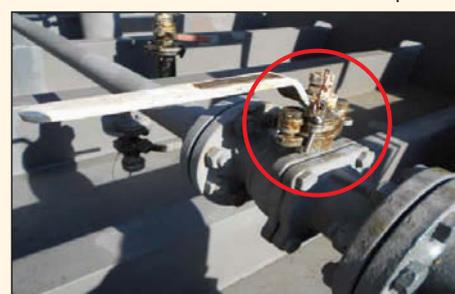
1. **Faulty design:** The supply valve for 5S tank cleaning machine was found partially open despite the order for all valves to be closed. All these valves were fitted with long operating handles very near deck level which could easily get in the way of a person walking past. During the final stages of loading, many ship and shore personnel were on deck in the vicinity of this valve handle as the tank was gauged and sampled. It is possible that anyone, particularly a shore person, could have accidentally kicked the valve handle and opened it without knowing the consequences;

2. **Crew negligence:** All tank cleaning line valves in this vessel are designed to accommodate a locking arrangement but many locking pins were missing and therefore the valves could not be positively secured in closed position;

◀ Corrective action – protruding valve activating handle secured shut with locking pin

1. A safety meeting was conducted by the marine superintendent at the next port and the incident was discussed in detail;
2. Crew re-trained on proper post tank-cleaning/pre-loading procedures;
3. Pre-loading check list has been amended to include the closing of all tank cleaning line valves, drain cocks/caps;
4. Missing locking pins on all valve handles have been renewed;
5. Placards have been posted near all tank cleaning and line drain valves to ensure they are closed prior to any cargo operation;
6. Chief Officer's standing instructions have been amended to ensure that all drain valves are positively shut after tank cleaning operations;
7. Incident made part of pre-boarding briefing for all officers.

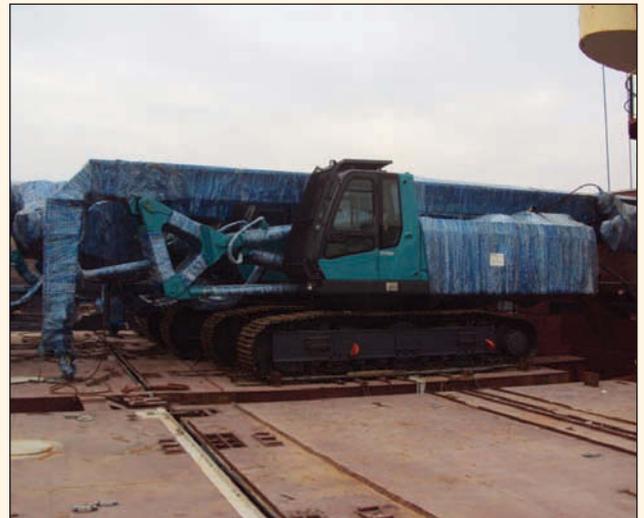
A heavy lift vessel arrived to discharge a consignment of project cargo at our terminal. The manifest included some units of a maximum weight of about 50 tonnes. However, many of them had both a paper sticker with shipping marks showing the gross weight written by hand (some overwritten with a figure different from the weight declared in the manifest), and a metal plate prominently affixed with punched numbers showing a figure far in excess of

▲ Typical deck cargo unit displaying both metal plate and paper label showing different weights

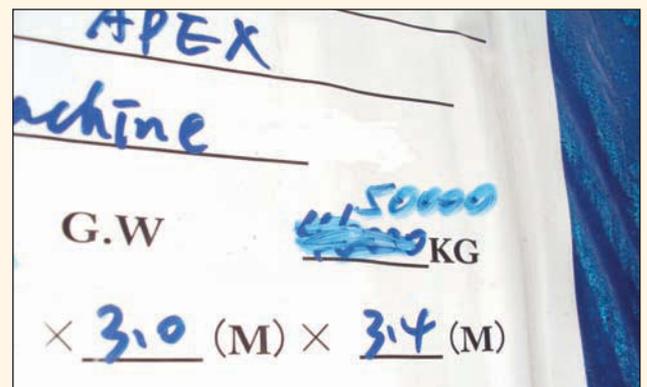
▲ Typical label bearing overwritten weight information
