Mariners' Alerting and Reporting Scheme

MARS Report No. 238 August 2012

MARS 201236

Breathing apparatus air compressor explosion

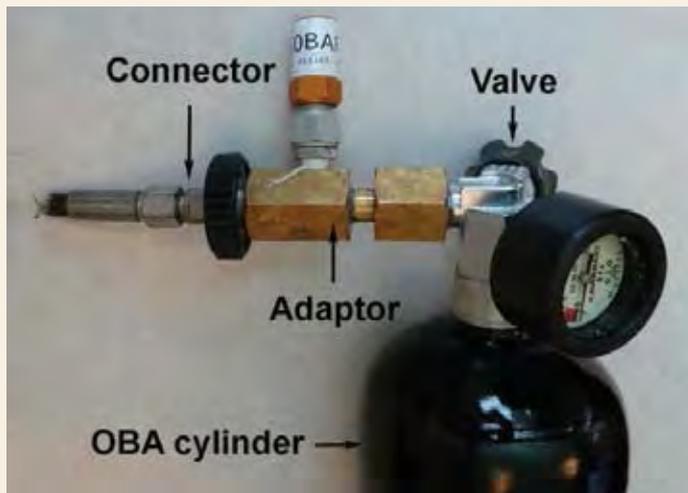
- 4 There are internationally recognised colour schemes used in industry so that high pressure cylinders containing different gases can be easily identified. There are also a number of different types of engineering controls that prevent a high pressure cylinder from being connected to an incompatible system – e.g. an oxygen / acetylene set - the threads on the high-pressure oxygen cylinder are right handed, whereas the threads on the acetylene cylinder are left handed, preventing incorrect connections. The SCBA and OBA sets supplied on board were compliant with European and Japanese standards respectively, and had different threaded connections. But, due to an unfortunate coincidence, the spare compressor discharge hose adaptor that was found in the box near the SCBA compressor allowed the connection of the Japanese-made OBA cylinders to the European-made air compressor.

View of adaptor that allowed the dangerous connection of SCBA air compressor discharge line to OBA oxygen cylinder

- 1 The ship's safety management system documentation to include appropriate guidance in relation to the operation and maintenance of OBA sets;
- 2 The company has forwarded a safety bulletin to all ships advising staff to:
 - re- fill all OBA oxygen cylinders ashore;
 - clearly mark the word 'oxygen' in English on all OBA oxygen cylinders;

- post signs on all breathing apparatus compressors stating that they are only to be used to re-fill air breathing apparatus and emergency escape breathing device (EEBD) cylinders;
 - seek approval from a responsible person prior to re-filling cylinders; and
 - assign more than one crew member to the task of re-filling cylinders.
- 3 All OBA cylinders to be supplied in the future will be permanently labelled to indicate that the re-filling of the cylinders with oxygen must only be carried out ashore.

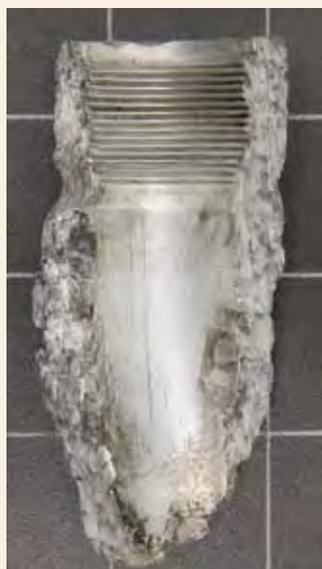
1 The investigation found that the explosion occurred as a result of a fire that started within the compressor when oil ignited in the hot, oxygen-rich environment. When the 3/O opened the OBA cylinder

- 2 When oxygen within a system is compressed rapidly, with no heat loss to the surrounding materials, it causes a rapid temperature rise in the gas. Within seconds, the temperature of the oxygen-rich environment would have exceeded the auto ignition temperature of any oil that had been trapped in the discharge tube filter, or any other part of the discharge circuit. Once the oil ignited, a near instantaneous over-pressurisation within the compressor caused the rupture of the discharge tube and hose. A flame front was then blown out of the compressor, engulfing the 3/O.

View of fragment of discharge tube after explosion

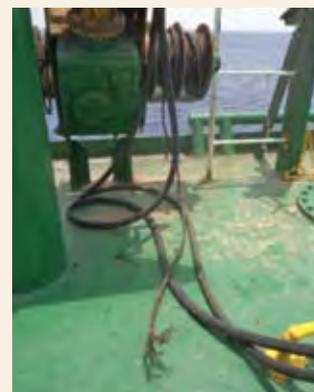
- 1 The fall wire had a kink in way of the failure location, believed to be a permanent stress point when the gangway is swung out to upper deck level;
- 2 The reeving arrangement of the fall wire consisted of a multi-drum winch, meant to rotate simultaneously for lowering / hoisting. It is believed that a slight disparity in synchronisation imposed high stress on the fall wire;
- 3 The crew failed to properly monitor the stress on the wire and the movement of the winch drums when preparing the gangway;
- 4 Inadequate inspection by the crew prior to breaking out the gangway;
- 5 Ineffective inspection/maintenance/record-keeping of the gangway, wire and fittings by the crew during routine maintenance;
- 6 There was no crew standing by in the vicinity when the gangway lashings were removed and the gangway was being prepared for use;
- 7 The fall wire had a fibre core.

View showing parted fall wire and gangway winch with multiple drums

- 1 Properly inspect the gangway, fall wires, and all standing and moving parts for proper condition and operation prior to unlashings / rigging and after securing the gangway;
- 2 Confirm that the winch drums are properly synchronised;
- 3 Update and keep inspection and maintenance records as per PMS;
- 4 Do not leave the gangway unattended once the lashings are removed until the gangway is fully rigged or secured.

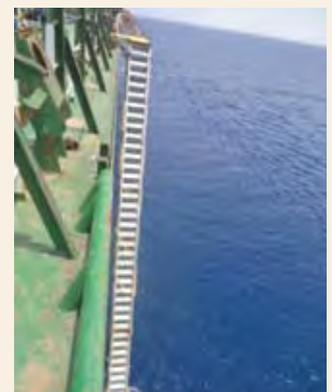
Ladder section trailing in the water after fall wire parted

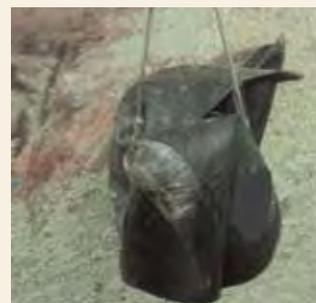
Damaged pneumatic fender hanging by wire sling and chain
