Mariners' Alerting and Reporting Scheme

MARS Report No. [REDACTED] 239 September 2012

MARS 201242

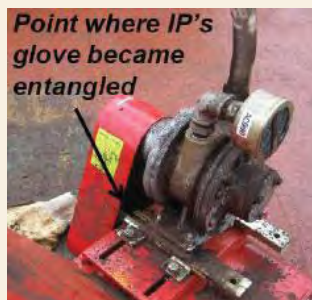
➔ A ship's crew member sustained a serious hand injury while using an air driven deck scaler during maintenance operations. The crew member was wiping clean the base of the scaler with the air motor running, when his glove became entangled in the moving drive belt, trapping his fingers. He sustained crush injuries to the tips of two fingers, and was medevaced for treatment and subsequent surgery. Fortunately, no amputation resulted.

- 1 The deck scaling machine had no 'dead man' control i.e. automatic stoppage when the start control is not deliberately held in the 'on' or 'run' position;
- 2 The crew member inadvertently placed his hand near the gap between the belt guard and the body of the scaler, bypassing the safety barrier;
- 3 The crew member violated existing company procedures for the use of this pneumatic device which clearly required the disconnection of the air line before carrying out any trouble-shooting or maintenance.

View of deck pneumatic deck scaler

View of gap in guard through which the crew member's fingers got trapped in moving drive belt

- 1 All power-driven deck scalers of this type were temporarily withdrawn from service pending effective implementation of appropriate control measures. These included 'hard' barriers such as more effective guards and a dead man switch, and 'soft' barriers such as risk assessment and understanding of proper operating procedures;
- 2 A 'hazard hunt' exercise was conducted whereby other equipment onboard was identified as posing a similar injury hazard i.e. drilling machines, lathes, bench grinders, etc. and appropriate control measures were stipulated to appropriately manage the risks;
- 3 The incident was communicated to the manufacturer of the deck scaler, highlighting the lack of a 'dead man' switch on the device, and a swift and positive response was received.

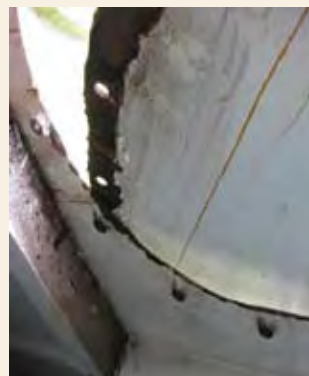
View of opened manhole cover from inside tank after all stud nuts had been cut off

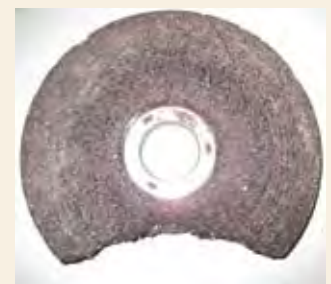
➔ A crewman was injured whilst using a power tool in an incorrect manner. He had been instructed by the C/E to clean paint and corrosion off the stud threads of a manhole cover in preparation for a tank entry. He was instructed to perform this task using either a hand-held wire brush or an angle grinder fitted with a wire wheel. However, presumably because of excessive corrosion on the fasteners, he unilaterally decided to fit a 5mm cutting disk on the angle grinder instead of the wire wheel, and then proceeded to cut off the nuts of the studs securing the manhole cover. Suddenly, the grinding disk rotating at high speed jammed between two adjacent studs. The disk shattered. The detached piece was flung at great velocity and inflicted a bruise on the crewman's left shoulder after cutting through his coveralls.

- 1 Existing company procedures and C/E's clear instructions were not followed;
- 2 Risk assessments were not conducted;
- 3 The crewman had received no training in this specific task and consequently demonstrated a lack of safety awareness that put himself, his colleagues and the vessel at risk.

View of broken rotary cutting disk – the missing segment which was flung at high speed could easily have caused very severe injury to the crewman or other personnel in the vicinity

- 1 Complacency in the use of power tools must be guarded against;
- 2 All persons involved in a task, from deck officers down to supervisors and ratings, must have a clear understanding of the nature of the task and safe work procedures;
- 3 All crew must understand the purpose and requirement for risk assessments for all routine and non-routine tasks;
- 4 All crew members must remember the importance of accepting personal responsibility for safety and that they all are empowered to stop work until safety concerns have been adequately resolved;
- 5 Shipboard training and familiarisation should include specific training on particular tasks and equipment.

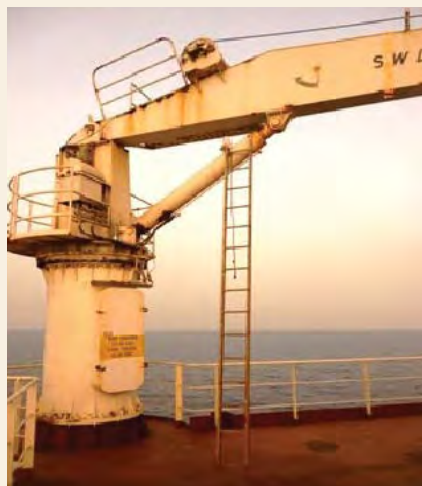
With the top section of the ladder secured to the crane jib, the A/B ascended to the top rung of the ladder and attempted to pass the fall restraining line of his safety harness around the crane jib. Due to the large dimensions of this section of the jib girder, the A/B had to lean out from his precarious perch to grab the free end hook of the line. Suddenly, the ladder became unstable, and the A/B lost his balance.

Unsafe method used: The top of the 6-metre long portable aluminium ladder is lashed to the crane jib

With no restraining line attached to the crane, he fell off the ladder and landed heavily on the deck. The Bosun and the second A/B attended to the injured person immediately, who was unconscious for a few minutes. He continued to breathe, and after regaining consciousness, his responses were normal and he could move all limbs except his right arm. Apart from concussion, and suspected fracture of right elbow, there appeared to be no other internal or external injuries. The emergency team removed the casualty to the ship's hospital, where it was noticed that his blood pressure was low and he was showing signs of dizziness and body tremors. On radio medical advice, a launch was arranged to transfer the casualty to a shore hospital and an accident report was sent to the designated person (DPA) in the shore management office.

- 1 A proper risk assessment was not conducted due to perceived lack of time;
- 2 During the toolbox meeting, the Bosun explained the precautions to the assisting crewmembers;
- 3 It was considered that there was sufficient number of crew assigned for the job and they had all donned proper PPE;
- 4 The work team was sufficiently rested before starting the work;
- 5 It was established that working on the crane jib from a portable ladder was patently unsafe and a safer access to the jib was available by slewing the jib over the adjacent compass (monkey island or flying bridge) deck;
- 6 It was determined that if the other A/B had positioned himself on the crane jib girder by climbing on to it from the crane pedestal, he could have safely secured the casualty's lifeline.

- 1 A fleet alert sent to all vessels on the incident requiring Masters to confirm full discussion and understanding of incident among all on board;
- 2 SMS amended to include new checklist to rectify procedural lapses exposed by this incident;
- 3 A visual training programme was distributed throughout the company and fleet highlighting safe working procedures for crane maintenance;
- 4 New officers and those on leave will be briefed on this case at the earliest opportunity;
- 5 The knowledge, understanding and proper implementation of these actions will be verified during internal audits and superintendent visits.

Editor's note: Maintenance work on lifting gear requires a stable and secure platform, particularly if the work is to be performed at heights exceeding 2 metres above the deck. Senior officers on board and shore management teams must consider equipping the vessels under their care with a reasonable quantity of scaffolding materials of suitable design and strength for greater safety and efficiency.

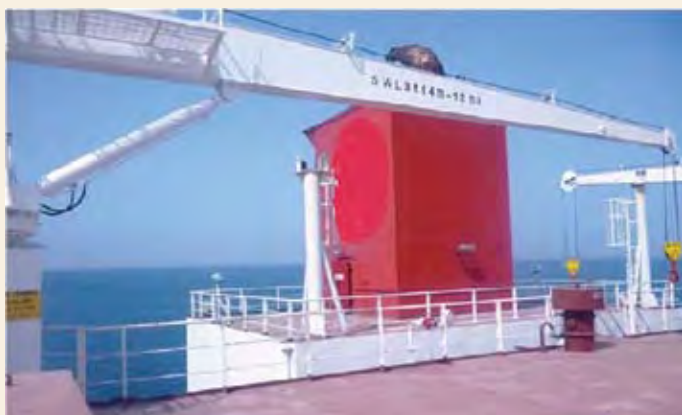
Post-maintenance photo showing the crane raised from stowage crutch and slewed over the bridge deck, permitting safe and efficient access from portable scaffolding

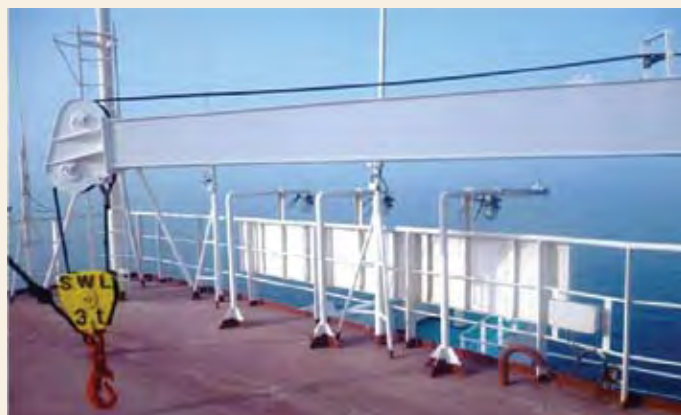
Slewing the crane over the compass deck permits safer access to the jib

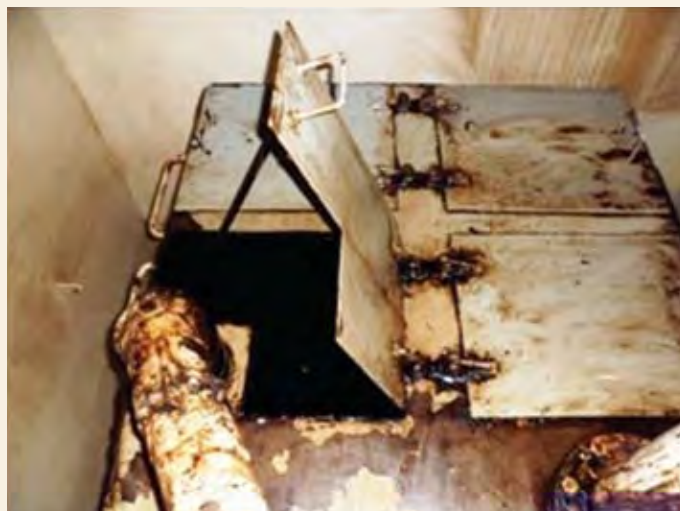
➔ A bulk carrier was at an anchorage port, loading coal. A trainee engine cadet was instructed by a senior engineer to clean the top of the waste oil tank, the contents of which was being maintained at about 70°C. The top of the tank was fitted with four hinged flap lids, one of them being held open by means of a stopper rod. Whilst carrying out the assigned task, the cadet unknowingly placed his foot in way of the opening and his left leg stumbled into the tank and plunged into the hot oil, scalding his leg below the knee. After being given first aid on board, the injured person was transferred to a shore hospital and later repatriated home. The senior officer who assigned the task to the trainee cadet declared in his statement that it was the practice on board to leave one lid of the waste oil tank always open and that he had warned the cadet about this and that the oil inside was hot.

- 1 Unsafe work practices
 - a. No risk assessment conducted when the job was planned, in violation of Company SMS;
 - b. There was no justification for the established practice of keeping one flap lid open on the waste oil tank;
 - c. An inexperienced cadet was assigned a hazardous task, without adequate briefing / supervision by senior officer;
- 2 High temperature of tank contents and no warning notices displayed at site;
- 3 Inadequate lighting at location.

View of waste oil tank with one lid kept open

- 1 Fleet circular issued with instructions for this incident to be discussed at the next onboard safety meeting;
- 2 Company's SMS procedures for the planning and execution of routine/ non-routine jobs on board suitably revised to prevent recurrence of this incident – tank openings to be kept closed at all times;
- 3 The company will review the contents of in-house Safety Officer Course to include notes on work planning, delegation and supervision;
- 4 Crews instructed to:
 - a. conduct and record a risk assessment before commencing any task;
 - b. Carefully identify all hazards in the work area and implement appropriate control measures;
 - c. Use the Daily Work Record Book to plan/ assign the daily work to crew;

- d. Be vigilant to new hazards at all times;
- e. Ensure that trainees are only assigned tasks under direct supervision of a senior crewmember.
