Risk Focus: Catastrophic Machinery Failure

Factors at play in machinery failure

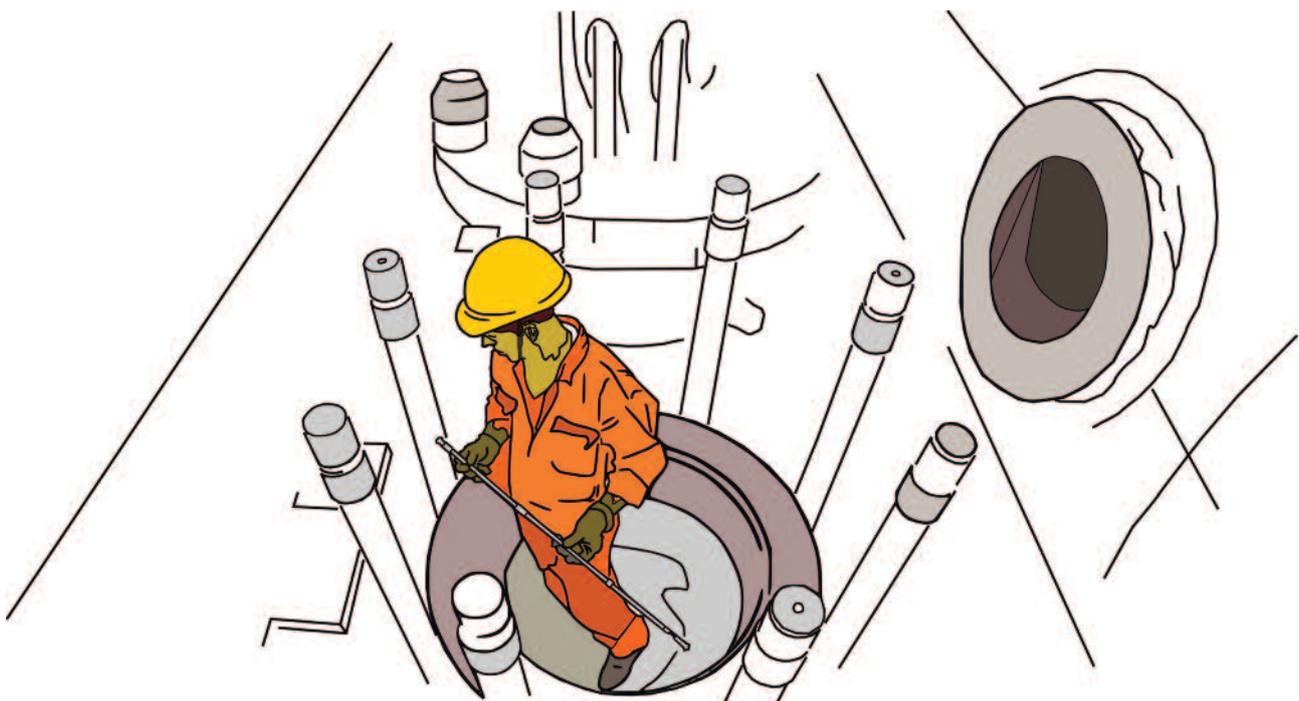
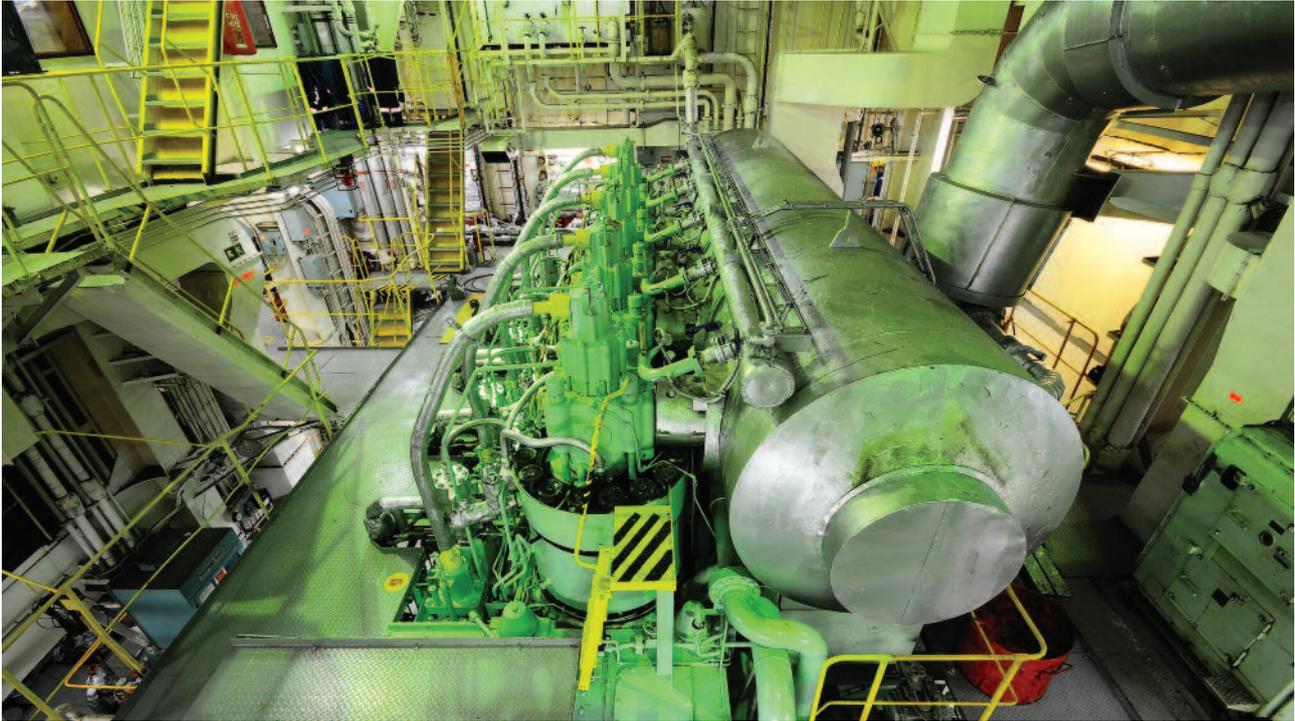
All was running smoothly for the next half an hour. Suddenly, a large amount of water was seen leaking from main engine unit number 6 around the cylinder jacket area. Engine room (ER) staff tried to isolate the leakage at unit number 6 but failed as the outlet valve was not holding. Due to the heavy leakage and low pressure on the cooling water system, the main engine (ME) automatic slowdown was activated.

The bridge team quickly considered all the options that would prevent the ship from colliding with the approaching bridge. The team's efforts were futile as the loaded vessel was not moving at sufficient speed to maintain steerageway. Within a few minutes, there was an allision with significant impact and the bridge centre pillar fendering was splintered.

The water leakage from unit number 6 was identified from a crack on the cylinder cover cooling jacket. Often such cracks are associated with insufficient cooling water maintenance. In such cases, heavy deposits of dirt and metallic particles i.e. rust are found in the system. Deposits are brought in by the circulating cooling water and tend to find their way into the clearances between the cylinder cover and the cooling jacket. This makes heat expansion of the cylinder cover impossible without exposing the cooling jacket to significant stress. Thus, insufficient cooling water treatment, combined with the heavy corrosion of the engine components, can also cause the cooling water jacket to crack.

It is important to ensure that the valves are holding so that a particular unit can be isolated quickly. Additionally, like fuel oil and lubricating oil, the engine cooling water is a medium that must be carefully selected, treated, maintained and monitored.

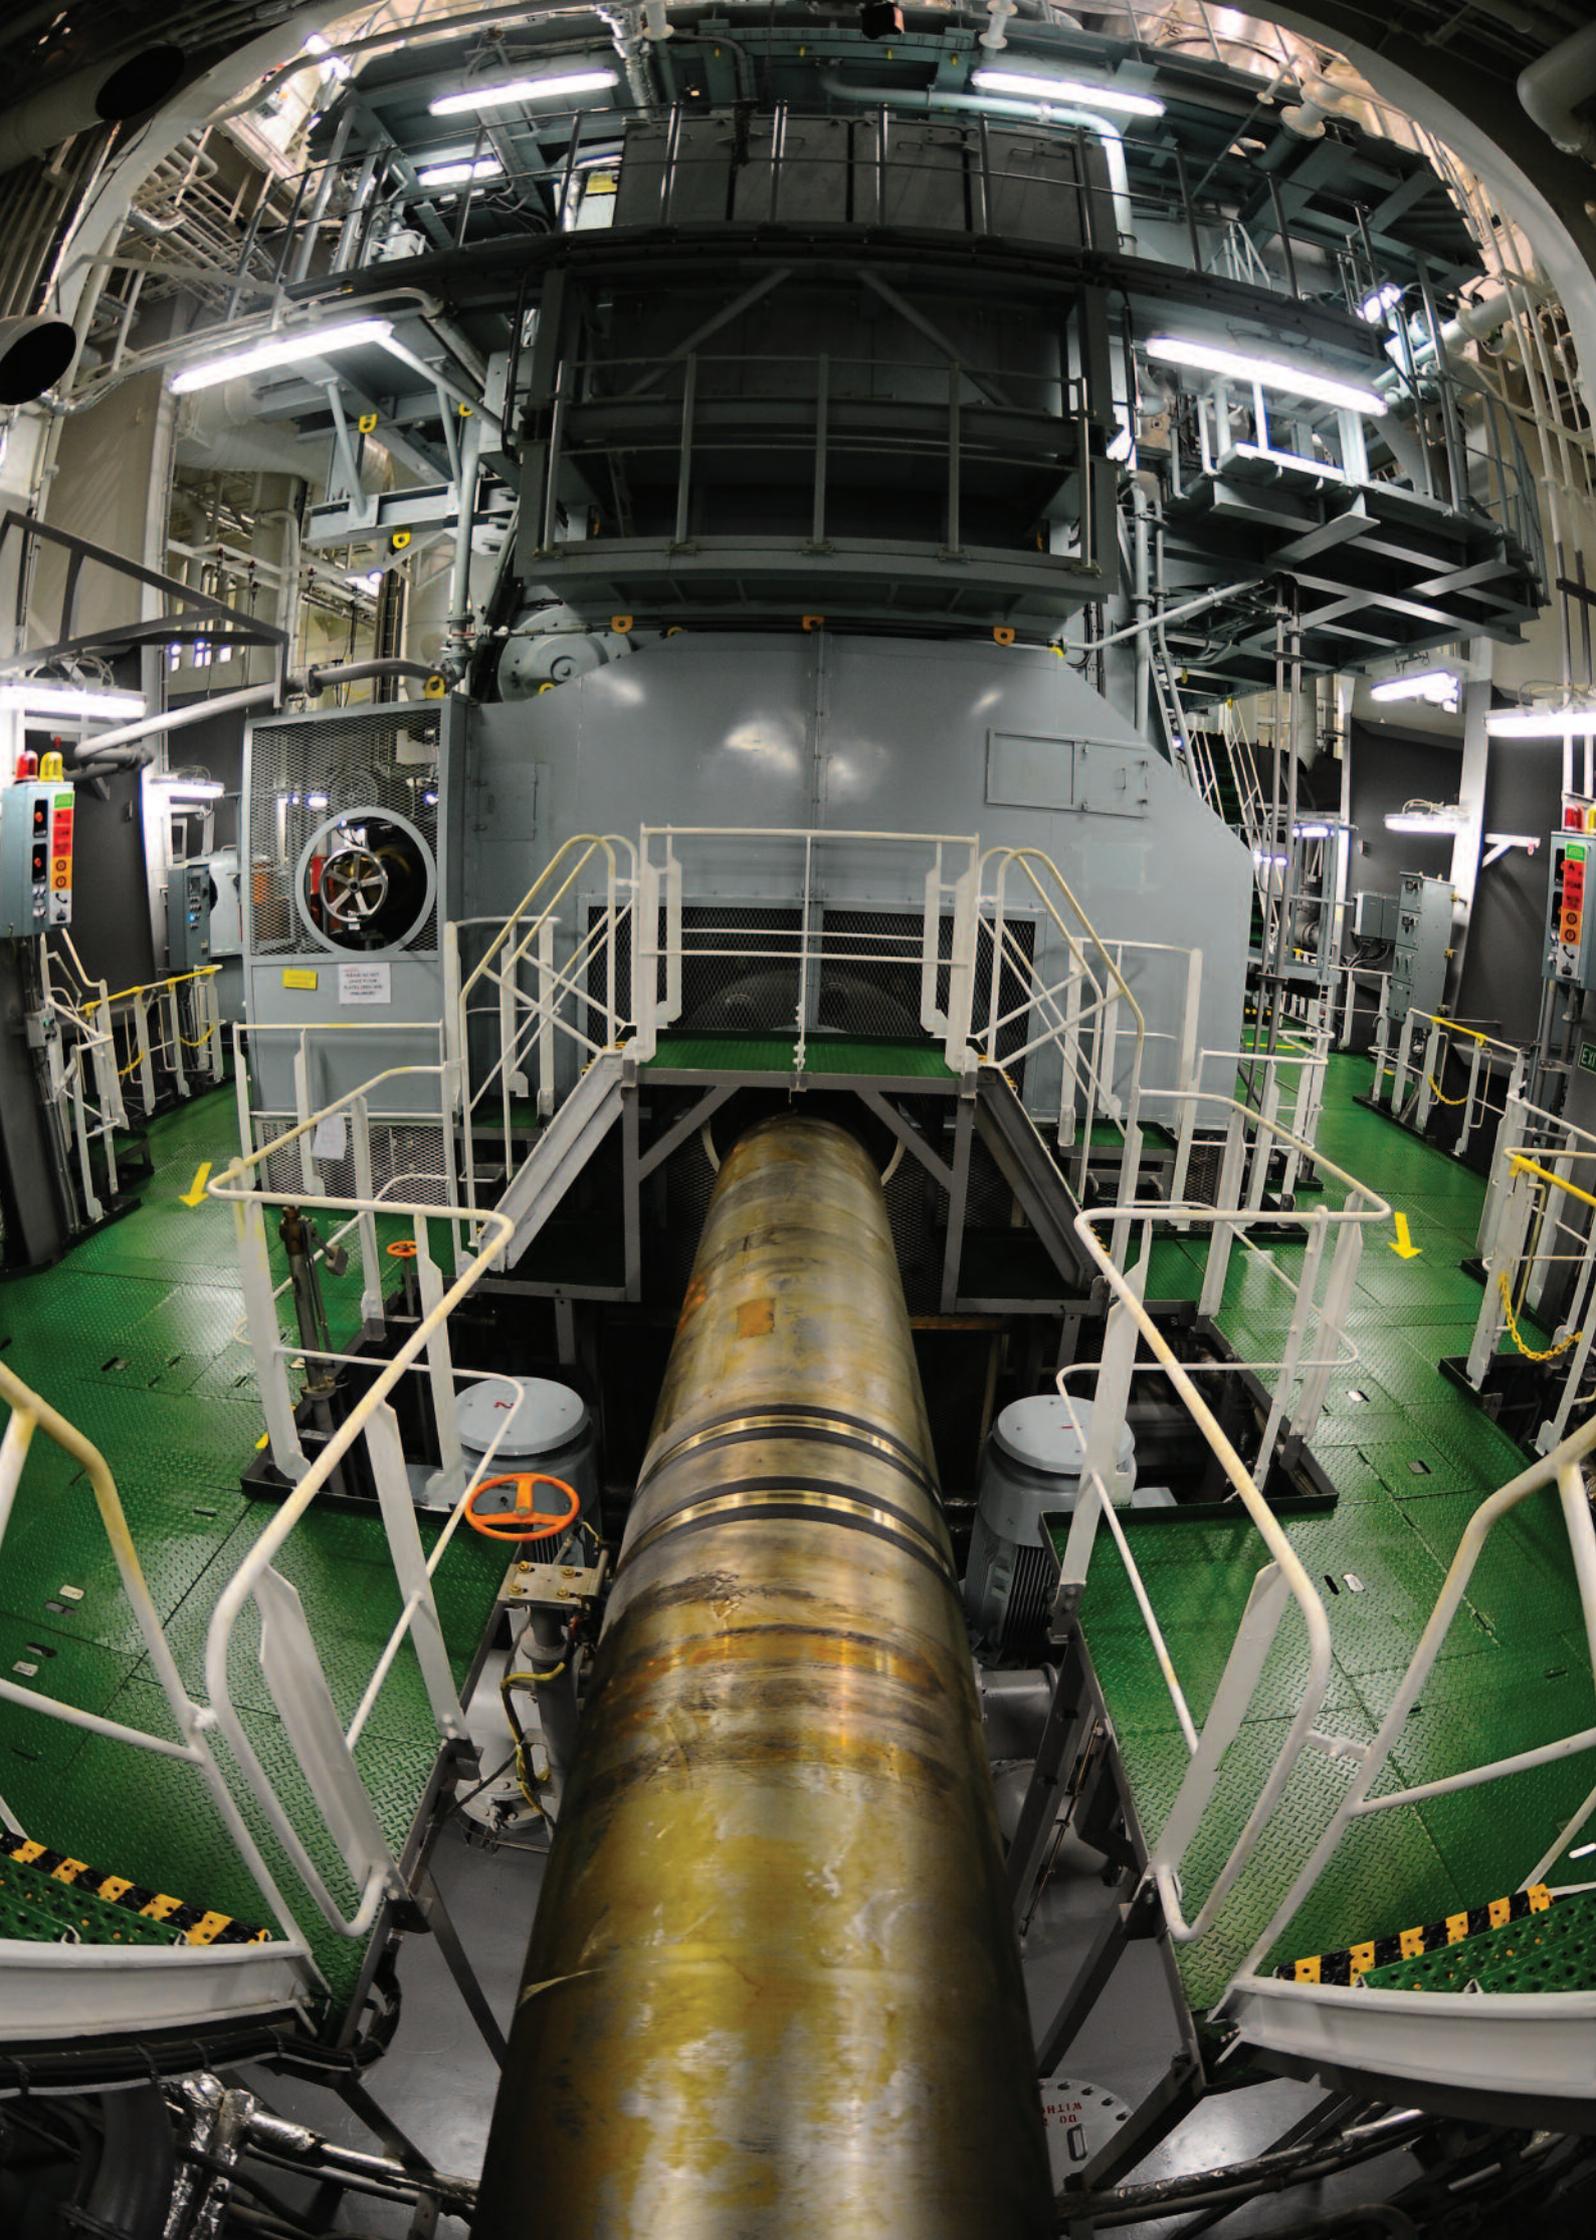
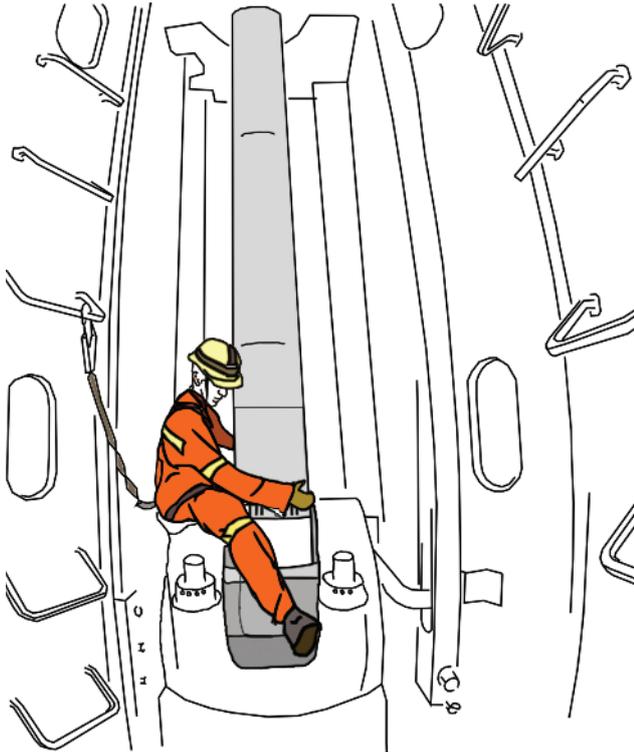
investigation, the crankpin bearing for one of the cylinders was found damaged. A decision was made to isolate the cylinder and run the engine on the remaining units.

The vessel arrived on her own power in South Africa, and a detailed inspection took place where further damage to the engine was established. The damage had extended to other ME units, and many of the bearings were damaged and scored, including the crankpins for some units.

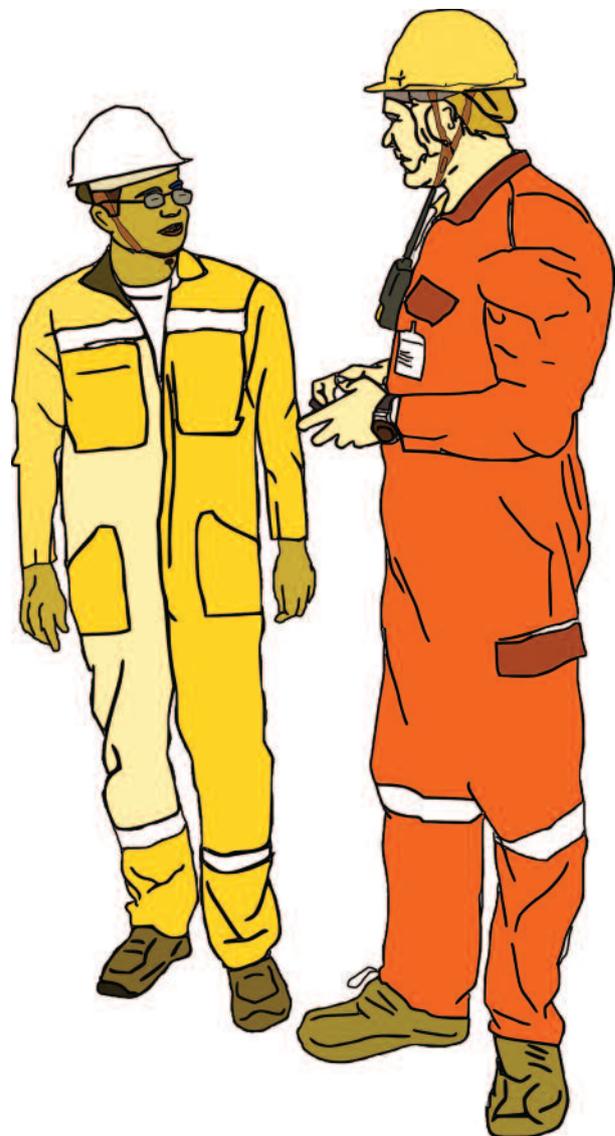
cleaned the burner and igniter electrodes again. This time, the boiler operated for approximately 30 minutes, after which it again failed to ignite. The electrician re-inspected the electrical systems. Simultaneously, the third engineer and fifth engineer dismantled and cleaned the burner and nozzle unit, reassembled it under the second engineer's supervision and refitted it to the boiler one more time. When the test-firing commenced, the third engineer, fifth engineer and electrician positioned themselves near the boiler burner to monitor the automatic starting and firing sequence. The forced-draught fan went through a five-minute purge programme, followed by a massive explosion when the igniter electrodes sparked.

The burner arrangement was ripped apart due to the explosion. The ducting from the forced-draught fan was also ruptured. Fuel lines running across the top of the burner were deformed, and some began to spill oil. The engineers and electrician standing near the boiler suffered severe burns over large portions of their bodies.

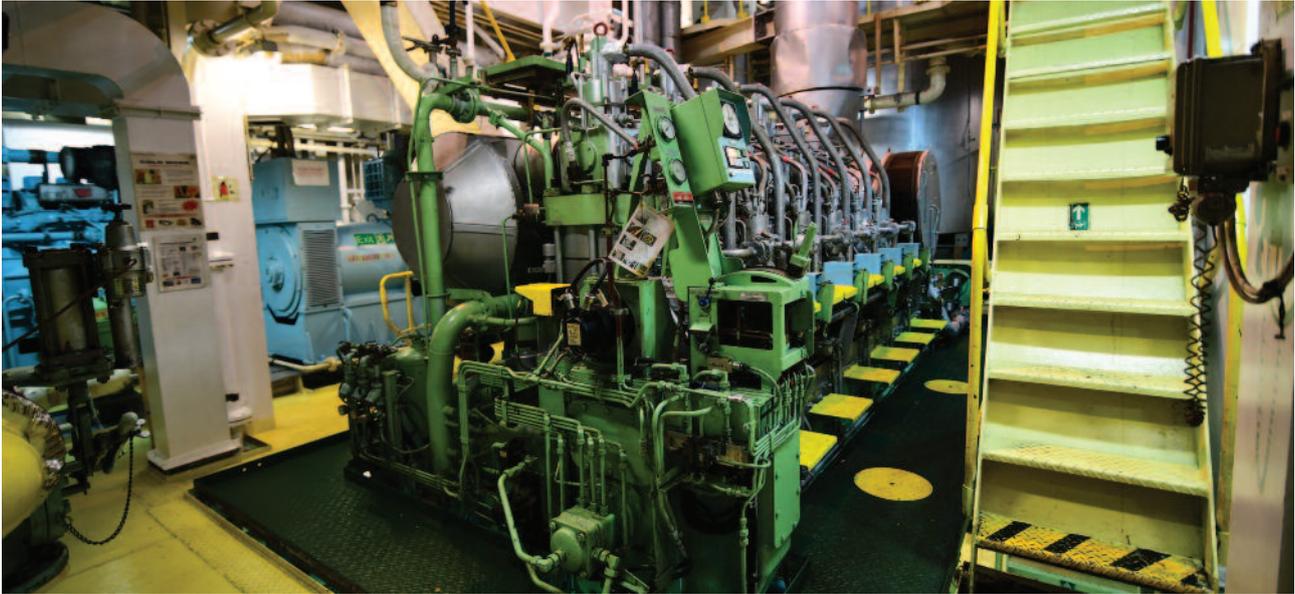
During the night, the officer of the watch noticed a rise in temperature in the freshwater cooling system. He called the second engineer, who attributed the rise in temperature to an ice blockage in the low sea chest suction. Arrangements were made to use water from the forepeak ballast tank to lower the cooling water temperature.

To clear the ice, engine staff unbolted the cover of the housing containing the low seawater strainer. As the crew were working, they noticed water beginning to overflow from the seawater strainer housing. They attempted to tighten the valve by hand but could not do so; a pry bar was then used, but the valve operating mechanism failed. Hydrostatic pressure forced the valve disc and valve operating mechanism upwards, allowing seawater to enter uncontrolled and overflow into the ER.

Multiple attempts to secure the cover on the seawater strainer housing were made but were unsuccessful. Within approximately ten minutes, the engine room's water was nearly 4m deep and had reached the level of the grating deck. After electrical sparks were seen, the Master ordered that the vessel be blacked out and the engine room evacuated.

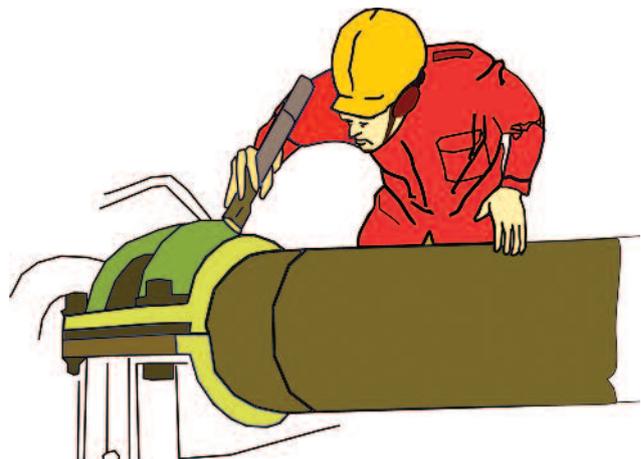
During operations offshore, the vessel's port inboard main engine failed with extensive damages to the crankshaft and bearings. Steps were immediately taken to bring in representatives from the engine manufacturers and shipyard to assess the problem. It transpired that the problem could not be remedied on site, so the engine had to be removed from the vessel for overhaul in a shore workshop before reinstallation. The breakdown was caused by an incorrect pipe layout by the shipyard, which was not picked up by the engine manufacturers when commissioning the vessel's engines.
