Seaways

Mariners' Alerting and Reporting Scheme

MARS Report No. 257 March 2014

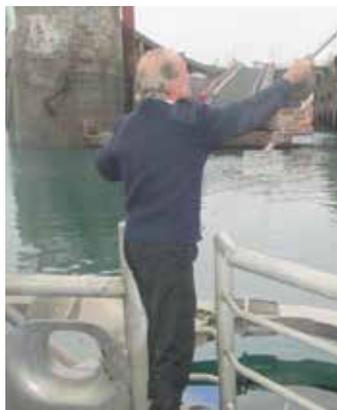
→ A fast ferry was shifting from an operational berth to a lay-by position after completing discharge. A seafarer at the aft mooring station was in position to receive the heaving line from ashore for the stern-line. After two attempts where the heaving line fell short the seafarer, holding a boat hook, placed himself right next to the aft fairlead's stag-horn, looking upwards in the hope that his more advanced position would help for the third attempt.

Suddenly, he over-balanced, falling over the two low rails (just below knee-level) and between the stag-horn and the adjacent railings, striking his head and coming to rest on the port jet thruster 'buckets' and guard. The port jet was immediately de-clutched (stopping movement of bucket) and quick action by deck and engine room crew on scene recovered the seafarer. While the engine room crew looked after the injured seafarer the vessel was secured and the victim then transported to medical attention. Having sustained an injury to the knee and a blow to the head, the seafarer was signed off work for a week.

Simulation showing position of the seafarer

- 1 Need for better guarding of the area concerned (and to eliminate the 'trip hazard' caused by the two low rails by the addition of a higher rail).
 - 2 Inadequate risk assessment for mooring operations on this class of vessel.
 - 3 Need for improved risk assessment procedures.
 - 4 The importance of mitigating the 'can-do' culture of seafarers to ensure that they always give priority to their own safety over other considerations.
- **Editor's note:** As the saying goes, always keep one hand for the vessel and one hand for yourself. Lesson number four is a good indication that the company management realises that often, employees just want to get the job done. It takes training and good leadership to change people's behaviour – and to ensure they always think about their own safety before and while undertaking a particular task.

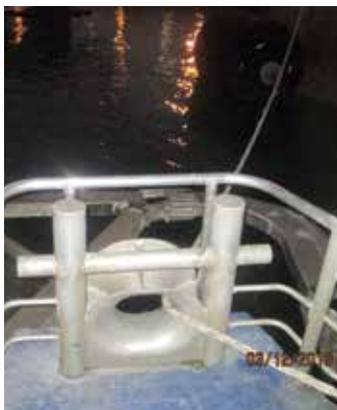
Modified guardrails

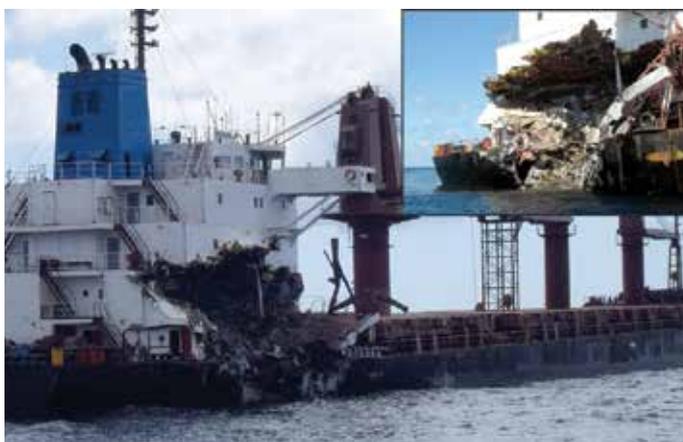
Vessel A

- Vessel A's OOW did not establish that vessel B was on a steady bearing, and that his was the give-way vessel. The inaction of vessel A's OOW showed a total disregard for the safety of his vessel and his shipmates. Despite his experience and knowledge of the Colregs, he made an unfounded assumption that vessel B would pass clear of his vessel.

- Vessel A's OOW did not assess the situation correctly initially, or reconsider his assessment when the situation did not develop as he expected. Even in the scenario that he had imagined, he was willing to accept a CPA that was much less than specified in the Master's night orders.

- The complacent attitude of vessel A's OOW, his misplaced belief in his ability to assess the risk of collision by eye, and his underestimation of the chance of encountering another vessel at close quarters combined to prevent him from taking the necessary actions to prevent the collision.

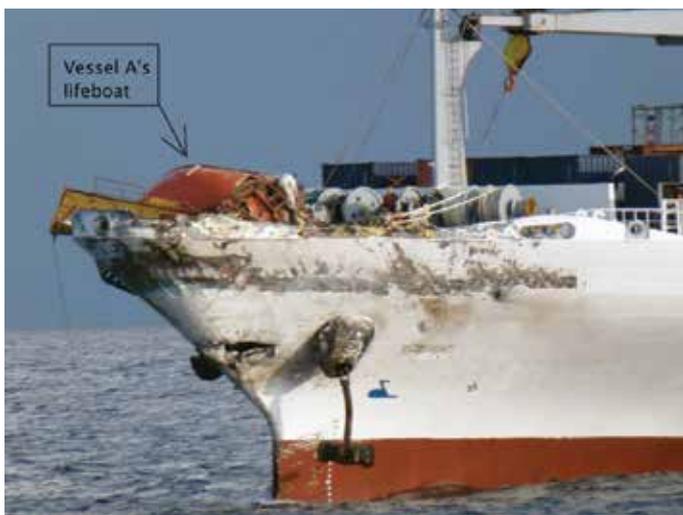
Vessel B

- Vessel B's watchkeeper did not post a lookout or set the watch alarm, and instead relied on his ability to maintain an effective lookout on his own.
- Vessel B's watchkeeper allowed himself to be distracted by tasks other than navigating and keeping a lookout, possibly by placing himself in a position where he could not see out of the bridge windows or look at his navigation aids.

- In choosing to take the watch alone and not setting the watch alarm, the watchkeeper on vessel B demonstrated extremely poor judgment, systematically overcoming each of the safeguards that should have been in place for keeping an effective navigational watch.

- The lack of regard of vessel B's watchkeeper for his primary roles as lookout and officer in charge of a navigational watch can only be assessed as complacent.

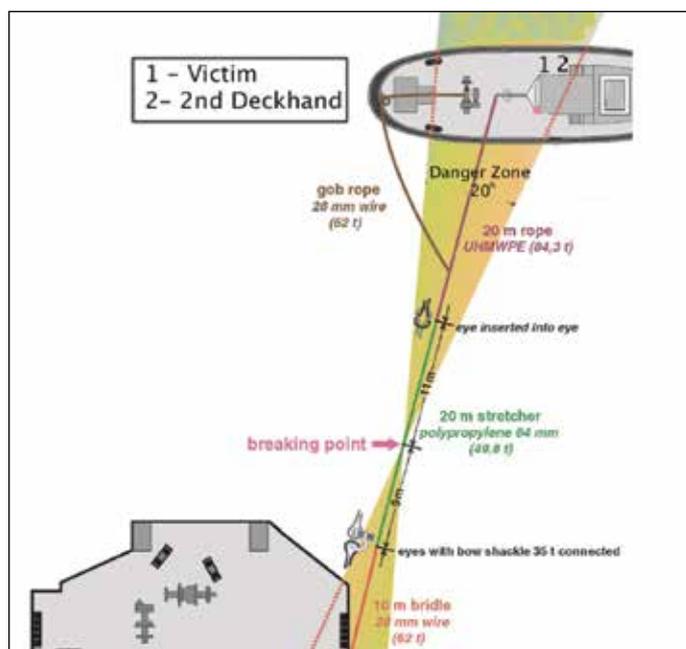
As can be seen in the diagram, the deckhands were within the snap back zone. A parted towsline snaps back faster than the speed of sound. This means that the break had already occurred before the bang was heard on the aft deck; the deckhands could not move to safety in time if they were still within the danger area. While the best protection is located in the superstructure, the Master and chief mate were already on station there leaving no room for the two deckhands. The procedures of the owner's quality management system do not define safety areas for the crew. Although the deckhand's safety area beside the companionway was apparently tried and tested at an earlier time, an analysis shows that the only possible safety area on the deck of an aft tug would be the forward edge of the bridge. Yet this is impractical on this tug as the trigger for the slip device cannot be accessed from that location.

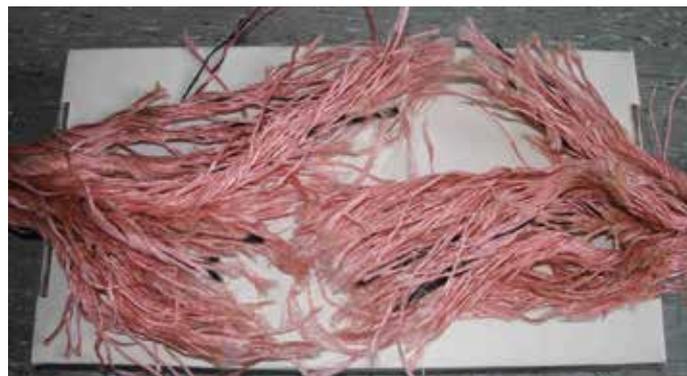
Failed stretcher, subsequently found to be undocumented and of unknown manufacture or SWL

- The material used for the fabrication of the stretcher was of low quality. Polypropylene split film of this type is normally used for mooring lines. The rope was manufactured and delivered without any of the 'tracer' threads that identify the company or the standard.

- The stretcher should never be the weakest component of the towing connection. Since a failure of the stretcher is virtually a worst case scenario, this element is normally oversized by 1.5 times the maximum tensile strength of the other connecting components, which themselves are usually set at two to three times the bollard pull of the tug.

- Best practice dictates that the length of the stretcher should be no less than 5m and no more than 10m for port towing connections. Also, only fairlead shackles should be used for connecting individual components of the towing gear. Both of these best practices were ignored in the present case.

- Prior to being used in this incident, 73 of the total of 456 fibres of the stretcher were already completely or partially frayed. The failure of the stretcher was primarily caused by this pre-existing damage.
