# Seaways

MARS Report No. 262 August 2014

## MARS ON THE ROCKS?

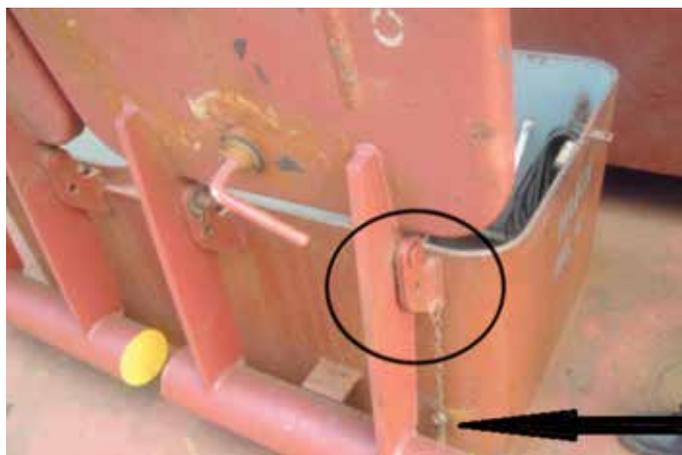
### Booby hatch unsecured

→ Personal access to a hold through hatch covers is possible via special openings often called booby hatches. When a person wants to use them they usually have to hold the booby hatch as support for the first few steps as they enter or exit. An authority for a large port reports that there have been numerous cases where the booby hatch locking pin was not in place. This resulted in the booby hatch inadvertently moving on its hinge while the person was using the hatch; some injuries have resulted. Although no serious injuries are known to have happened, there is certainly a possibility of falling into the hold, which would result in grave consequences.

Ship's crew should ensure that the locking pins are always properly secured whenever the booby hatch is in the open position

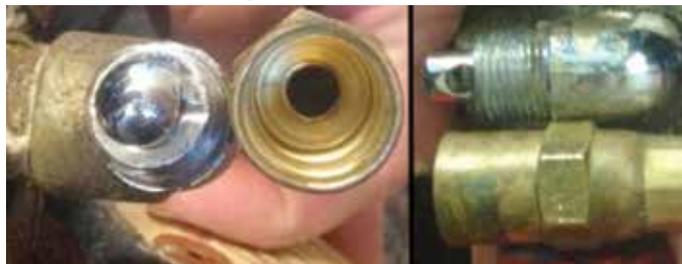
### Thread mismatch impairs fire extinguisher

→ During a fire investigation onboard a vessel it was discovered that a portable carbon dioxide (CO<sub>2</sub>) extinguisher had failed to properly discharge during the fire-fighting event. CO<sub>2</sub> only seeped from the neck of the extinguisher when it was used, rather than sprayed. The fire was subsequently extinguished using a dry-chemical fire extinguisher.

During examination it was found that the hose and discharge horn had been replaced. The end of the hose screws on to a diffuser on the side of the discharge valve/handle assembly of the extinguisher. The diffuser is a ported protrusion on the male end of a 90° fitting. On the side of the protrusion are orifices through which the CO<sub>2</sub> flows. The examination revealed that the spherical end of the protrusion, which contains no orifices, 'bottomed out' against the orifice in the connection fitting that leads to the hose and horn assembly. The flow of CO<sub>2</sub> was thus completely blocked.

It was further noted that the male threads of the diffuser were tapered US national pipe threads, while the female threads of the hose connection were straight. This thread mis-match likely allowed the hose connection to be tightened to a greater extent than intended on the diffuser threads. This permitted the spherical end of the diffuser to 'bottom out' against the orifice in the tube. This may have also resulted in the reported leakage from the neck of the extinguisher due to back pressure.

There are newer types of diffusers in which the orifice follows the length of the protrusion and the end is not spherical. However, the issues regarding the tightening of the two components and the importance of ensuring proper lengths and compatibility of the threaded and machined surfaces remain. Binding or ‘bottoming out’ should not occur except at the threaded surfaces. Replacement parts should be as specified by the equipment manufacturer and servicing should always be done by qualified fire safety equipment technicians.

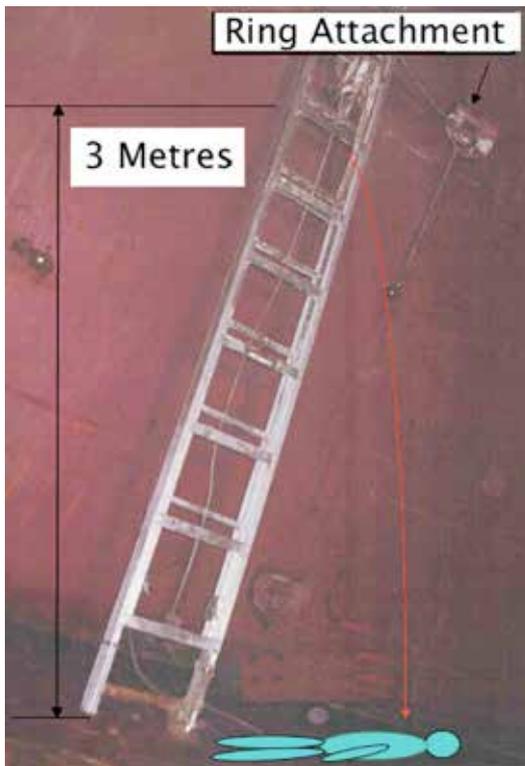
**Three metre fall causes death**

→ While berthed and after discharging cargo, crew were instructed to clean the hold. As one rating climbed a portable ladder another rating steadied it. The rating climbing the ladder wore a safety helmet and a safety harness, but on the way up he was not attached to anything. He was headed up to the ring attachment to secure his harness. Once at the level of the ring, he attempted to fasten the lifeline, which was about one metre to his right. As he extended himself to attach the lifeline he lost his balance and fell to the tank top three metres below.

- The investigation found the following:
- There was no evidence of fatigue in this accident.
  - The distance from the right handhold of the ladder to the centre of the metal ring was about one metre. The average hand reach of males of the victim’s nationality is about 0.6 metre. Therefore, it was a risk for the rating to fasten his lifeline under this condition. The risk could have been reduced if the ladder was placed closer to the metal ring.

- The main contributing factor of the accident was the work attitude and safety consciousness of the victim. He should have stopped the operation and climbed down the ladder. The operation should only have resumed after the ladder had been properly aligned closer to the safety ring.

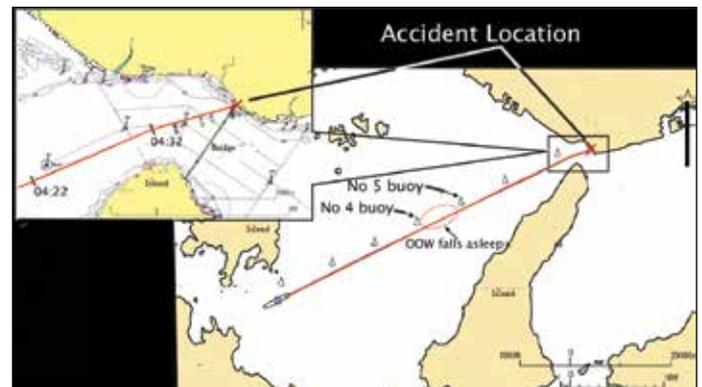
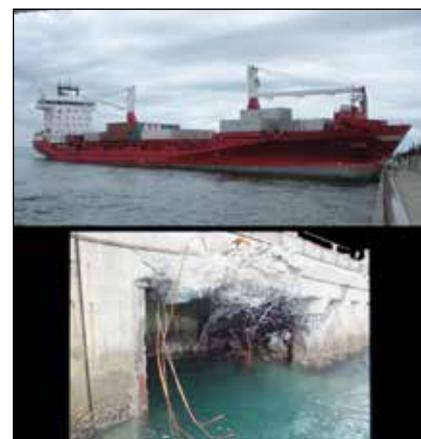
**Fatigue wins again as ship hits seawall at 15 knots**

→ In the early morning hours, but still in darkness, a small container ship was making way at about 15 knots on autopilot with the officer of the watch (OOW) as the sole watch-keeper on the bridge. The visibility was good and there was no traffic, so the Master had given the instruction for the OOW to be alone on the bridge while making way in darkness. A few hours into his watch the OOW began to feel drowsy, so he began walking briskly around the wheelhouse. He then sat in the chair in front of one of the radars, confident he would not fall asleep. Somewhere between buoys four and five as they made landfall he fell asleep.

About 40 to 50 minutes later, at approximately 04:40, he woke up abruptly when he was thrown out of the chair by the impact of a collision. The vessel had hit the sea wall on the northern side of a nearby bridge. The ship was not equipped with a bridge watch navigation alarm system (BWNAS) at the time of the accident, nor was it required to have one.

- Had a proper lookout been assigned to assist the OOW it is unlikely the collision would have transpired.
- Had the OOW reported his drowsiness to the Master, alternative watch arrangements could have been made.

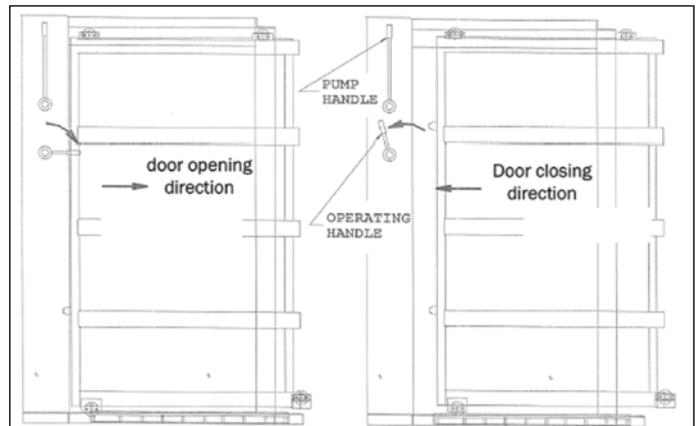
### Watertight door fatality

→ While at berth, the crew of a small passenger ship were conducting a fire and emergency drill, which included closing and testing the hydraulically operated watertight doors. The Master closed the watertight doors remotely from the bridge. Some minutes later, the chief engineer opened the watertight door to the engine room, but for some reason he became trapped by the door as he passed through the doorway. He remained trapped for more than eight minutes before being found and freed. He was resuscitated but never regained consciousness and later died in hospital. The door closing pressure was later measured to be 1,650 kg.

The watertight doors were normally set in the local-control mode, which meant that they could not be remotely closed from the wheelhouse. At the time of the accident the doors were in the remote-close mode for the exercise, which meant they would automatically close when the user released the opening handle. The crew routinely passed through the watertight doors without fully opening them when the doors were in the local-control mode. This practice was probably also followed when the doors were in the remote-close mode. It is possible that the victim tried to pass through the door before it was fully open, and for some reason (such as releasing the handle) it began closing and trapped him.

- It was common practice on board not to fully open watertight doors before passing through. It is possible that the victim did not fully open the door on this occasion, which would have contributed to his becoming trapped.
- The doors were set to close with a speed that was twice the maximum allowable under the SOLAS regulations (which specify never less

than 20 seconds). This would likely have contributed to the victim becoming trapped.

- The door operating handle protruded farther inside the watertight doorway space than was necessary. This meant the victim was not able to free himself when the door closed on him.
- The watertight doors on board the vessel had not been maintained and tested in accordance with the manufacturer's instructions and did not meet the performance standards required by the IMO and the Flag State Administration.
- The audible door closing alarm was not working after the accident. If it was not working at the time of the accident, that could have contributed to the victim becoming trapped in the door.
- The safety management system on board the vessel did not deal in an appropriate way with the maintenance, testing and operation of the watertight doors, which were safety-critical apparatus that presented a known risk to the crew.

- Always fully open a watertight door before passing through the doorway when the door is in the remote-close mode.
- The faster the door closes, the greater the risk.

- Under no circumstances should watertight doors be set to close faster than the maximum allowable speed.
- Ship operators should adopt specific procedures for operating watertight doors in both local-control and remote-close modes. The procedures should be compatible with the doors' purpose and design, and the frequency with which they are used.

- Poorly maintained watertight doors are dangerous. Shipboard planned maintenance systems should be designed and followed to ensure that watertight doors are maintained in accordance with manufacturers' instructions, and in accordance with good standard marine engineering practice.
