Seaways

The International Journal of The Nautical Institute

Mariners' Alerting and Reporting Scheme

MARS Report No. 271 May 2015

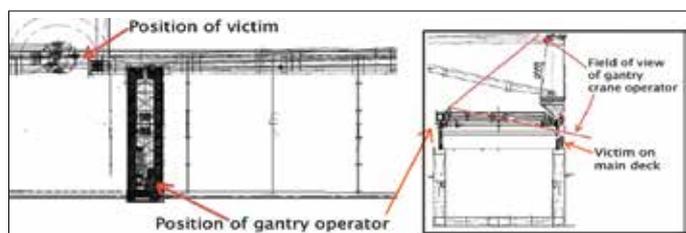
→ While in port, several cargo hold hatch cover pontoons had to be shifted from forward to aft. An officer was operating the hatch cover gantry crane and a deck crew member was standing nearby, but at one point the crew member was not within the field of view of the operating officer.

It appears that the crew member was standing with his back to the oncoming gantry, so he did not see the gantry nor the flashing warning lights to indicate its operation. Additionally, the noise of the port may have drowned out the ringing of the gantry alarm.

The crew member's coverall became stuck on the leg of the gantry and pulled his left hand and arm between the gantry crane leg and the structure of the cargo crane. The crew member's left arm was severed at the elbow and the remaining tissue badly mangled. He was transported to a local hospital where the remaining part of his arm was surgically removed.

- Clear 'danger area' paint markings could be applied at the forward part and aft part of each crane base (black and yellow stripes with letters reading 'danger area' for example).
- On the port side of the gantry crane, a horizontal nylon cord could be installed at a height of about 120 cm from the main deck, connected by means of an electrical switch to the emergency gantry stop.
- A fish eye camera could be installed on the port side of the hatch cover gantry crane, including a display at the operation unit of the crane. The operator would then have a clear view on the port side area of the crane.

■ **Editor's note:** Even with physical 'defences' such as functioning lights and an alarm, a serious accident occurred and a crew member's seagoing career was instantly ended. Physical defences appear to be insufficient for this workplace, although a camera for the gantry operator would probably increase safety. Additionally, procedures would need to ensure 'no go' zones were enforced while the gantry crane is in operation.

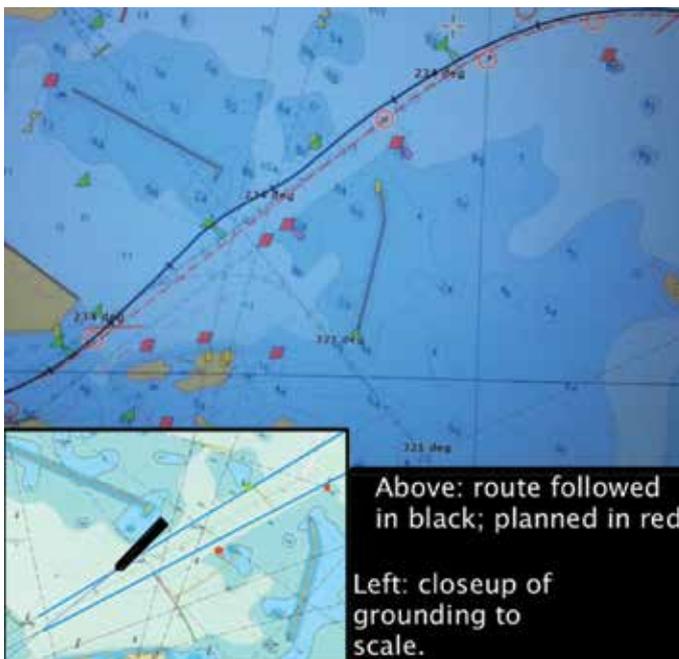
→ In darkness and good visibility a ferry (196m in length) was making a routine entrance into one of its normal ports of call. There was a light northerly current and SSE wind of about 20 knots. As the ship approached the port at a speed of 14 knots, the OOW initiated the turn to port to follow the fairway using the autopilot and a preset turning radius of 0.3 nm. The autopilot was set in 'heading mode', which meant that the drift was to be corrected manually. After the turn, the first green buoy encountered was passed somewhat closer than planned and a little beyond the intended route. At that moment, the Master told the OOW he was manually taking over the steering and engine control on the starboard bridge wing. He then disengaged the autopilot.

drifted from their planned course and the Master affirmed. He applied starboard rudder in an attempt to bring the stern away from the starboard shore before the aft part of the vessel had completely passed the buoy. The Master then looked forward and perceived that the next green buoy was straight ahead, so he put the rudder to port and crossed the engines to place the ship on the correct side of the buoy. He then saw the green buoy disappear under the vessel at approximately mid-length. The vessel made contact with the bottom shortly thereafter.

- The central navigation stations were not equipped with hand steering, and bridge routines had developed whereby control of the ship was taken at the bridge wings during the last (critical) part of navigation into the port.
- There were no log or wind indicators at the bridge wing controls.
- The division of workload between bridge team members when navigating in narrow fairways is critical.

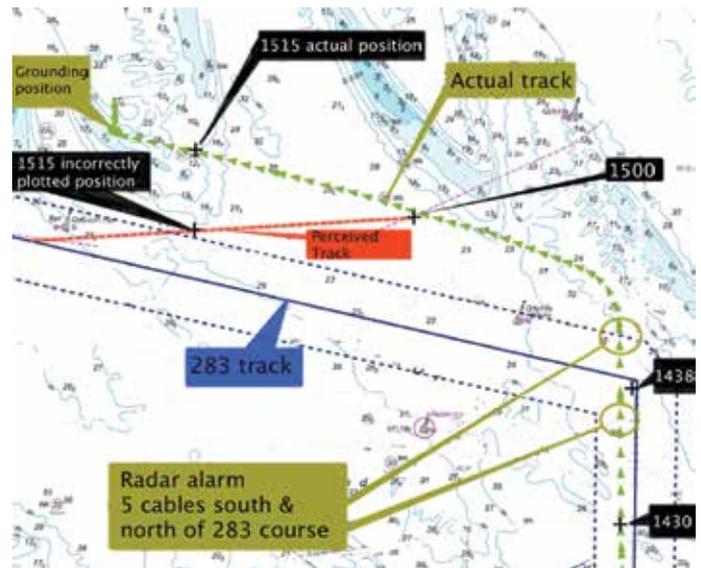
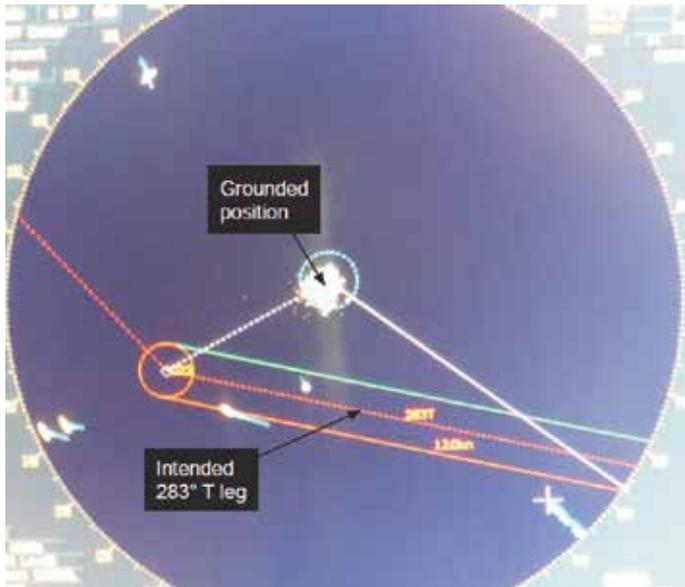
When the OOW eventually altered course to port, the vessel was already well to starboard of the 283° track. His choice of 270° and then 267° were not effective in regaining track. When plotting the fix at 1515, the OOW's unfounded understanding of the situation was that the vessel was regaining the track. As a result, it is highly likely that he plotted the fix showing where he perceived the vessel to be based on this incorrect assessment.

Additionally, the S-band radar and map function would have clearly shown the vessel's actual track diverging away from the intended track as seen in the diagram overleaf.

- The OOW was distracted from his task of navigating the ship by undertaking passage planning and chart corrections when on watch, causing him to miss the planned course change and lose positional awareness.

- After the alteration of course to 270°, the OOW did not effectively monitor the vessel's position; no fix was taken when steady on the new course, no estimated position (EP) was calculated and radar parallel indexing was not used.

- Unaware of the significant northerly set, the OOW assessed that the intended track was being regained and plotted the 1515 fix where he perceived the vessel to be.

- **Editor's note:** Good navigation results are unlikely if the OOW is preoccupied with other duties such as chart corrections. Close coastal navigation requires 100% of your focus and attention.

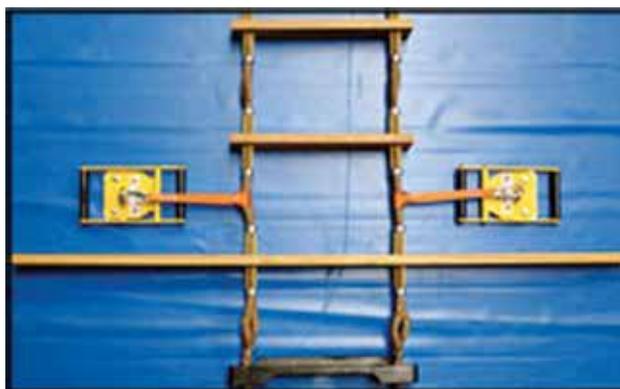
Hull magnets are easy to operate devices and when two of them are positioned correctly they provide substantial holding force. The handle of the magnet is also a lever and enables easy release from the hull of the vessel. Proper use of the magnets is shown in the image below left.

Specialised embarkation equipment should be used as per manufacturer's instructions and should never be modified other than under manufacturer's specifications.

Regular inspections of existing vessel boarding equipment should be carried out and any improper modifications returned to the manufacturer's original design.

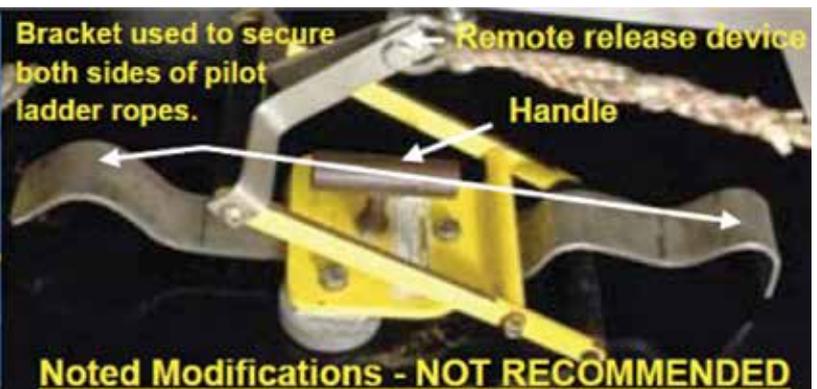
→ While boarding a vessel a pilot suffered a concussion; a modified embarkation ladder hull magnet device disconnected from the ship's hull and struck him on the head. Unfortunately, this was not an isolated incident. Incidents with injuries have occurred on other vessels at several different ports. In each of those instances the hull magnets had been modified prior to the accident. Moreover, in all cases, after restoring the hull magnets to their original design no further problems were experienced.

In the incidents where the magnets unexpectedly detached from the hull, only one securing magnet was used, placed between the rails of the ladder and alterations (remote release device) that deviated from the manufacturer's design had been made (image below right).

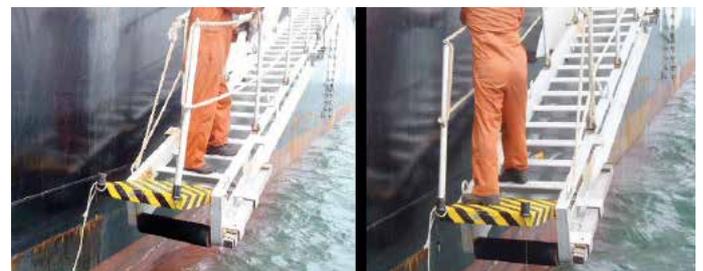
→ Several readers quite rightly objected to our labelling of the photos in MARS 201510. The photo on the left was labelled 'wrong' and that on the right 'correct'. Of course, we were referring to the method of rigging the stanchions, keeping the outboard side clear for easy access to and from a launch. However, in both photos the crew member is without a lifejacket and/or safety line, so in that sense both photos are wrong.
