MARS Report No. 267 January 2015

MARS REPORTS

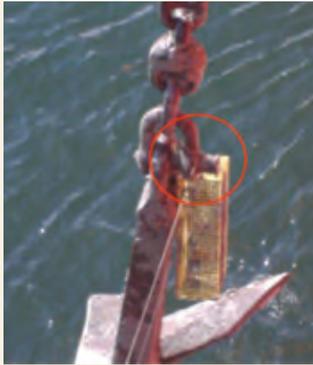
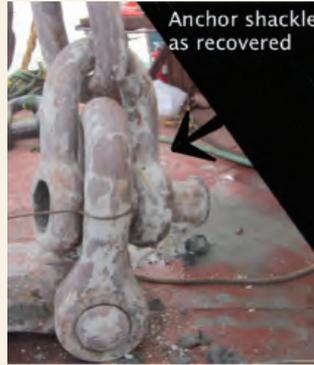
→ While preparing to depart anchorage and heaving the port anchor it was discovered that the end shackle pin was protruding from its normal position. The anchor wash was shut off to get a better view of the end shackle arrangement, and it was confirmed that the anchor was supported only by a small portion of the end shackle pin. The Master and Pilot decided to return to the anchorage area and lower the starboard anchor while awaiting further investigation.

The company investigation found that it was most likely that the lead seal of the tapered pin had worked itself loose and went missing. The pin securing the shackle bolt was then able to work itself loose. Although the company's managed vessels had a procedure in their planned maintenance system for checking the integrity of the anchor joining shackle tapered screw and seal, it did not include any direction as to what the check should include or why it was required. Nonetheless, this job had been carried out annually without any discrepancies noted.

Anchor shackle as recovered

the practice was deemed insufficient to meet the requirement. In order to accurately check the security of the lead seal an up close physical inspection would need to be arranged. Company procedures were changed accordingly.

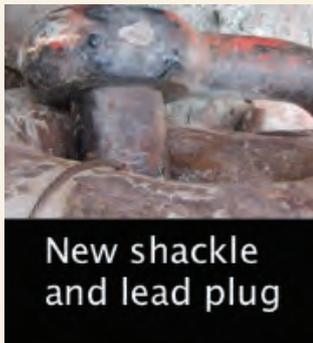
A spare end shackle and tapered pin was located onboard with certificate. The next day, a tug and barge came alongside and the vessel's crew met with the foreman of the barge to determine a plan to replace the end shackle. A risk assessment and toolbox meeting was conducted and the job undertaken. A statement including pictures regarding the end shackle replacement was sent to Class.

New shackle and lead plug

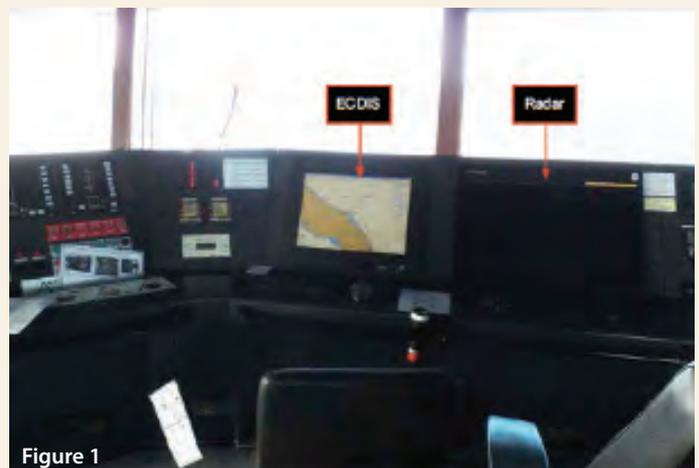
Figure 1

The safety contour had been left at the factory default value of 30m even though the vessel's draught was only 7.9m. The OOW then sat in the port bridge chair where he had a direct view of both radar and ECDIS displays (Figure 1).

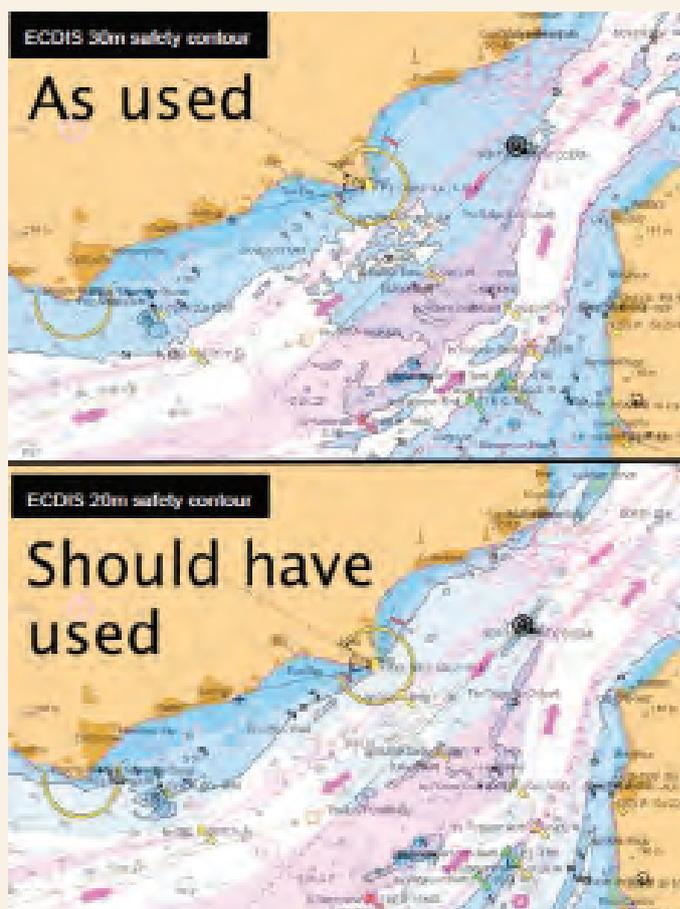
9. The ECDIS display for the voyage had the safety contour set at 30m, which was the manufacturer's default setting. The preferred safety contour for the vessel should have been obtained using the formula in the vessel's SMS ($\{\text{Draught} + \text{squat}\} \times 1.5$, or about 13m in this instance). The ECDIS would then have defaulted to the nearest deeper contour on the chart in use, the 20m contour. This in turn would have given a much better indication of the dangers and hazards along the route (Figure 3).

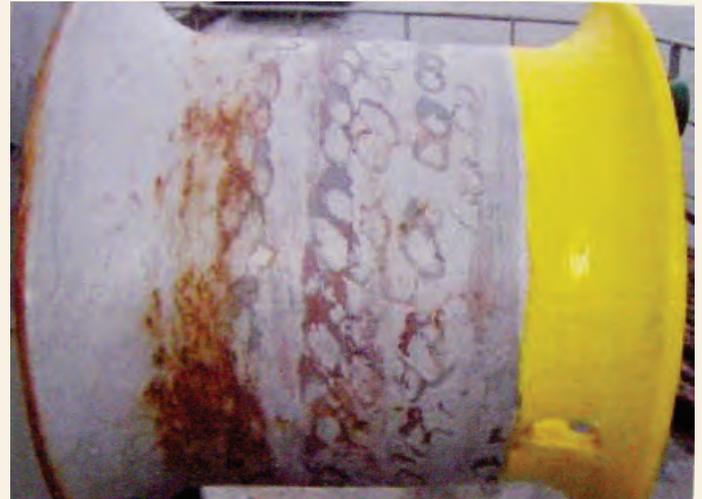
➔ Many recently audited ships have been found to have painted capstan or windlass drum ends (rounded contact surface) and some crews and Masters are adamant that there is nothing wrong with this practice. The problem, however, is that the paint itself is the hazard. As the rope is surged on the drum, it creates friction which melts the paint. As soon as the surging is stopped, the paint solidifies and glues the rope to the drum. The rope will then not surge and cannot be slacked until the bond is broken, usually with a corresponding jump in the rope. This jump is easily capable of breaking a wrist or worse.
