# Seaways

The International Journal of The Nautical Institute

# Mariners' Alerting and Reporting Scheme

MARS Report No. 249 July 2013

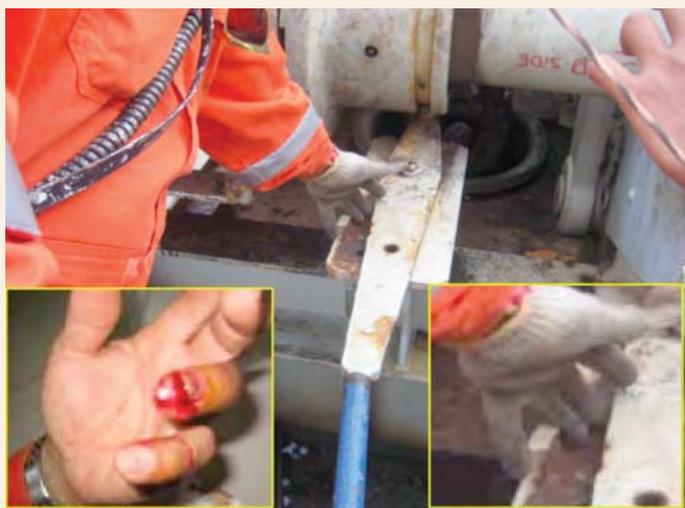
→ While the vessel was in dock, the bosun and an assistant carried out adjustment work on the windlass. After completing the job they intended to disengage the clutch by shifting the clutch lever. The bosun removed the stopper pin for the lever and instructed his assistant to shift the lever, which the assistant did (after first confirming all was clear and getting a confirmation back). However, the bosun's finger was still positioned between the edge of the clutch lever and the stopper plate. As the assistant swung the clutch lever the bosun's finger was crushed as the lever approached its end position. The victim sustained several superficial lacerations, a distal edge nail laceration and a fractured finger joint. He was treated with sutures and application of a prosthetic nail after surgical nail-bed repair.

The accident occurred at the end of a hard day's work so fatigue may have played a part. Neither the bosun nor his assistant were aware the bosun's fingers were in harm's way.

■ **Editor's Note:** This seemingly simple task still resulted in an unfortunate and rather serious accident – surgical nail bed repair is nothing to joke about. The two crew seemed to be communicating well enough but they both had less than adequate situational awareness. This company should be praised for identifying fatigue as a possible contributing factor – fatigue should always be considered until it can be shown not to have been a factor. It may be of interest however that from a formal investigative standpoint, fatigue is usually identified by documenting work and rest over a period of 72 hours or more, not just one day.

More importantly, had the bosun or his assistant accomplished this task alone, no injury could have occurred. If the same person first removes the pin and then throws the clutch lever their fingers cannot be in harm's way. Of course, hindsight is 20/20 but this nonetheless highlights the advantages of carefully evaluating each task to be accomplished before acting.

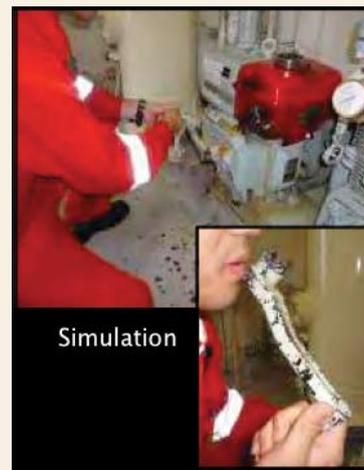
→ An engineer was carrying out routine inspection and maintenance on the emergency air compressor including a start test. When starting the compressor by manually cranking, the engineer failed to remove the handle before the engine reached its self-ignition RPM speed. As a result, the handle was thrown off the crank engagement nub when the compressor began turning over on its own, hitting him in the face. The engineer suffered two chipped teeth and lacerations of his lip.

The vessel's investigation determined that the engineer was not fatigued at the time of the task. Additionally, he had carried out the same starting operation a number of times in the past.

The compressor starting procedure was apparently followed during start-up, covering items such as leaving the compressor drain valve opened and operating the engine de-compression lever at the time of testing.

■ **Editor's Note:** If all procedures were truly followed during this task yet this accident still occurred, the residual risk would appear to be somewhat high. In that case, it may require a re-evaluation of the fundamental design or of the PPE necessary to accomplish this task, such as requiring a full face mask much like wood cutters in the forest industry.

- Suitable caution notice should be displayed near the unit to remind the operator of the danger.
- The operator should receive specific training and be made aware of this danger when joining the vessel and before he/she carries out this test for the first time.
- The operator should be positioned suitably and firmly and pay full attention at the time of crank-starting the compressor.

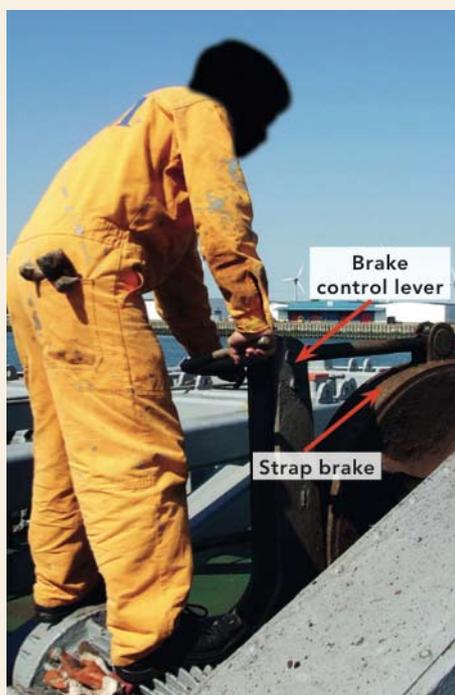
suddenly failed. Since the electrical systems on board the vessel were linked to the main engine via the shaft generator, the electricity failed as well and for a short period of time the vessel suffered a blackout. During the blackout, the rudder unexpectedly turned to port, causing the vessel to deviate sharply from its course and toward the tug and tow. In order to prevent a collision, the captain, on VHF radio, ordered the anchor let go. As there were crew on deck at the time, the anchor was let go very quickly after the order – within 15 seconds. At the time the anchor was let go the cargo vessel still had a speed over ground (SOG) of 7.5 knots.

Despite the attempts by the AB to secure the winch brake, the anchor chain continued to run out. The last length of chain had broken loose from the chain locker, and the AB was hit and fatally injured by the bitter end.

Simulation of A/B attempting to secure the brake as the chain ran out

The use of the anchor to slow down the ship in an emergency: IACS stipulates that an anchor must be constructed in such a way that it is suitable to anchor a ship temporarily in 'moderate' ambient conditions. The anchor gear is not designed to stop a ship. Anchoring at high speed is an extremely risky operation that may result in fatal injuries to crew members and serious damage to the ship. Such a manoeuvre should only be considered in an extreme emergency. The captain, in consultation with the bridge team, should assess whether the potential benefits of such a manoeuvre outweighs the substantial risks for the crew and ship.

The need for uninterrupted power supply when sailing in confined waters: Sailing in narrow waters entails increased risks of collision or grounding. Therefore, prior to commencing a passage in confined waters, a risk analysis should be carried out (or consulted) as part of the SMS in order to verify that back-up systems are instantly available. Uninterrupted power supply in confined waters is essential in order to guarantee a ship's manoeuvrability and should be considered a best practice.

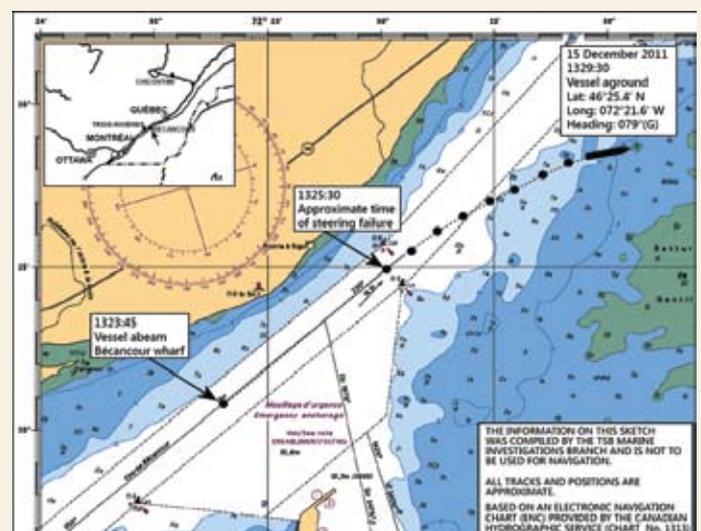
At one point a port alteration was requested; however, the rudder angle indicator showed 10° to starboard. Several port and starboard helm inputs were attempted with the FFU but no rudder movement could be observed on the rudder angle indicator. The pilot then ordered the engine to be stopped and that the anchor be readied.

The Master arrived on the bridge just as the vessel was leaving the buoyed channel. He went directly to the steering stand and transferred the steering system actuator switch from the port system to starboard system. This action restored control to the steering but it was too late. The vessel ran aground at an estimated speed of 8 knots over the ground.

follow-up (NFU). The helm order data signal to the steering gear telemotors is provided by two potentiometers that are mechanically linked to the helm wheel and electrically linked to each telemotor: one potentiometer per telemotor. It was later discovered that the port system helm follow-up potentiometer had failed, rendering the FFU useless until the starboard system was belatedly selected by the Master.

- 1 Without the regular replacement of potentiometers, there is an increased risk that they will fail in service.
- 2 Crew may be unfamiliar with the steering control methods of the non-follow-up mode or switching steering systems in cases of steering failure if this information is not incorporated into technical manuals, familiarisation, and drills, or adequately described and posted near the steering stand.

Many reports and surveys have shown that crew are not instinctively switching to NFU when a steering failure in FFU mode occurs – yet this should be their first reaction. Switching steering systems (port to starboard or vice versa) is also a procedure that takes only a few seconds and could save the situation.

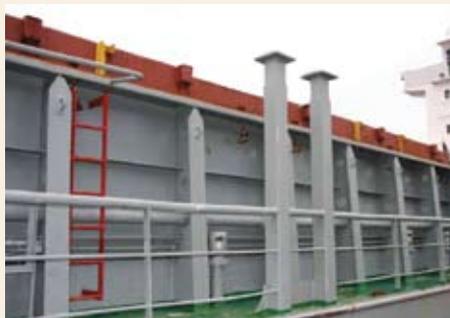
➔ During operations, an O/S climbed onto the 2.2 metre hatch coaming and used the guard rail for foot support. Presumably, as there were no direct witnesses, he lost his footing and/or handhold, fell backward

onto the deck and struck the guard rail with his head causing fatal injuries. He was wearing size 10 mixed fabric (cotton/rubber) gloves and a protective helmet. An examination of the work rest schedule of the victim did not reveal fatigue as a factor.

No ladder was located in the immediate vicinity of the accident; there were only three permanently installed ladders along the whole of the hatch coaming. It would have been possible to safely stand on the hatch coaming with such a ladder as an additional handhold and backfall preventer is offered by the rail above each ladder.

The official BSU report found that the accident was the result of structural defects and inappropriate protective equipment, amongst others. Had more ladders been installed on the hatch coaming then it is very likely that the accident would not have happened because controlled operation with additional protection (in this case, a backrest on the coaming) would then have been possible.

Scene of the accident (simulation)

A protective glove suitable for all activities on board does not exist because the spectrum of applications is too wide. In this case, it was noted that only one glove type had been made available, and only in size 10, for all the shipboard activities. Gloves should be fit for service and be supplied in the right size so as to provide a snug fit.
