MARS 200933

Preventing mooring accidents

Adapted from UK P&I Club's *Loss Prevention Bulletin* January 2009

MARS 200934

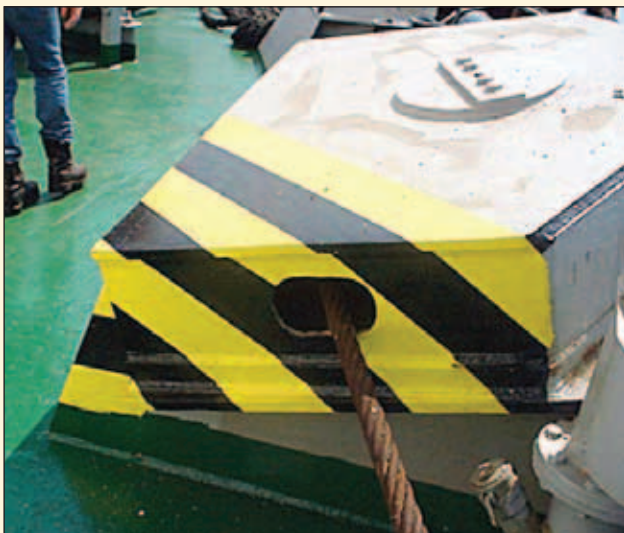
▲ Figure 1: Obstruction / trip hazard highlighted with 'tiger' stripes

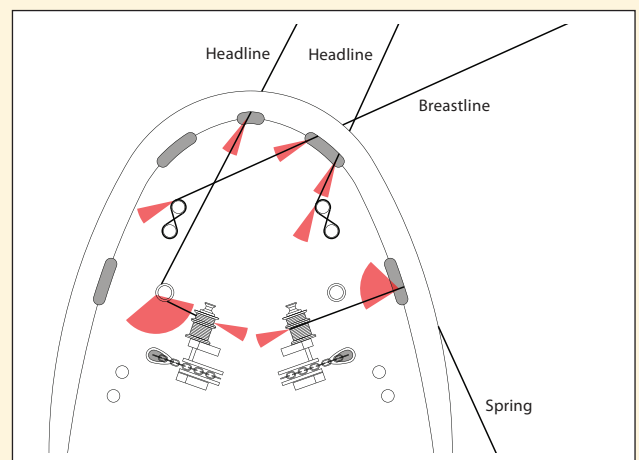
▲ Figure 3: Typical snap-back danger zones at forward mooring station

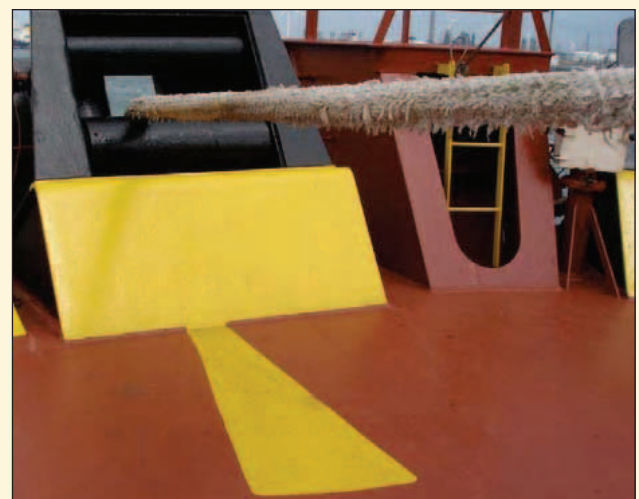
▲ Figure 4: Snap-back zone marked in way of a single multi-angle roller fairlead

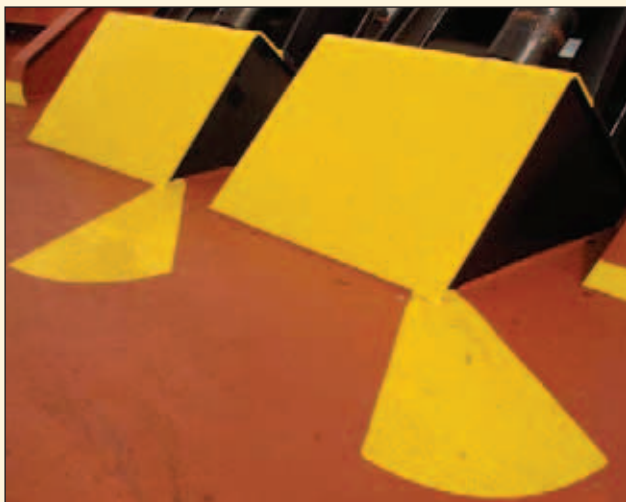
▲ Figure 5: Snap-back zones marked in way of a double multi-angle roller fairlead

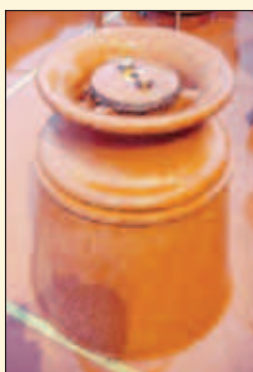
▲ Figure 6: Pedestal fairlead

Figure 6 shows a pedestal fairlead that is well maintained. There is evidence that it has recently been turned and greased and the grease nipple on top is highlighted.

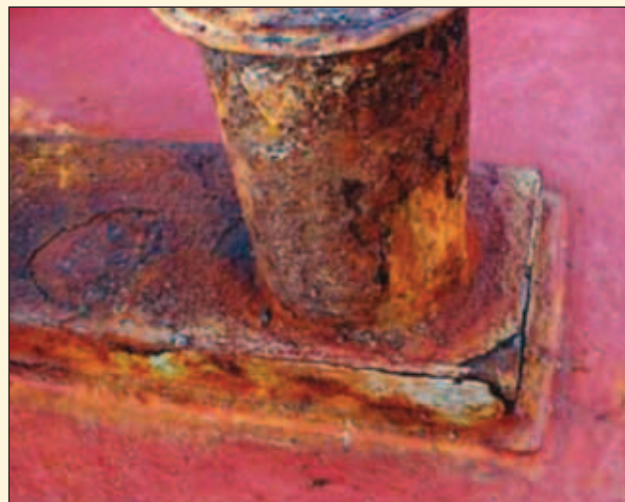
▲ Figure 7: Mooring bits

Figure 7 shows mooring bits that are badly wasted. The deck is in equally bad condition and there is a danger of the bits being torn from the deck.

Not only should moving parts be greased, and surfaces suitably coated, but metal that is wasted should be replaced and not simply painted over. Mooring equipment that has suffered severe wastage will not perform to the certified standard. This also applies to the steel to which the equipment is welded.

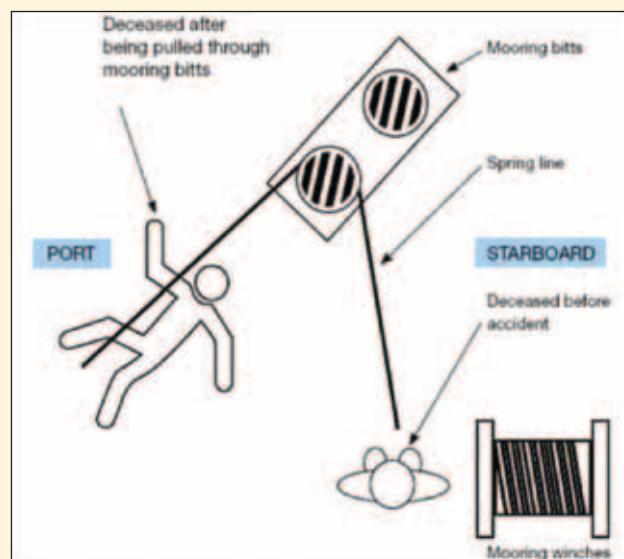
▲ Figure 8: Accident reconstruction

In the above incident, the mooring party forward informed the bridge that all lines were clear when they were, in fact, still in the water. Nobody noticed that as the vessel was manoeuvring away from the berth, one of the lines became snagged on one of the wharf buttresses. The unfortunate seaman was recovering the line but stepped in a bight of the mooring line as it suddenly became taut and was then dragged through the bits as the fouled line surged out of control.

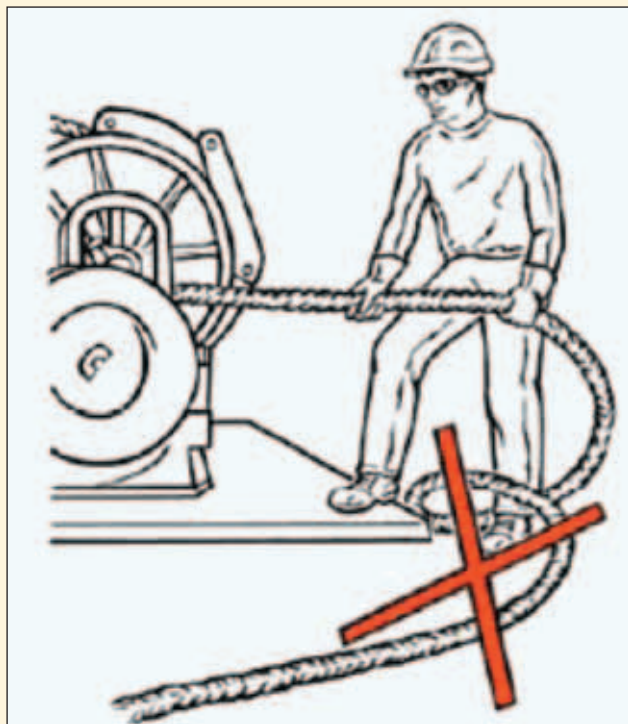
It is important to remember that bights don't always look like bights. Figure 9, p 19, shows a seaman who has inadvertently stepped over the line and put himself at risk.

▲ Figure 9: At risk...

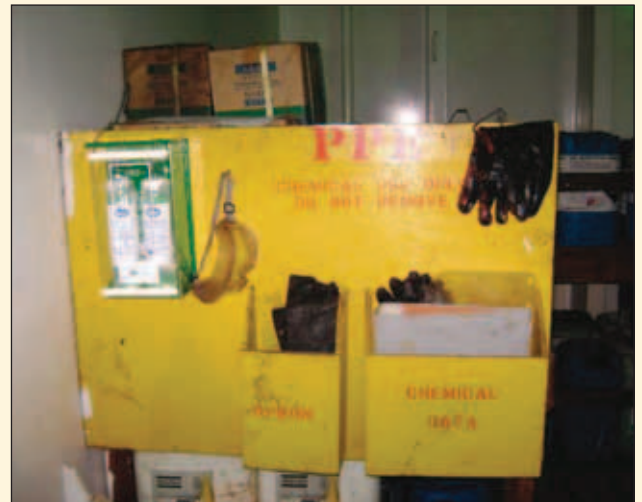
▲ Figure 10: Well laid-out stand in chemical storage space

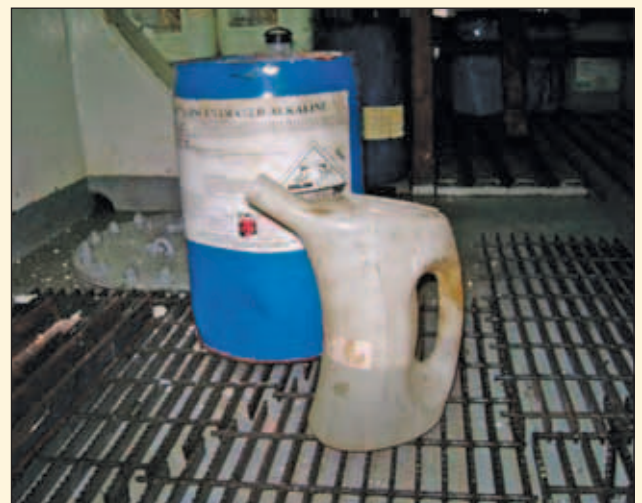
1. Lack of proper work planning;
2. After estimating the quantity drawn and deciding to pour out more chemical, the engineer failed to put the goggles back on;
3. The engineer replaced the chemical container on the storage rack with a jerk without replacing the lid;
4. The fact that the third engineer was performing without adequate supervision, in the belief that it was not a hazardous operation, demonstrated insufficient risk assessment and training.

▲ Figure 11: Chemical container and measuring jug immediately after the incident

1. Always use a clean protective face shield when handling chemicals.
2. Always replace the container lids on completion of transfer.
3. Comply with SMS procedures.
