Bulletin 705 - 07/10 - Defective Lifebuoys - Worldwide

The Association has been informed that the Swedish Transport Agency has found serious defects in the Altura series of lifebuoys produced by Veleria S Giorgio.

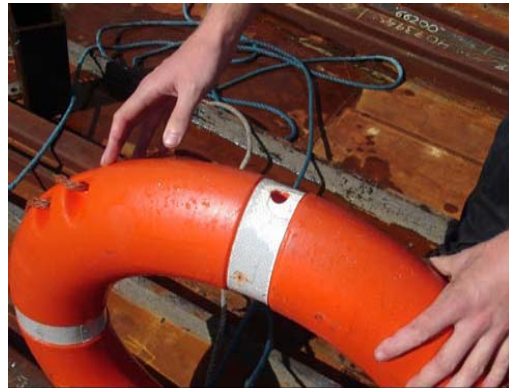
The lifebuoys in question have a small 15mm hole under the reflective tape which can fill with water. Veleria S Giorgio have provided instructions for testing this range of lifebuoy which are reproduced below.

1. Weigh the lifebuoy.
2. Remove one of the four reflective tapes covering the hole.
3. Check if the lifebuoy is full of foam material.
4. If the lifebuoy is not full of foam material, put it in water for a few minutes to let water inside the lifebuoy.
5. Weigh the lifebuoy for a second time and compare this result with the first one. The difference should not exceed 400gr.

In the case of a higher difference, the lifebuoy should be removed from service and replaced.

Members are advised to check lifebuoys and carry out the above test where necessary, Defective lifebuoys may be returned to the supplier.
