Risk Focus: Burns

Burns are bad news wherever they occur, but when they happen at sea, remote from shore medical facilities, the consequences can be grave

Minimising the risk of seafarers suffering burns at sea

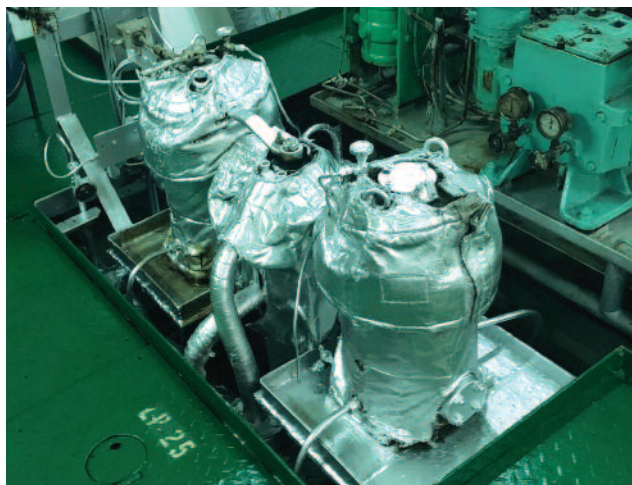
While the vessel was at anchor, the chief engineer instructed the duty crew to clean the duplex filters for the fuel oil booster pumps. The diesel generator was changed over from Heavy Fuel Oil (HFO) to Diesel Oil (DO), the HFO heater was shut off and the feed and booster pumps stopped. The third engineer was said to have closed the valves before and after the filters and then slackened off the air vent plug to relieve the pressure in the filter unit. As the third engineer commenced removing the filter cover, hot fuel oil was ejected from the casing, causing extensive first and second degree burns to his arms, legs and feet. The engineer was quickly transferred ashore and hospitalised.

The actions reported to have been taken to isolate the FO filters and relieve pressure were consistent with standard practice and yet there remained enough fuel and pressure in the system to cause the discharge of hot oil from the opened filter casing. This shows that it should never be blindly assumed that the system is 100% safe when being opened up – what if a drain or vent is blocked or a valve is not closing properly?

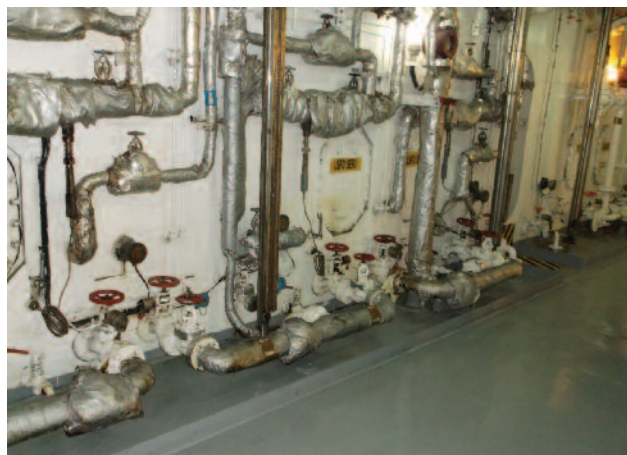
As the third engineer was conducting routine rounds of the engine room, he noticed that the waste oil settling tank level was low. He decided to fill up the tank and at the same time, opened up the top cover of the level gauge as he suspected the float was stuck. As he removed the float, pressurised, high temperature sludge was discharged from the gauge column resulting in second degree burns to his face and hands.

This is only one of numerous crew burn injuries the Club has handled attributable to inadequately planned opening up of engine room oil storage tank level gauges. The third engineer should not have opened up the gauge without consulting with a more senior officer and exercising proper job planning. The injuries may not have been so severe if the engineer was wearing a full face visor when doing the job.

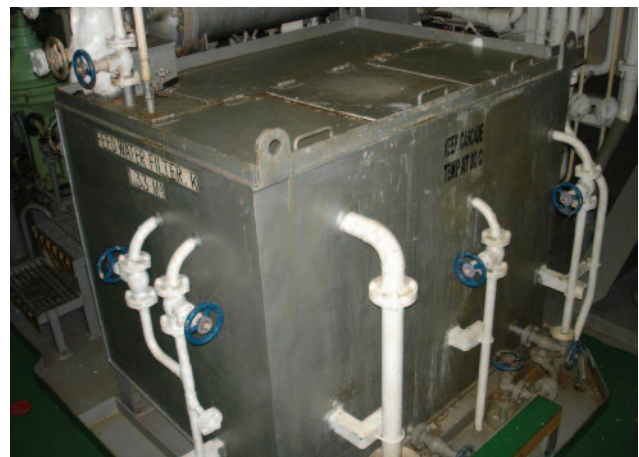
One of the ship's engineers was routinely tasked with adding water treatment chemical to the boiler hot well tank. The chemical was contained in a 25 litre plastic drum and on this occasion, was almost full. After opening one of the hinged lids on top of the hot well, the engineer unscrewed the container cap and stepped up on to a pipe bracket in order to pour the chemical into the tank. As he was doing this, he lost his balance and fell onto the deck, causing the chemical to splash onto his face and neck. He immediately flushed his skin and eyes using a nearby fresh water hose and was assisted by other engine room crew to the workshop where medicated eyewash was also applied. The engineer was quickly transferred ashore to a hospital for professional medical attention.

Water treatment chemicals are highly alkaline (pH of 13-14 undiluted) and can cause severe burns and eye damage. In this case, the seafarer was fortunate in that appropriate first aid could be very quickly given and that the vessel was in port enabling prompt transfer ashore. A number of factors relating to deficient working practices contributed to this incident, including inadequate arrangements for handling and transfer of the chemical, the routine nature of the task engendering complacency, a lack of appreciation as to the very hazardous nature of the chemical and the absence of a proper working platform to perform the job safely.

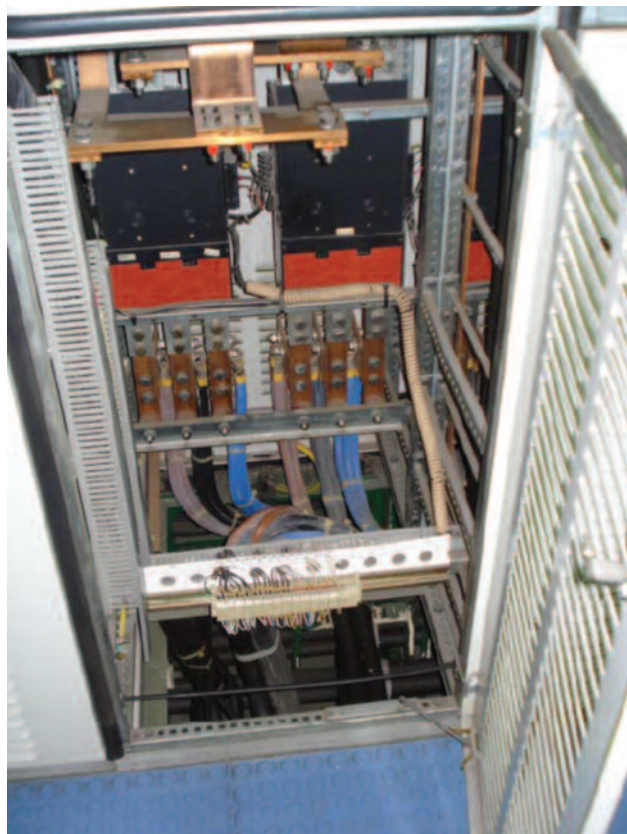
The chief engineer instructed the electrician to troubleshoot a fault on the 440 Volts main switchboard relating to the operation of no.2 generator. The electrician opened the relevant rear switchboard panel before starting work on

identifying the defect. While carrying out his checks, it appears that the electrician touched a live component, which delivered an electric shock, rendering him unconscious. When later discovered lying next to the switchboard by the chief engineer, he was transferred to the ship's hospital where he recovered consciousness after first aid was given. Both hands sustained severe third degree burns down to the bone. The next day, the electrician was transferred ashore for professional medical attention and later endured a long and painful period of treatment and rehabilitation as well as permanent disability.

Investigation of the accident revealed a serious neglect to comply with the Company Safety Management System. The generic Risk Assessment forms relating to electrical maintenance and fault finding at the main switchboard were not consulted, no Permit to Work was prepared and no tool box talk was carried out. Despite both the chief engineer and the electrician being experienced, trained seafarers, there was a demonstrable lack of hazard awareness and observance of basic safety precautions. Certainly the electrician should not have been working unattended and the fact that the vessel was rolling at the time would not have provided a stable working platform.
