UK P&I CLUB

LP Bulletin

Bulletin 1017 - 01/15 - Bauxite Loadings - S America/Asia

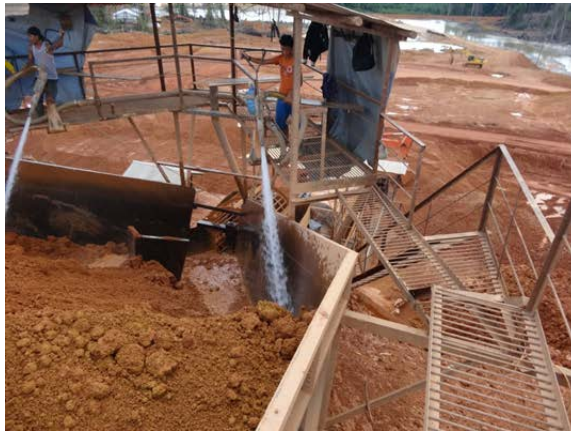
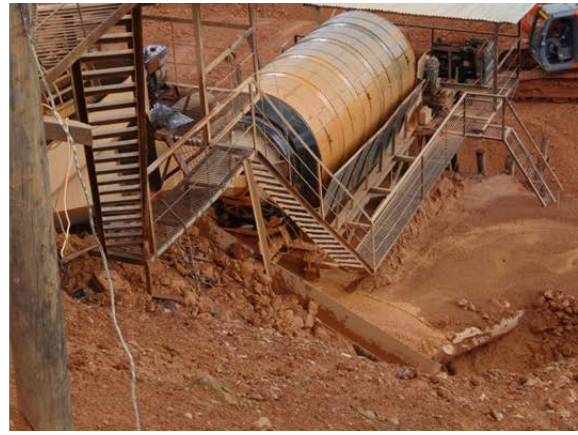
Photographs Showing Sieving in Operation at a Bauxite Mine in Kalimantan, Indonesia.

One of the problems with sieving is that high pressure water cannons are used to force the ore from the loading hopper into the rotary sieve (see photos above). This increases substantially the moisture content of the fines fraction to the extent that even slurries can form as shown above with the risk that the ore will not subsequently lose that moisture by natural drainage or drying (see below). Some Indonesian mines stockpile the fines separately and may ship these out as discrete parcels or mix them in with the slightly coarser ore. This is sometimes done because the fines usually have higher alumina content and are used to ensure that the alumina content of the ore, as specified in the sales contract, is maintained.

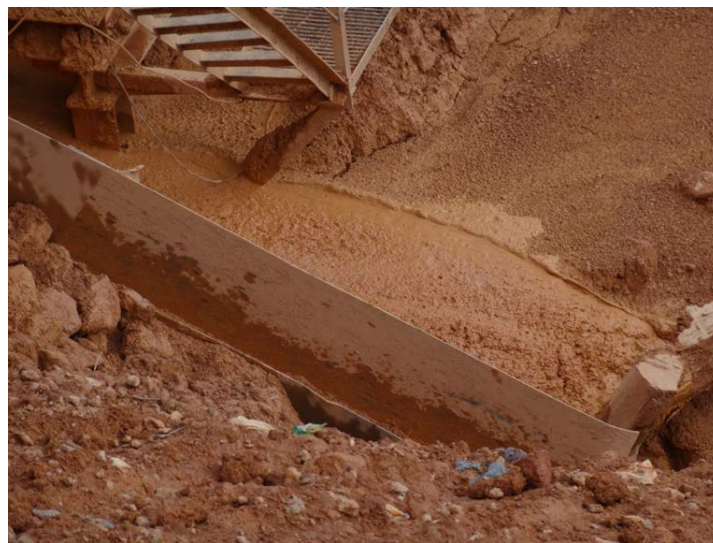
Close-up Photograph Showing Slurry of Bauxite Fines Underneath the Rotary Sieve.

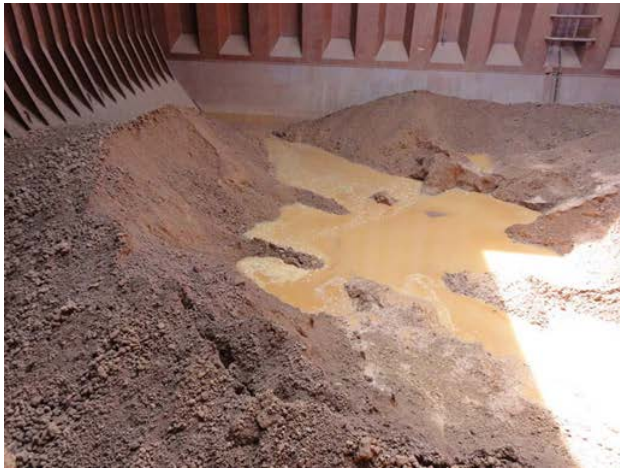
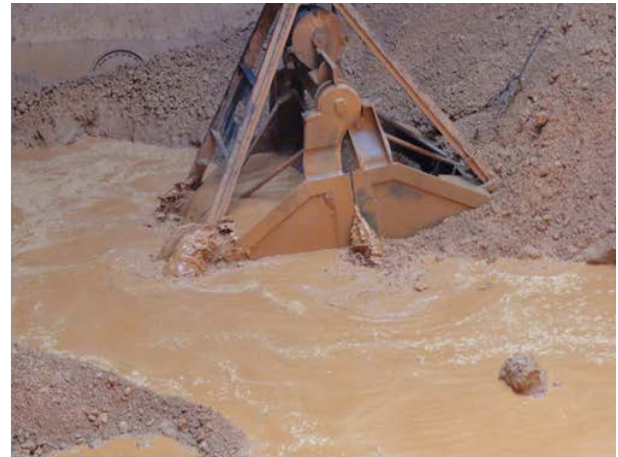
It should also be noted that the fines have higher moisture content, typically around 15% or more. This is to be expected as the water is trapped/retained between the particles of fines, as indeed is the case for all Group A cargoes. If the ore is saturated (i.e. contains water at levels in excess of that which can be held within the structure of the material), then some natural drainage is likely to occur. If such a cargo has been loaded, then drainage and accumulation of water may result in pooling of water around the periphery of the stow or in the lower reaches of the cargo stows, where, due to the presence of fines, the water may not be able to drain freely into the bilges.

Below the saturation point, water may not necessarily drain freely from the material and it is important to remember that most Group A cargoes are not saturated at the Flow Moisture Point (FMP). Thus if the ore is saturated with water draining from it and forming pools around the peripheries of the stows then the moisture content of the material is most probably above the FMP.

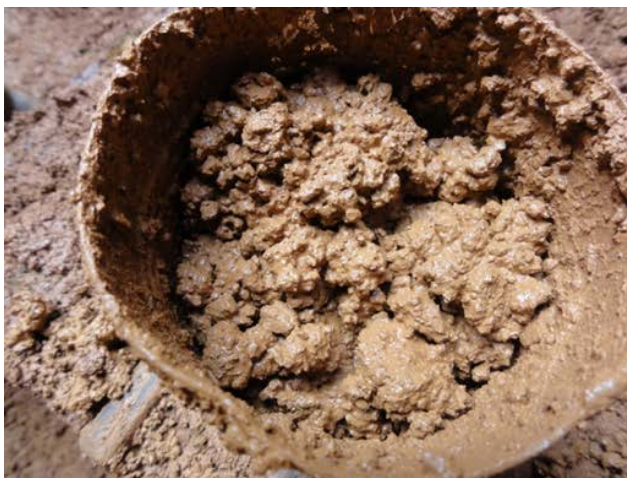
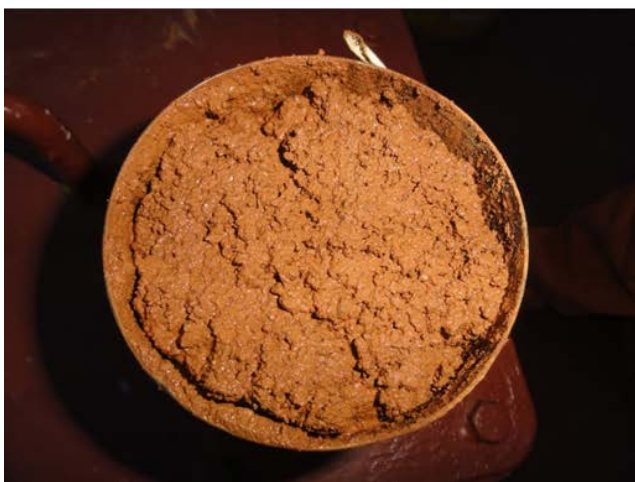
Before testing.

Onboard the vessel, the Master, Officers and Crew should, as with any potential or declared Group A cargo, conduct frequent and regular can-testing in accordance with the method set-out in Section 8 of the IMSBC Code. Development of a flat surface with signs of free moisture i.e. glistening or shiny surface, are indicative of a flow state and thus a ‘fail’ (see photos below).

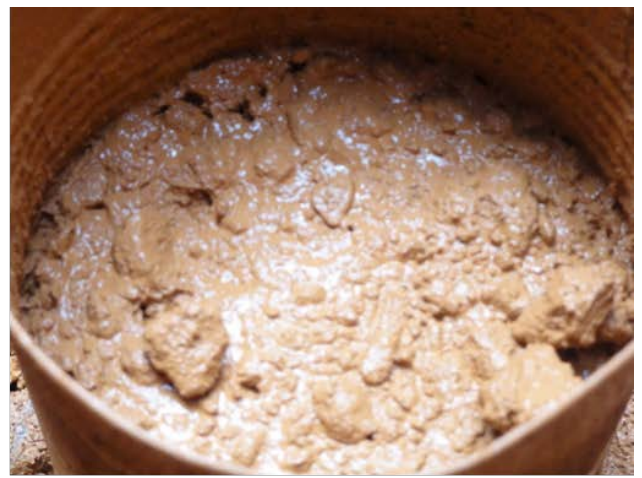
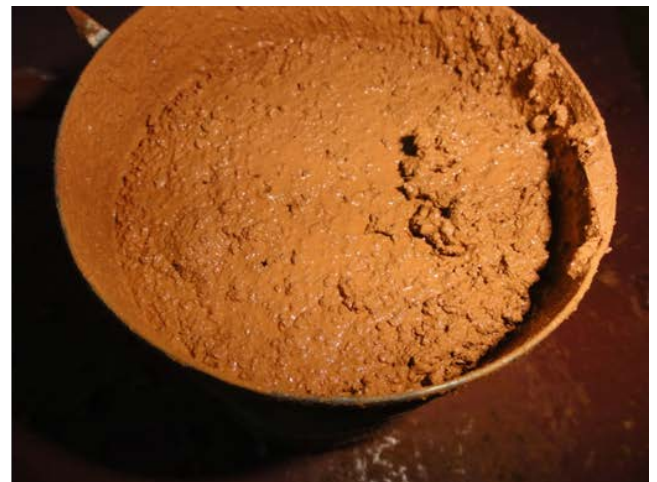
After can-testing.

In the event of failed can tests, or the presence of splatter marks and/or pools of free water our advice would be to suspend loading until the cargo has been properly tested for flow characteristics in a laboratory.

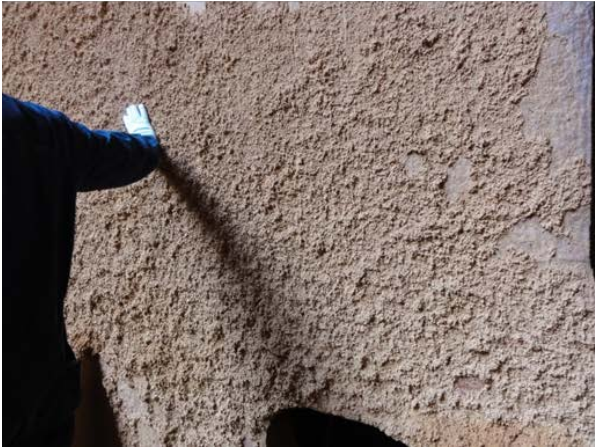
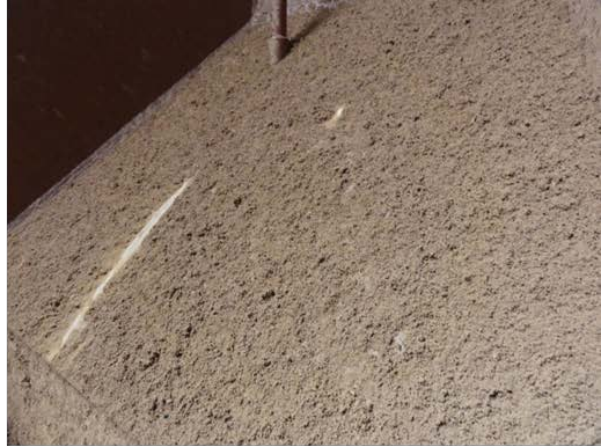
The Crew should also keep a close watch for the presence of cargo splatter marks on the bulkheads, shell plating and hatch coamings as these can only arise as a result of transient liquefaction of the cargo as it is being dropped onto the developing cargo stow in the holds. The presence of such marks indicates that portions of the cargo loaded have moisture content in excess of FMP. In addition, the crew should check for accumulation or pooling of water around the periphery of the stow as this may indicate that the cargo is saturated.

Bauxite splatter marks.

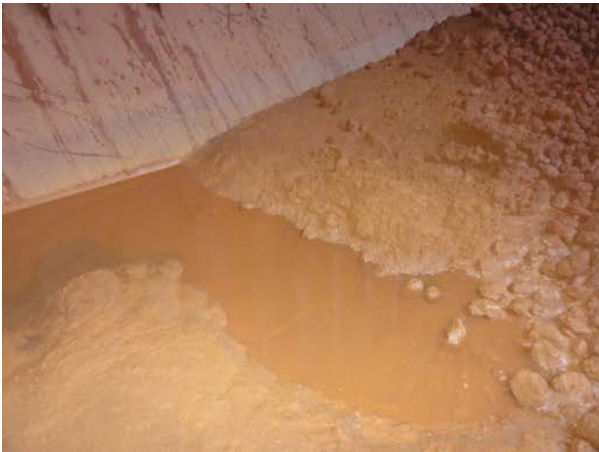
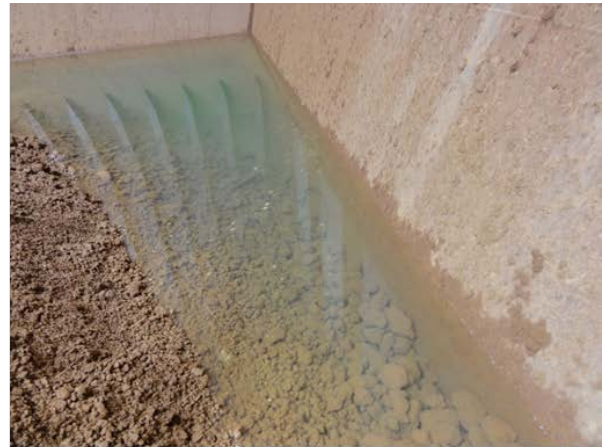
Water accumulation around the peripheries of bauxite stows.
