Understanding mooring incidents

Major accidents involving mooring equipment in the last 20 years have injured many seafarers and have cost the UK Club over US\$34 million

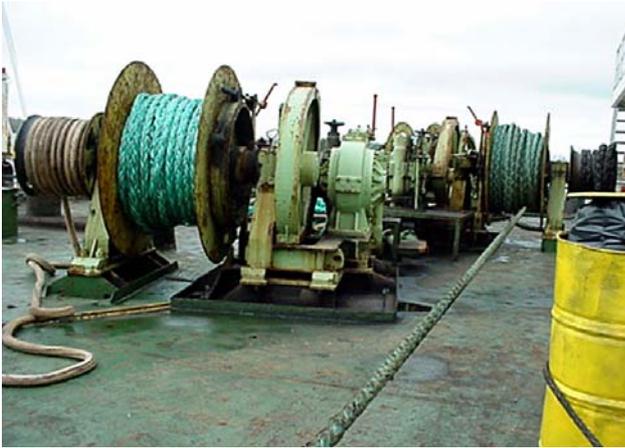
Poor and potentially unsafe mooring area example

Unfortunately this photo illustrates a sight sometimes experienced by the UK Club ship inspectors. Not only are the windlasses rusty and poorly maintained, but the mooring area as a whole suggests poor safety and maintenance standards on board:

- The mooring area is dirty and all surfaces are in need of maintenance.
- All surfaces are painted the same colour, hiding trip hazards such as save-alls, windlass platforms, forecandle access hatch and bits.
- There are no hazard highlightings or warning markings.

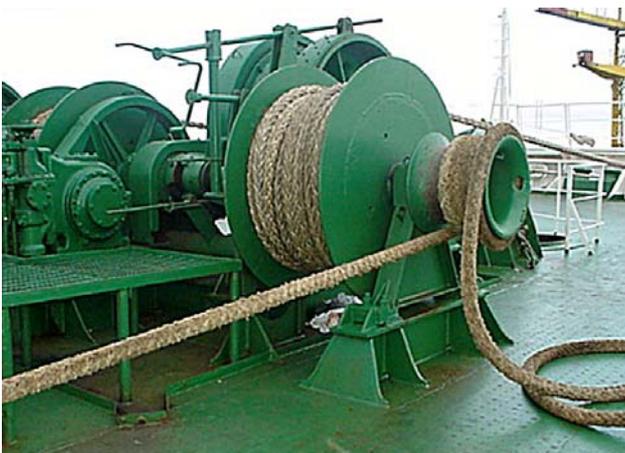
Well painted but poorly highlighted mooring station

The following images illustrate how effective hazard highlighting can be, when compared with a mooring station that is simply well painted.

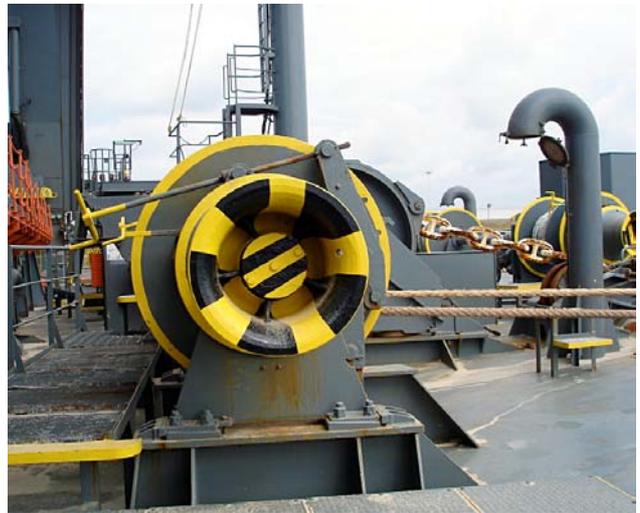
Mooring station with effective hazard markings

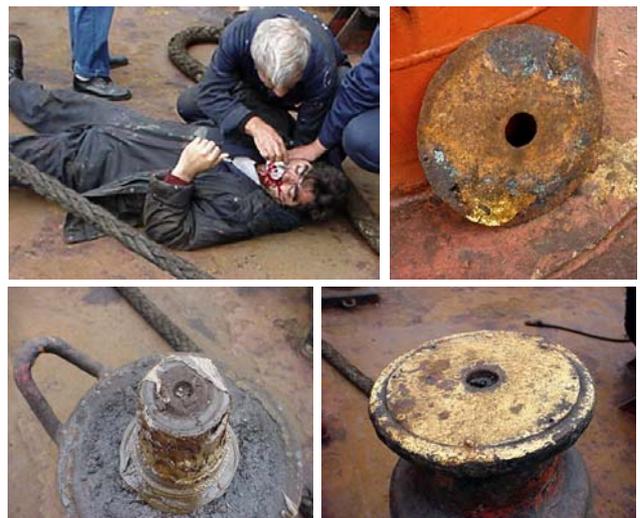
An A/B was seriously hurt when a roller fairlead detached from its pedestal whilst under the influence of a mooring line under tension. The A/B was standing in the snap-back zone and was struck by the rope, which hurled him into the foremast causing head injuries.

The rope hurled the roller fairlead 20 feet from the ship to the quayside.

The angle or directional lead of a rope should be considered when using leads in order to prevent incidents like this. But this particular incident also highlights the importance of proper maintenance of mooring equipment.

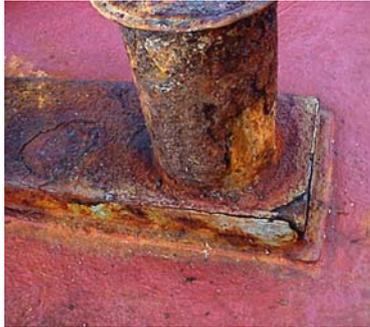
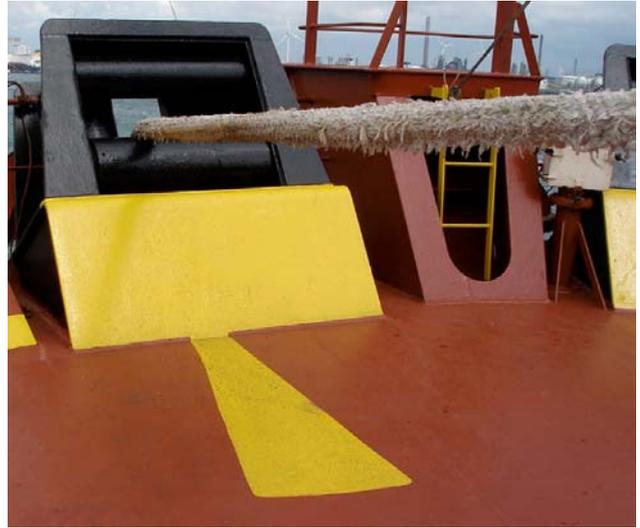
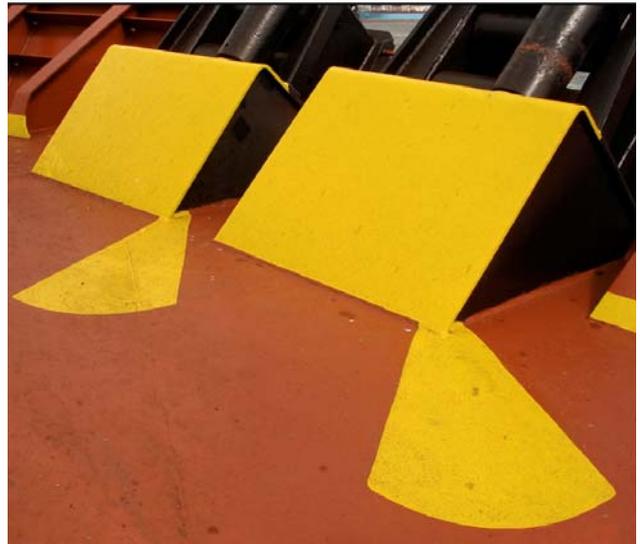
The image (left) shows a pedestal fairlead that is well maintained. There is evidence that it has recently been turned and greased and the grease nipple on top is highlighted.

Mooring equipment that has suffered severe wastage will not perform to the certified standard. This also applies to the steel to which the equipment is welded. The image shows mooring bits that are badly wasted. The deck is in equally bad condition and there is a danger of the bits being torn from the deck.

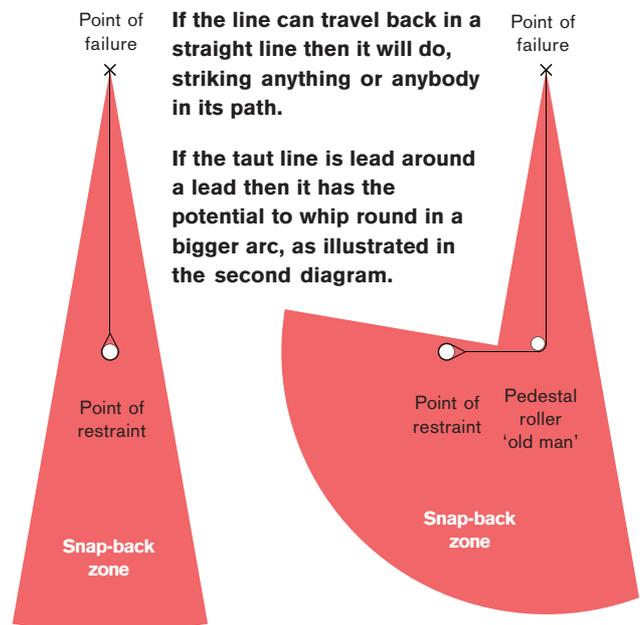
When a line under tension parts, it will whip back to the remaining point of tension.

If snap-back zones are painted on the deck then crew will be alerted to the danger when they notice they are standing in a highlighted zone.

Painting these areas also helps supervising officers instruct crew to keep clear when lines are coming under tension.

Highlighting mooring line snap-back zones ensures that crew can visibly see the danger areas without having to purposely think about them while working.

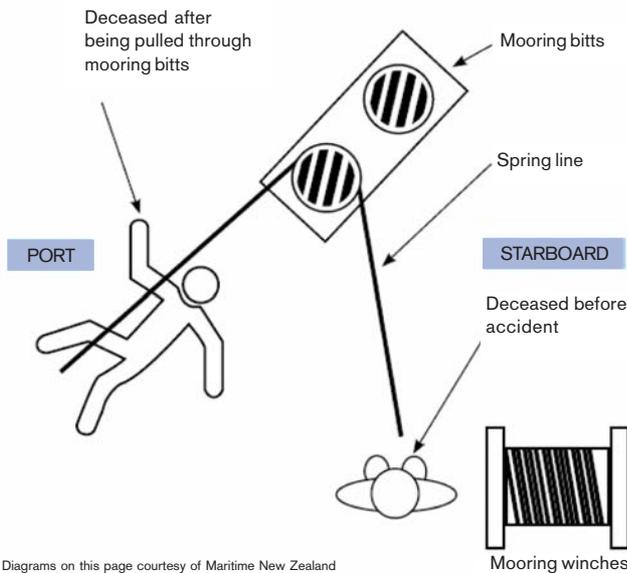
The diagram forms part of an investigation report into the death of an A/B who was dragged through a set of bits by a mooring line.

This incident also highlights procedural and awareness issues because the mooring party forward informed the bridge that all lines were clear when they were in fact still in the water. Nobody noticed that as the vessel was manoeuvring away from the berth, one of the lines became snagged on one of the wharf buttresses.

The unfortunate seaman was recovering the line but stepped in a bight of the mooring line as it became taut and was then dragged through the bits as the fouled line ran from the vessel.

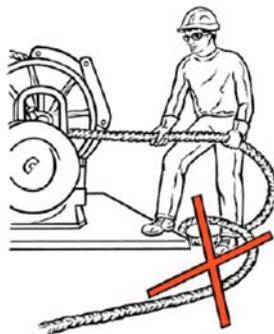
Bights don't always look like bights. Here a seaman has inadvertently stepped over the line and put himself at risk

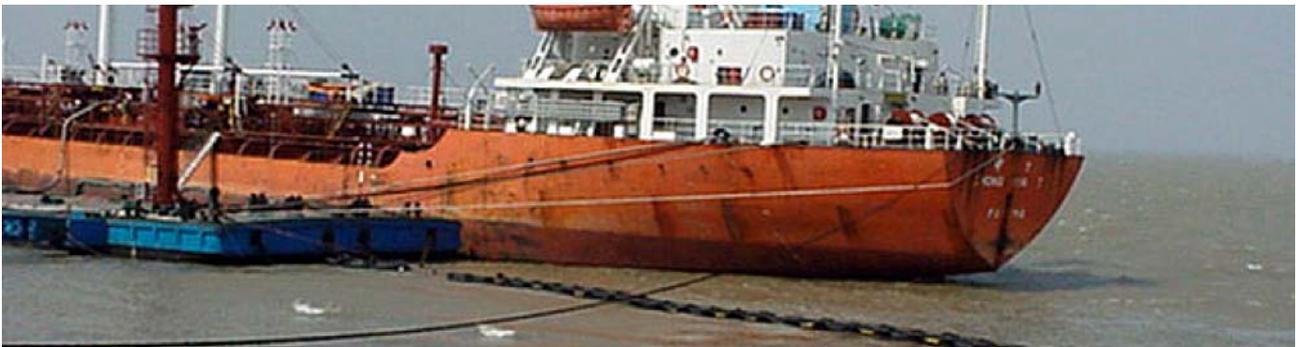
The image below shows a vessel considerably overhanging her berth. She is therefore unable to lead any stern lines aft of the ship. The image shows one line in particular being lead an extremely long distance, rendering it pretty much useless.

The ship has correctly put out as many lines as possible but should also consider the use of the anchor and mooring lines running aft from either the main deck or other suitable areas. In situations like this it is important to analyse local tidal and weather patterns in order to predict how the vessel will be affected. The vessel owners should be informed and cargo operations stopped (or not commenced) if conditions do not appear safe.

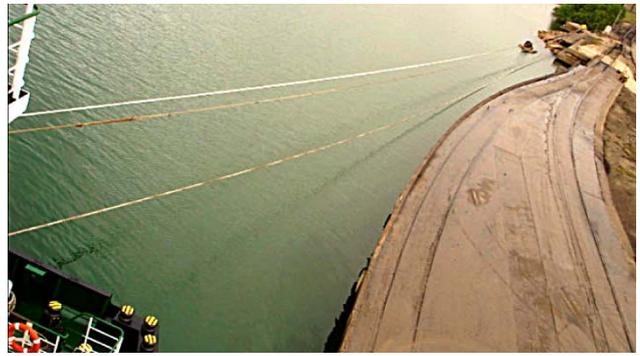
The following image shows insufficient mooring arrangements ashore and the vessel is forced to pay out an extremely long lead on the stern lines. In this event, the master should protest to the port authority, take photos and inform the owners.

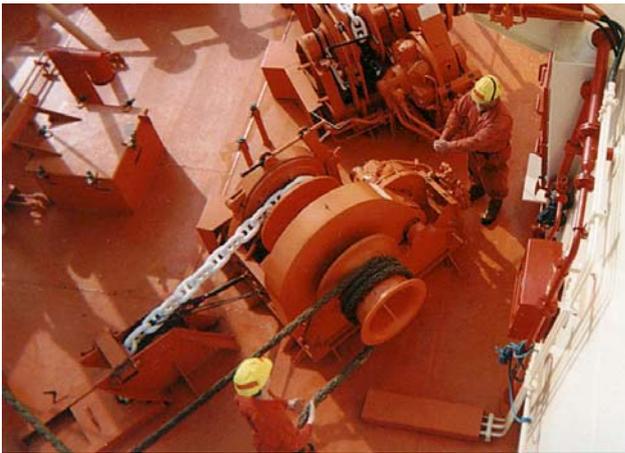
Mooring operations should be conducted in a safe manner. In the image below:

- The line on the windlass drum is being handled safely. The crewmember at the drum is keeping his hands clear of the turns and positioned so as not to become fouled in coils of rope.
- The crewmember operating the windlass has a good line of sight of the rope and the man handling it.
- Both crew are appropriately attired in correct personal protective equipment.

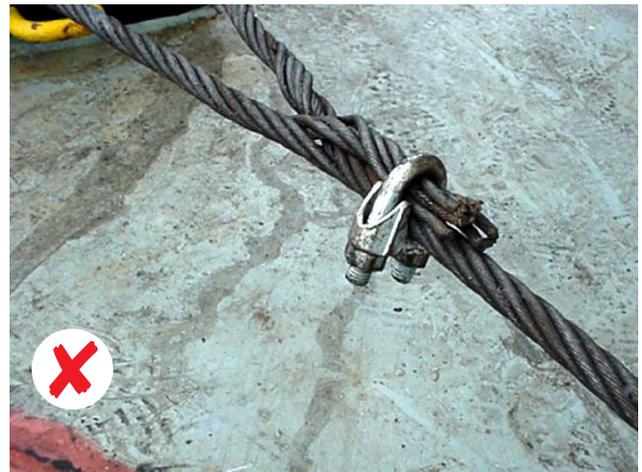
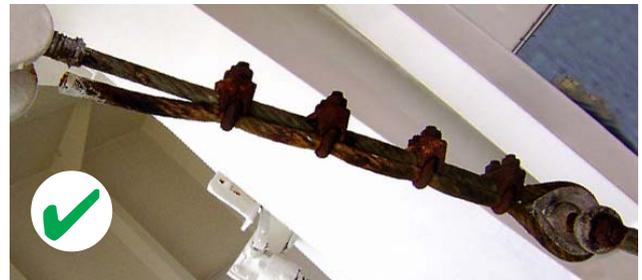
- An allowance of 150 mm should be made between the last bulldog grip and the end of the 'dead' wire. It is important to ensure that the lashing wires are not cut short immediately next to the bulldog grips.

- Bulldog grips have a grooved surface in the bridge piece which is suitable for a standard wire of right-hand lay having six strands. Crosby grips have a smooth surface in the bridge piece. The grips should not be used with ropes of left-hand lay or of different construction.
- The first grip should be applied close to the thimble or at the neck of the eye if a thimble is not used.

Other grips should be placed at intervals of at least one clear grip (albeit a distance of six rope diameters apart is suggested) between each other.

- The grips must all face in the same direction and must be fitted with the saddle or bridge applied to the working or hauling part of the rope. The U-bolt must be applied to the tail or dead-end of the rope. If the grips are not applied as indicated above, the effectiveness of the eye can be seriously affected.

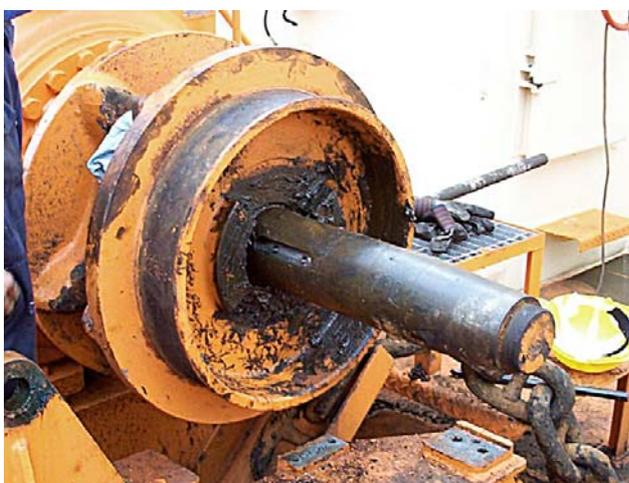
This windlass drum suffered bearing damage and is being overhauled

Windlass drums are not designed for taking the weight of mooring lines for a long period of time. If windlass drums are used for this purpose then over a period of time they will suffer damage and be in need of repair.

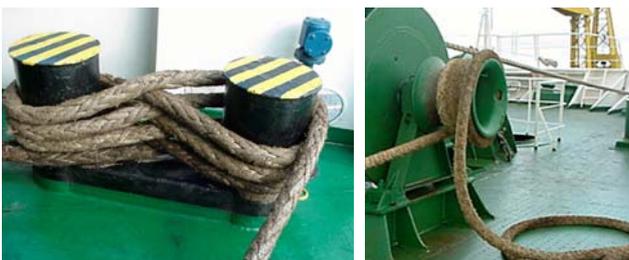
Once ropes have been hauled tight they should be secured to bitts as in the good example on the left

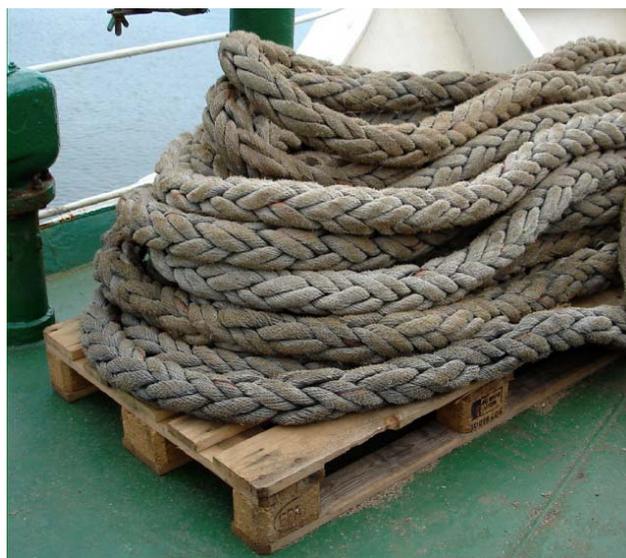
Ropes correctly stowed off deck

stowed off the deck and if possible away from precipitation and direct sunlight. If baskets or other storage devices are not available then ropes should be coiled down on pallets (see below).

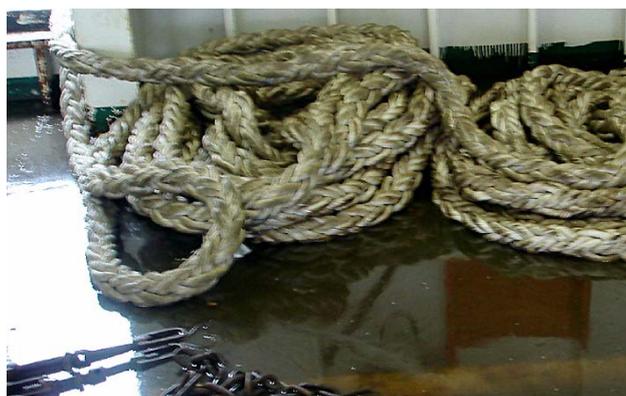
Ropes badly stored on wet deck
