Self-contained breathing apparatus cylinder connections

Sets should be maintained to the highest possible standard

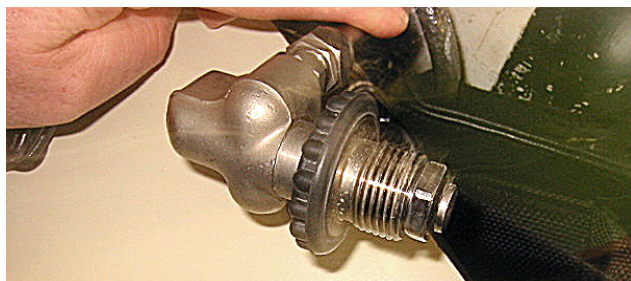
The SCBA cylinders are highly engineered and can be progressively damaged by incorrect use. The screwed thread on the cylinder is a tapered thread. This ensures that as the screw connection on the high pressure air line is tightened by hand, the fit becomes secure enough to withstand the high pressure of the air (>300 bar on some sets) flowing from the cylinder to the apparatus.

It is not uncommon to see that this valve has been secured to the apparatus using spanners or other hand tools. This should not be done, tightening by spanner

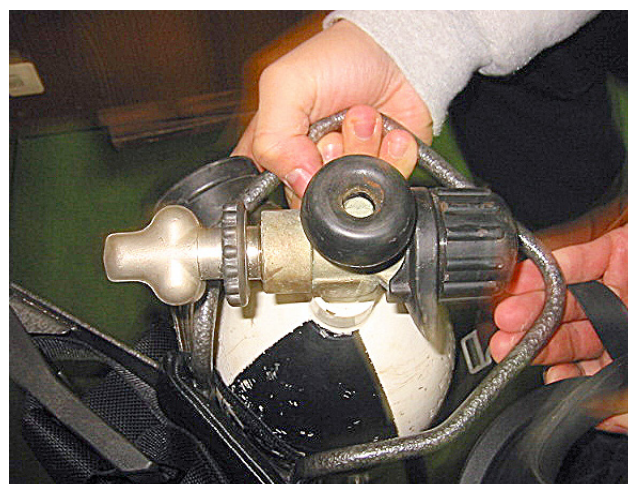
results in the screwed thread being overly compressed and tensioned. Consequently the threaded connections are not air tight and in an effort to make them so PTFE tape (polytetrafluoroethylene plastic thread tape) has often been used (photo below right).

The use of PTFE tape in this area is dangerous and should be avoided. It is possible for particles of tape to enter the airlines of the apparatus and block the piping to the mask via the reducing valve. This could result in a fatality if the equipment was being used in a real emergency.
