## **Technical Bulletin**

**NUMBER 30 FEBRUARY 2009**

## **Engine room sounding pipes**

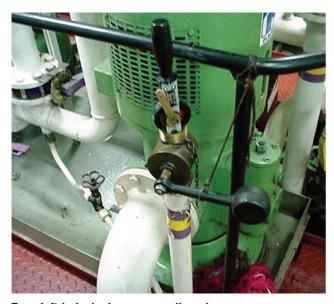
It is commonly found that the 'deadman' weight has been removed, reversed, or lashed open. With springloaded types the springs are often also removed. Sounding rods/tapes or funnels are frequently found to be left inside the open sounding pipe for ease of operation, or for dumping of residues back into the tanks via the sounding pipes.

Tape left in lashed open sounding pipe

Sounding pipe closing devices are important to the vessel's safety and should remain closed at all times, together with the 'caps' in place, except for routine soundings.

This practice can potentially place the vessel in a hazardous situation:

- Flooding of the engine room due to overfilling of tanks or the breaching of the hull in the area of the tanks.
- Sinking due to the flooding being uncontrollable.
- Flash fire caused by oil spill through the sounding pipe coming into contact with hot machinery or exhausts.

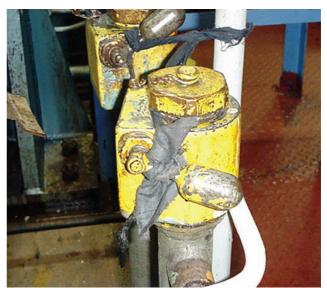
Sounding pipe lashed in an open position
