## Bulletin 415 - 05/05 - Fatal Fall in Engine Room

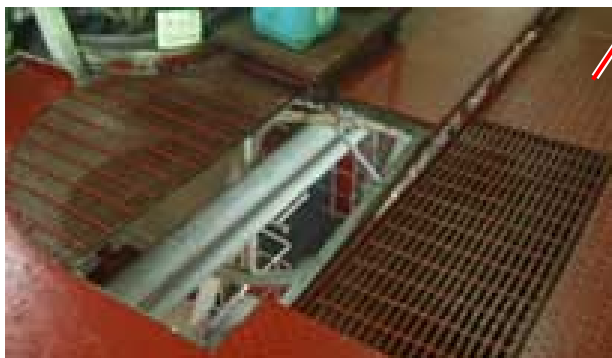
The grating of an opening on the 3<sup>rd</sup> deck level in the engine room of the entered vessel was removed so that a ladder could be passed through it. Unfortunately a young crew member was unaware of the unguarded opening in the deck and fell through it and later died due to his injuries. The image (right) indicates the height of the fall.

The Merchant Shipping (Code of Safe Working Practices for Merchant Seamen) Regulations 1998 deals with areas of concern including the guarding of openings and safety signs.

The Code states that where a normal transit area becomes unsafe to use for any reason, that area should be closed until it can be made safe again.
