# Seaways

# Mariners' Alerting and Reporting Scheme

MARS Report No. 277 November 2015

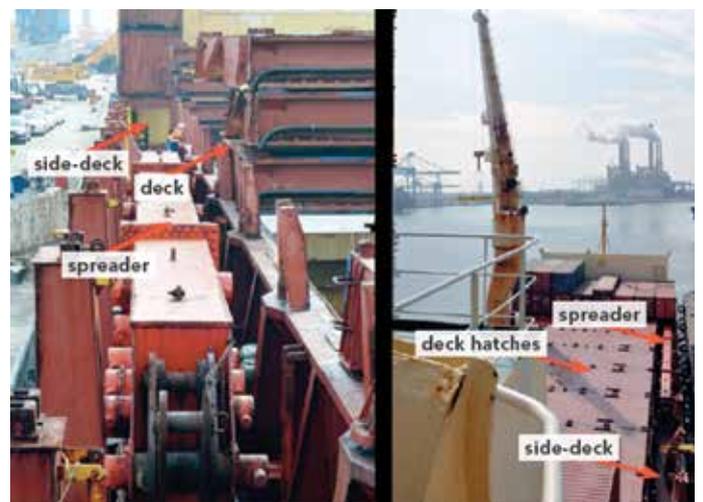
➔ After unloading containers from a general cargo vessel, crew prepared the decks and holds for a new cargo. One task was to move the hatch covers forward; a crew member operated the ship's crane to move the hatch while two other crew guided the hatch with securing lines on each side. The crew member guiding the hatch on the starboard side was blocked by the vessel's heavy lift spreader stored on deck, so he had to climb the spreader in order to continue his pace forward. At some point while on the spreader he lost his balance and fell overboard between the ship and the dock. An officer nearby heard the splash and rushed to the scene. With the help of other crew, the officer was able to recover the fallen crew onto the quay but the victim was unconscious. The victim was taken to hospital but died of his injuries later that day.

It is not known how the crew member lost his balance, but after the accident it was found that his shoes and coveralls were in very poor condition. At the time of the accident the victim was not wearing a safety harness, life vest or helmet.

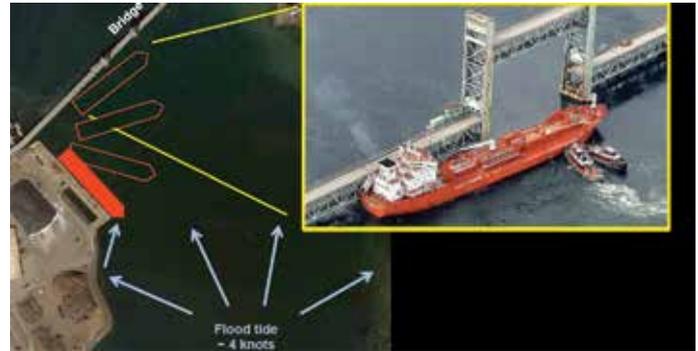
Because of draught considerations, the vessel was docked such that the ship's bow extended 30 feet beyond the east end of the wharf. After docking, a crew member conducting a patrol noticed dust and smoke coming from the brakes of the mooring line drums on the bow. The alert was given and the bridge team tried using the ship's bow thrusters to push the vessel toward the dock but to no avail.

As the vessel's bow was pushed into the river, the three mooring lines that were on bitts parted (both forward springs and one aft spring). The remaining mooring lines were on winches; the winch brakes began slipping and the lines quickly ran free off the drums and fell into the water. Within about 10 minutes of the initial warning, the ship was adrift in the river. Anchors were dropped but they only slowed the drift. A few minutes later the vessel struck a bridge, which sustained approximately \$2.5 million in damage, while damages to the vessel were estimated at \$1 million.

- All mooring lines should be equally tensioned so as to share the load.
- Never underestimate the force a current can exert on the vessel and carefully evaluate the vessel's mooring situation with respect to possible current interactions.
- Mooring winch brakes should always be in top condition and properly adjusted.
- Given the vessel's bow was exposed to the flood tide current, several bow lines should have been on bitts as opposed to on mooring winches.
