### MARS 200935

#### Eye injury due to burst hose

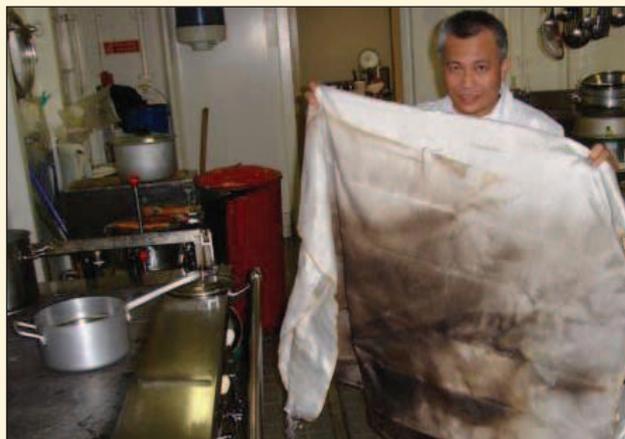
Just before noon, the cook was making French fries in a deep aluminium cooking pan, placed over the hot plate. When the potatoes were added to the hot oil, the pan was overfilled and some oil overflowed and landed on to the hot plate. The temperature of this was sufficient to cause the oil to auto-ignite. The flames immediately spread, causing the oil vapour in the pan also to ignite.

The cook instantly drew out the fire blanket from its container in the galley and covered the pan with it. However, the spilled oil on the hot plate continued to burn around the

covered pan, so he removed it, still-covered, and doused the flames on the hot plate with a wet towel. He telephoned the bridge to alert the OOW of the situation, by which time the fire had been extinguished with no damage to the galley or injury to personnel.

1. Lack of company standard: the vessel was not fitted with a stand-alone deep fat fryer, resulting in the unsafe practice of open deep frying over a hot plate;
2. There was too much oil in the cooking pan before potato chips were added.

▲ Figure 5: Cook displaying fire blanket after the incident

1. Management to consider fitting stand-alone deep fat fryers in all newbuildings.
2. Cooks to use deeper cooking pans and smaller quantities of oil when cooking potato chips.
3. Fleet to discuss the incident at safety meeting and determine the circumstances under which the fire alarm should be activated and fire party mobilised. Also to impress upon crews that the fire party should be standing by for some time after the fire is extinguished to prevent re-ignition.

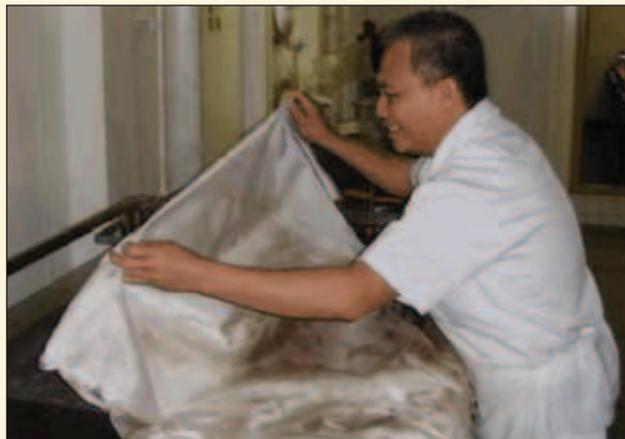
▲ Figure 6: Cook demonstrating use of fire blanket
