Bulletin 387 - 11/04 - Chemical Drum Explosion in Engine Room Workshop

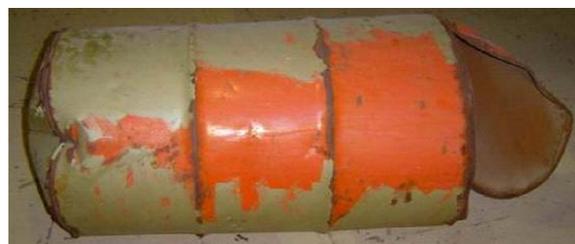
Apparently the two men lowered the drum to the E/R workshop, without any water rinsing, and the engine boy proceeded to use a pneumatic grinder to cut the drum. Evidence on the drum shows that they had barely penetrated the drum when it exploded from the bottom, owing to the explosive atmosphere within the drum (the drum was sealed with both its caps on, see picture below).

The crew obviously did not fully appreciate the inherent risks involved in the task. The lack of supervision allowed the engine boy and motorman to pick up a drum from the deck, lower it into the engine room and proceed with the job of disc cutting the drum without any checks either from the Chief Officer, regarding why the drum was being removed from the deck, or the 2nd Engineer as to why the drum was being cut up in the engine room workshop. The procedures for hot work in the onboard safety manual did not specifically include how to deal with empty drums. Consequently, in this case, the crew did not treat the task as dangerous and failed to carry out the risk assessment/procedures associated with hot work.
