MARS Report No. 267 January 2015

MARS REPORTS

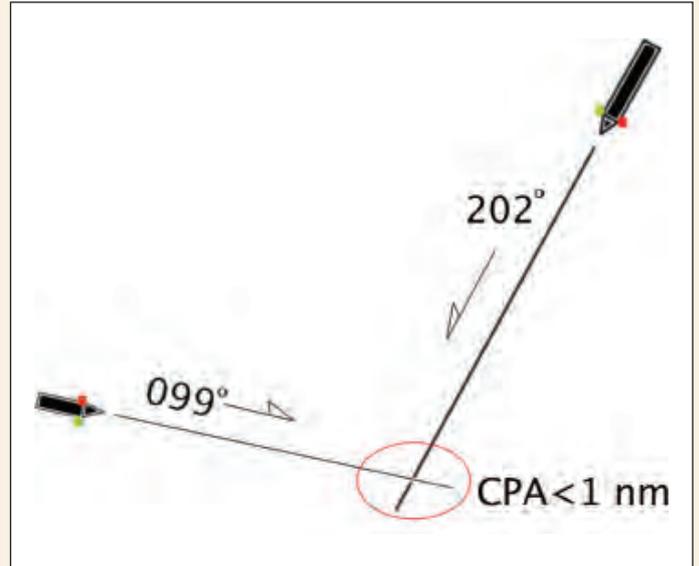
The unprofessional attitude of the cargo vessel's OOW is evident here; at 10 nm he was aware of the crossing situation with a small CPA but he apparently assumed that since he was on the larger vessel he could 'bully' the smaller vessel into changing course instead of assuming his responsibilities under the collision regulations.

This unprofessional attitude is again evident by the lack of proper communication. The OOW of the cargo vessel never confirmed his actions, saying vaguely he was 'watching'; and only within minutes of the CPA did he abruptly alter course to starboard without warning.

At 10 nm, an alteration of course of 30 degrees to starboard for a relatively brief period by the cargo vessel would have cleared the situation with minimal consequences to their schedule.

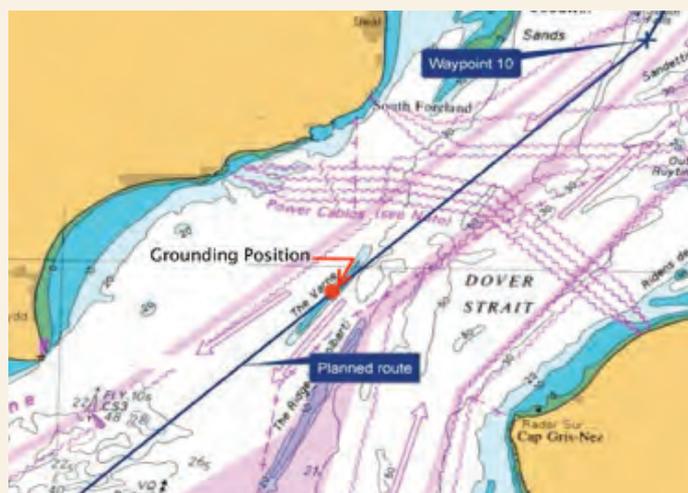
At this point, the OOW did not yet realise that the vessel was aground. Three minutes after grounding an engineering alarm sounded and the OOW placed both azipod control levers to zero. He then informed the Master of the alarm and also rang the engine control room to request they check the engines. Within a few minutes the engineer telephoned the bridge and informed the OOW that ahead pitch was available on the starboard azipod. Accordingly, the OOW moved the starboard azipod control lever to pitch ahead but the ship remained stationary. This led him to assume that there was still a problem with the ship's engines.

A few minutes later, after having been contacted by VTS, the OOW zoomed in on the ECDIS display and realised that the vessel was aground. He placed the starboard lever back to zero pitch and called the Master, who came to the bridge.

1. The passage plan had the vessel pass directly over an area of water with less depth than the draught of the vessel.
2. The passage plan was not properly checked for navigational hazards using the ECDIS 'check-route' function, nor was it verified by the Master.
3. When taking over the watch, the OOW did not check the ship's intended track relative to any dangers to navigation that would be encountered on his watch. Additionally, the OOW monitored the vessel's position solely against the intended track. Consequently, his situational awareness was poor.
4. Although the lights from the cardinal buoys marking the shallow water were seen by the lookout, they were not reported.
5. The ECDIS audible alarm was inoperative. Although the crew were aware of this defect, it had not been reported.

9. The ECDIS display for the voyage had the safety contour set at 30m, which was the manufacturer's default setting. The preferred safety contour for the vessel should have been obtained using the formula in the vessel's SMS ($\{\text{Draught} + \text{squat}\} \times 1.5$, or about 13m in this instance). The ECDIS would then have defaulted to the nearest deeper contour on the chart in use, the 20m contour. This in turn would have given a much better indication of the dangers and hazards along the route (Figure 3).
