Seaways

Mariners' Alerting and Reporting Scheme

MARS Report No. 260 June 2014

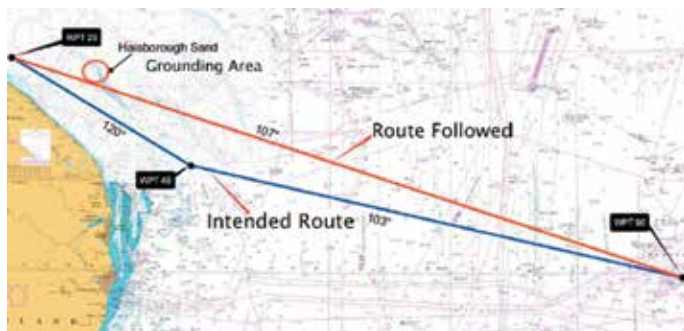
In the incident report forwarded to the ship's manager after the vessel was re-floated and had anchored, the Master stated that the chief officer had experienced a problem keeping the vessel on course. He reportedly had changed from autopilot to hand-steering to emergency steering, but this did not solve the problem. The chief officer had called the Master to the bridge, sent the chief engineer to check the steering system, sent seamen to open the ventilation flaps to allow the use of the bow thruster and to prepare both anchors for letting go. The Master also stated that when he arrived on the bridge, he checked the steering but the vessel was drifting onto a shallow bank. The incident report also included the chief officer's account, which accorded with the Master's description of events and a report from the AB on watch which stated that he had been on duty on the bridge between 0000 and 0400.

Subsequent investigations proved this story to be false.

- The vessel departed from the intended route because the waypoint selected as the destination in the GPS did not follow the sequence of waypoints detailed in the voyage plan.
- The chief officer did not notice that the vessel had deviated from the intended route because he relied solely on GPS and did not verify the course the vessel was following or plot the vessel's position on a paper chart.
- The chief officer probably fell asleep for an extended period; he was alone on the bridge and the bridge watch alarm was switched off.
