LP BULLETIN

Bulletin 592 - 7/08 - Case study: improper use of fumigant in bulk cargoes - Worldwide

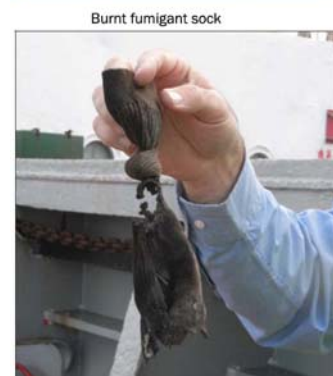
When the hold was opened, it was apparent that only two small areas of the cargo had been affected. Both of the affected areas had burnt in a circular pattern that was centred on the location of a fumigation sock. However, the fires had not grown in size over the ensuing days because as they developed they had consumed the available oxygen in the cargo hold.

The socks containing the fumigant were buried in the cargo. The

surrounding cargo would have slowed the dissipation of heat from the reacting fumigant tablets. As a result, it is likely that the local temperature rose to a level above the auto-ignition temperature of the diphosphine gas and that the gas subsequently ignited.

Furthermore, it is possible that the local concentrations of the gases built up quickly as a result of the hot and humid conditions inside the cargo hold and that there may have also been too much fumigant placed in each sock.
