MARS 200933

Preventing mooring accidents

Adapted from UK P&I Club's *Loss Prevention Bulletin* January 2009

MARS 200934

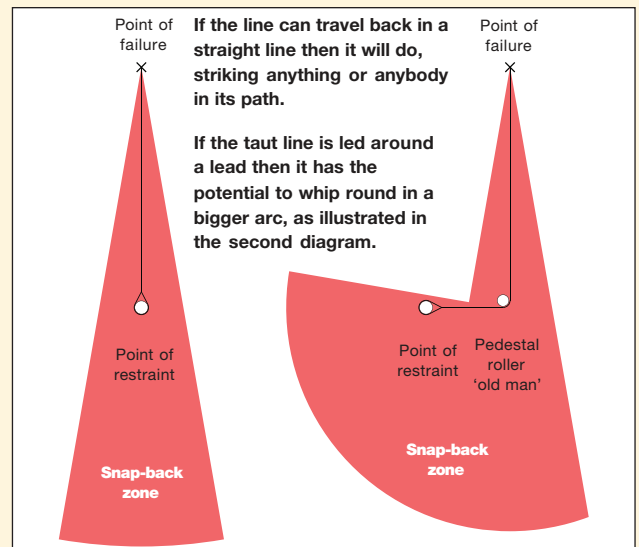
When ropes under stress break, or if tension is suddenly released (for instance when a mooring line that is jammed on a bollard under another vessel's lines, or is otherwise obstructed in any way, and suddenly clears under tension), the free end tends to 'whip' or 'oscillate' violently (see incident on p 18, under 'Maintenance'). It is possible to estimate the limits of these 'snap-back' zones and if they are highlighted on the deck, the mooring crew can avoid standing inside or close to these danger areas.

▲ Figure 2: Method of estimating snap-back zones (from MCA Code of Safe Working Practices for Seamen)
